## **Street Audit: Tollcross (Edinburgh)**

**Living Streets Edinburgh Group**

**October 2015**

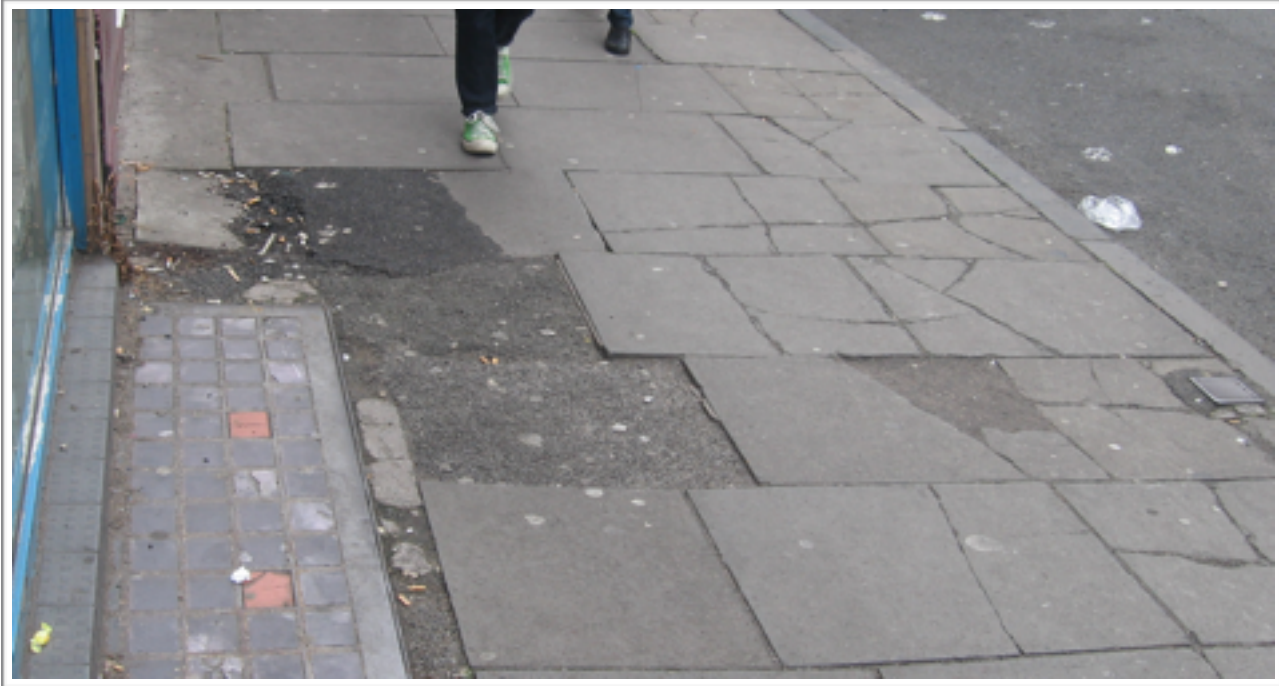
Figure 1

At several places along both Home Street and Lochrin Place, the pavement surface is in poor condition. This results in trip hazards and difficulties for elderly and disabled people. Examples of this are in Home Street (East) outside Greggs, the Kings Pantry and Omega Travel (Figure 1) and on Lochrin Place (North side). As part of the cycle way project, defective footways should be repaired or replaced to an adequate standard.

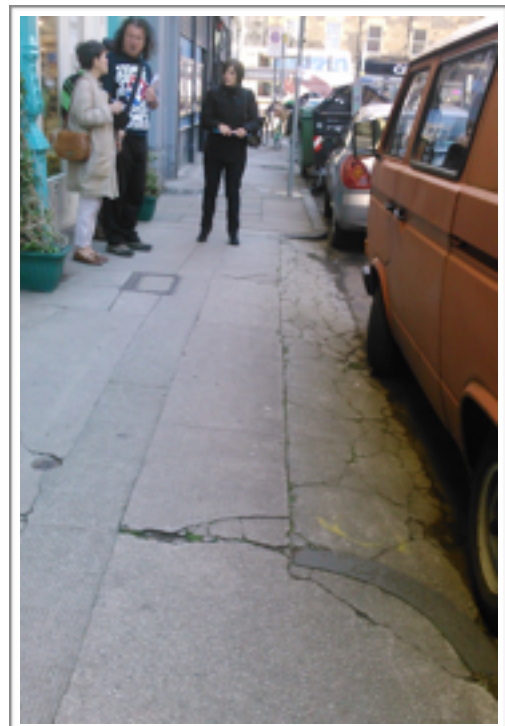
Figure 2

It was noted that some sections of the footway on Lochrin Place (North side) retain vestiges of old kerbs, presumably remnants from former vennels (Figure 2). These should be retained, in order to maintain some elements of the historic streetscape.

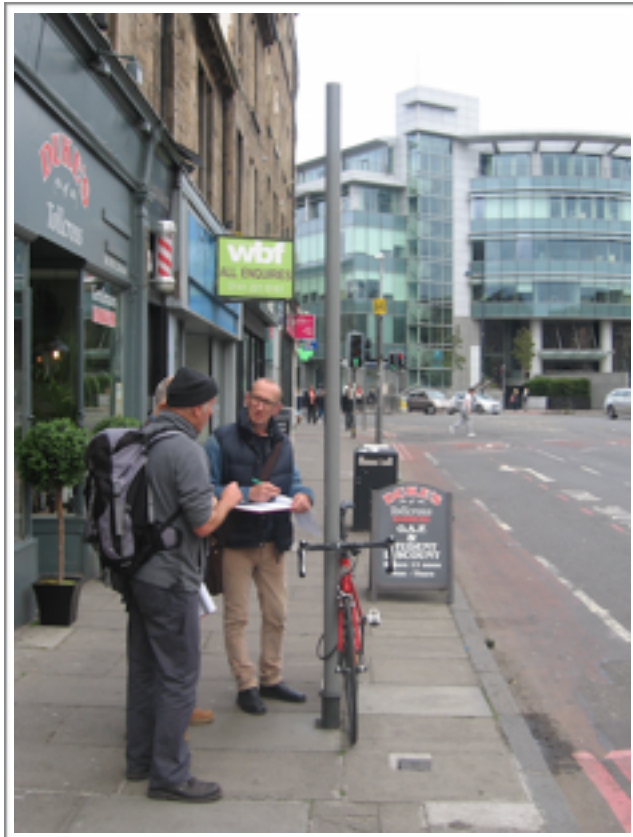
Figure 3

- Home Street West (Dukes/Anatolian) - bare pole with no sign attached (Figure 3)
- Home Street West (Cancer Research) - unnecessary 'dead end (except cycles)' sign (Figure 4)

1. consider if the sign is required at all; if not, remove altogether;
2. if the signage has been assessed as required, consider an alternative location for the sign (eg move the sign to a lamppost, onto another signage pole, or on a building wall)
3. if this is not possible, locate the signage pole as close to the kerb as possible, and group signs onto a single pole. Poles should have sufficient contrast in colour/tone to

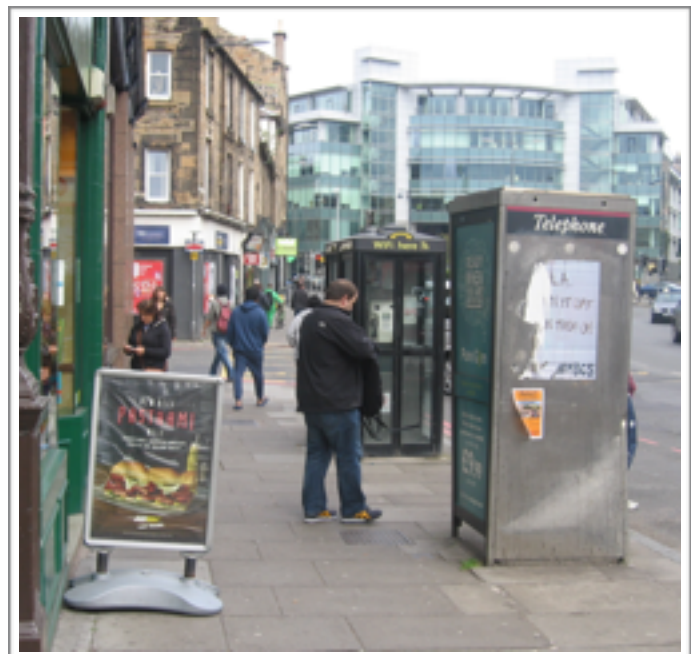
Figure 5

Finally, near the Cameo cinema, a group of three telephone kiosks forms a particular obstruction. One of these, a BT phone box at Subway (Figure 5) is completely gutted internally (despite the 'temporarily out of order' sign) and should be removed, with any repairs to the footway implemented to reinstate the pavement surface appropriately.

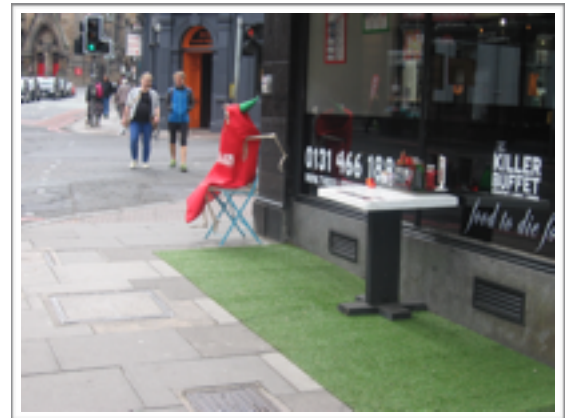
Figure 6

Home Street in particular suffers from an excess of temporary clutter in the form of displays, A-Boards and waste bins. This is especially acute in the section between Lochrin Place and Thornybauk (outside the Cameo Cinema, exacerbated by the presence of fixed street furniture too (see above). Examples are outside McGills and Hex and outside the Killer Restaurant (junction Home Street and Gilmore Place) where the pavement display reduces the already-narrow pavement (Figure 6). On-street displays are also present at the Cuckoo's Nest (barrels and an unstable board) and Tollcross superstore (fruit and vegetables). Although a matter of subjective judgement, some advertising displays were also considered unsightly and 'tacky', which does not contribute to an attractive street ambience.

We accept that retailers are entitled to advertise through street displays, and do not advocate 'sterilised' streets; however we suggest that displays or other advertisements should be limited to one per shop. They should also be placed next to the building (not the kerb) as consistent placing will assist blind people navigating the street and minimise the sometimes haphazard zigzag path which pedestrians are currently faced with. Where the pavement is narrowed further because of fixtures such as signage poles (see Figure 8), there should be no A-Boards (unless the poles can be removed).

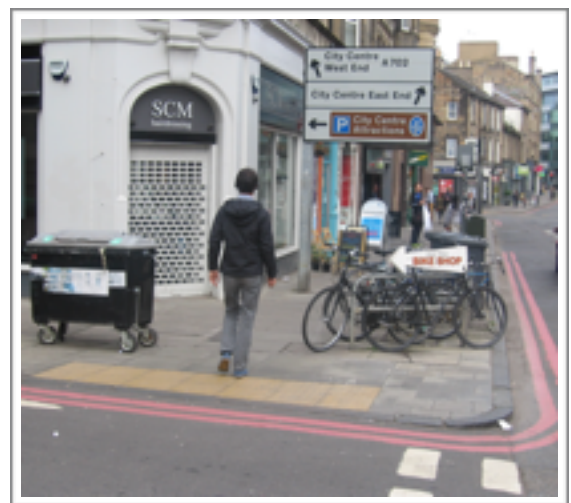
Figure 7

With regard to waste bins, these also present significant and unpleasant obstacles for pedestrians, with the junction between Home Street and Lochrin Place a particular hotspot for this problem (Figure 7). We found 15 bins located at this single junction, a mix of trade and residential waste. One (movable) bin was sited directly on the pedestrian desire line along the small pavement space left on Home Street.

The main cycle parking facility in the area audited is located at the congested junction of Lochrin Place and Home Street, which as noted above already suffers from a number of other permanent and temporary obstacles (Figure 7 above). This cycle parking is well-used which suggests a demand for cycle parking at this juncture, but it should be re-located from the pedestrian desire line.

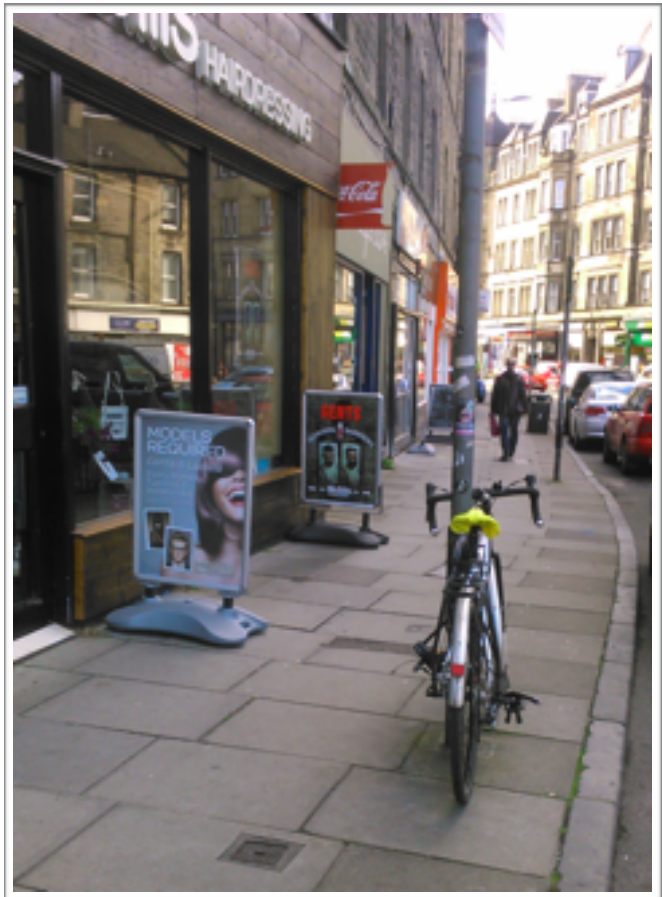
Figure 8

Views on the merits of cycle hoops attached to signage poles (as present on the east side of Home Street, Figure 8) were mixed. Ideally, as noted above we would like to see cycle parking provided off the footway entirely. However, cycle hoops do make it more likely that bicycles attached to street furniture remain upright, and parallel to the main pedestrian flow. As such, they may have a place to provide cycle parking where pavements are wide enough and there may otherwise be a risk of cyclists leaving their bikes in a less appropriate place. The pavement is too narrow for cycle hoops to be used at #3, 9 and 18 Home Street and we therefore recommend their removal.

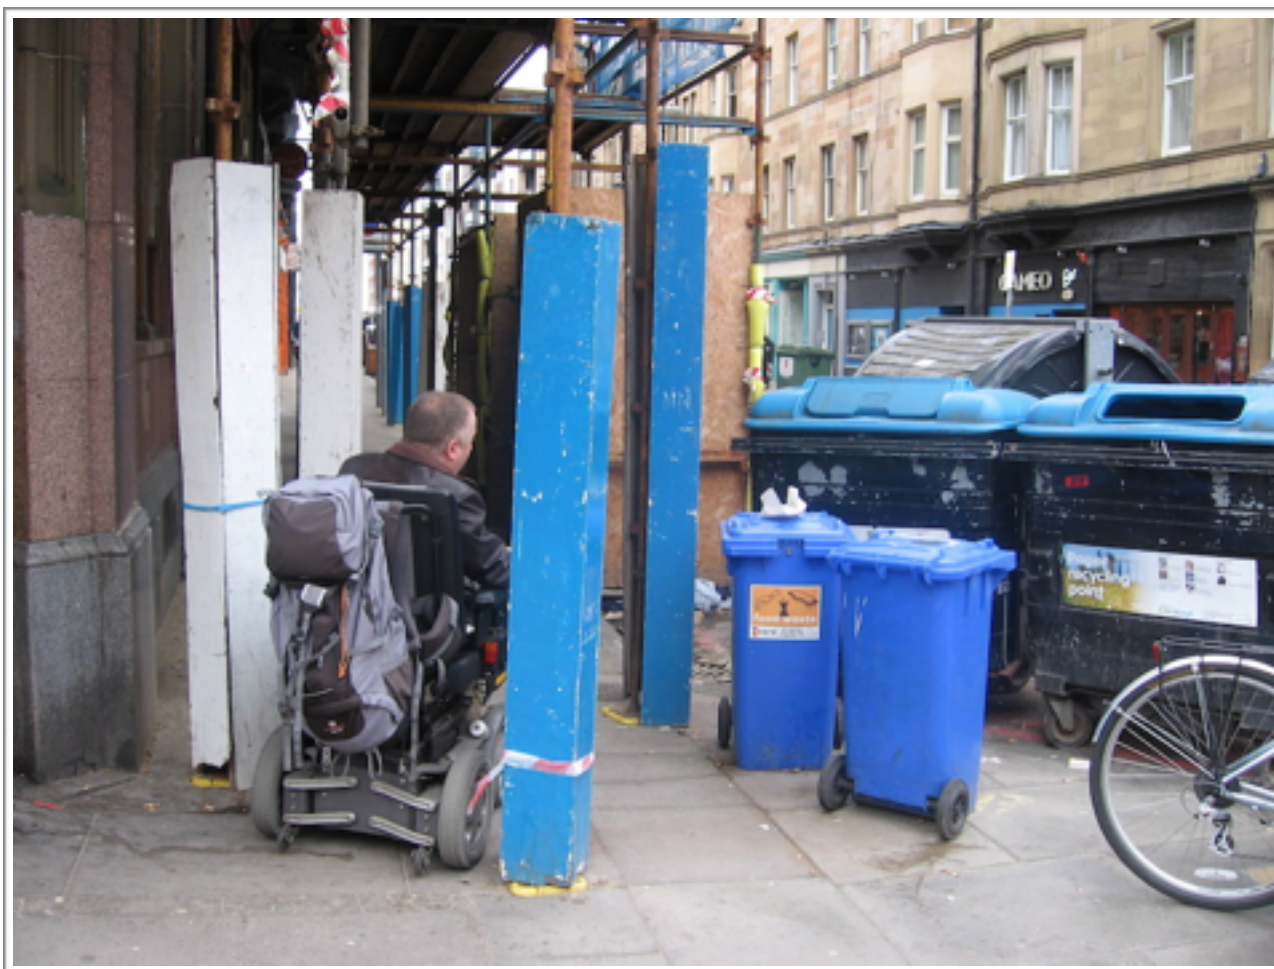
Figure 9

Many of the problems we identified about the functioning of the street for people walking appear related to ineffective management and enforcement of legal and licensing requirements. We have noted above the proliferation and poor location of many waste bins and A-Boards; of other examples encountered, one of the most potentially serious is the scaffolding at the corner of Lochrin Place and Home Street. Apart from constituting yet another obstacle to this unpleasant junction, the scaffolding is not properly protected with soft covering as required by Council policy (4) (Figure 9).

One pole - the first encountered by a pedestrian walking north along Home Street - is entirely unprotected and represented a significant hazard to all pedestrians and especially anyone with a visual impairment (Figure 10). This was reported for urgent attention to the council's CLARENCE reporting system (and has since been removed).

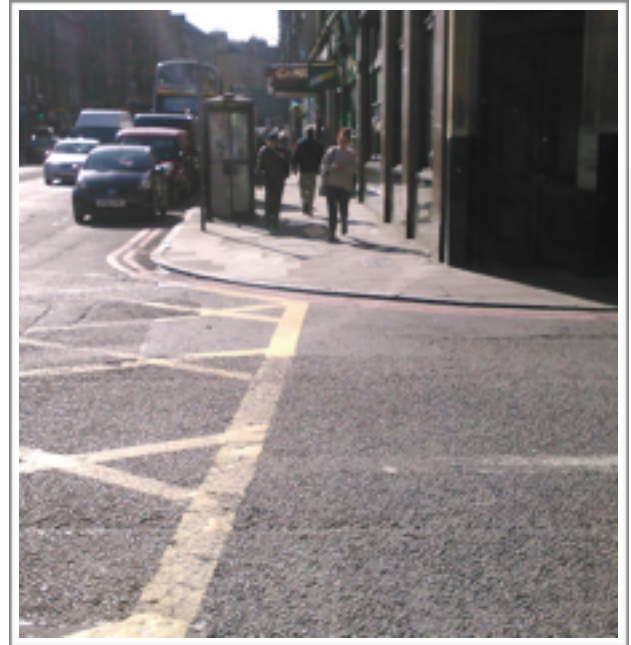
Figure 12

The junction of Thornybauk (also known as Lochrin Terrace) and Home Street is wide and difficult to cross. There is no dropped kerb or tactile paving at the south side of this junction which should be rectified (Figure 12). In the longer term, the road should be narrowed if possible to make it easier for pedestrians crossing - especially if travelling northwards along Home Street, where traffic turning left (ie from behind the pedestrian) can be fast. The junction would also benefit from a consolidation of signage and removal of guardrails, it is appreciated that this would require full consideration of the needs of the local Fire and Rescue service which is based further up the street.

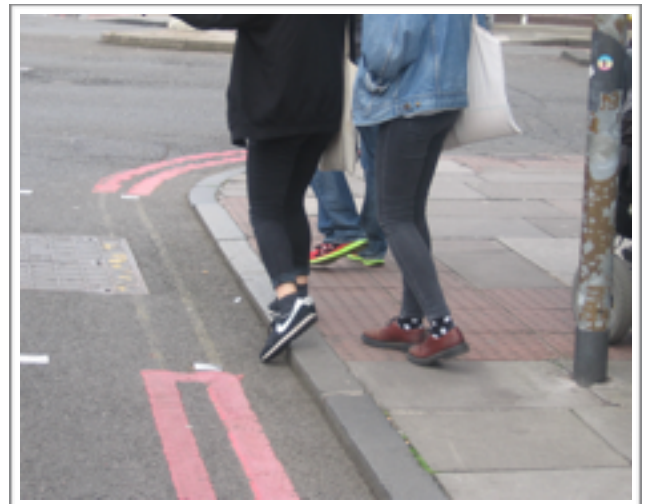
Figure 13

On the east side of Home Street, three slabs of tactile paving are missing at the pedestrian crossing at William Hill. In several locations, e.g. at Home Street/Tarvit Street junction, and at the main Tollcross junction, dropped kerbs are not adequately installed currently and should be replaced; outside James Morrow (Home Street East), the vertical drop was measured as 40mm (Figure 13). Remedial works should ensure that kerbs are not merely 'lowered' but are flush with the carriageway surface.

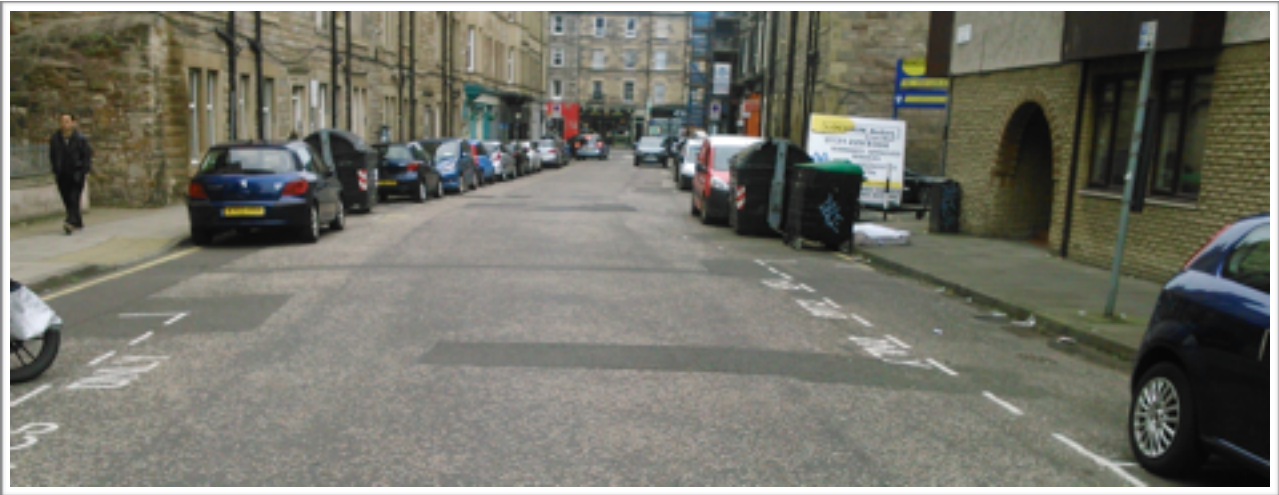
Figure 14

On Lochrin Place (North), there are four dropped kerbs (outside #20, #22 and up to #19 West Tollcross) which appear to be designed for access to waste storage in the tenements. These all have tactile paving incorrectly installed, signalling to someone with a visual impairment that it is a safe crossing point. However, there are no dropped kerbs or tactile paving on the corresponding (south) side of Lochrin Place (as the dropped kerbs are not intended to facilitate pedestrian movement but access to waste bins).

We suggest that consideration is given to retaining the current dropped kerb/tactile paving at the far west (canal) end of Lochrin Place and at 20 Lochrin Place, and installing a similar dropped kerb with tactile paving on the opposite (south) side of the road. This would provide crossing points at these two locations and be intelligible and useful to people with a visual impairment. For the other two dropped kerbs, we recommend that the tactile paving is removed and replaced with a standard paving surface. This would eliminate the misleading signal to blind pedestrians that this has been designed as a safe location to cross Lochrin Place.

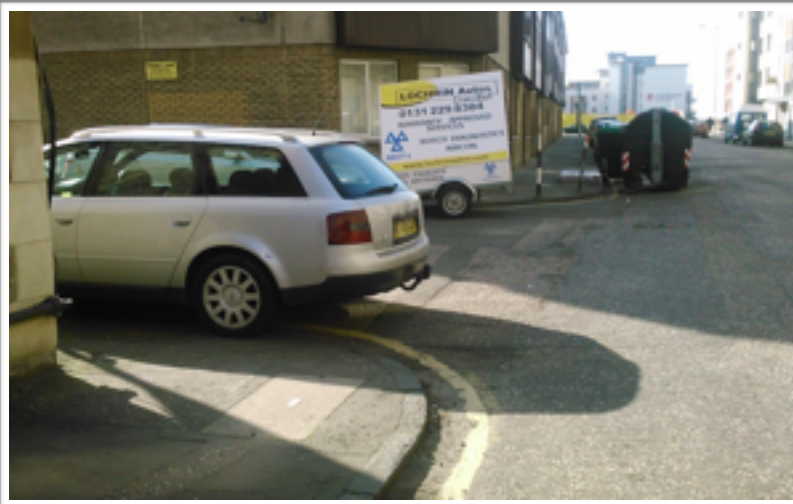
Figure 15

On the south side of Lochrin Place, there is a significant problem at Lochrin Autos (Figures 15, 16). Most obviously, the pedestrian route is blocked through a lack of parking controls and the apparently long-term parking of an advertising trailer on the corner of the pavement. There are also old rusty metal bollards, presumably intended to deter pavement parking, and there are no dropped kerbs or tactile paving on either side of the minor junction. Our recommendation here is to make the pavement continuous across the garage junction in order to provide a level surface giving priority to pedestrians (rather than install dropped kerbs). There will be a need for tactile paving to signal to visually impaired people that vehicles might cross the pavement at this point. This would also permit the bollards to be removed.

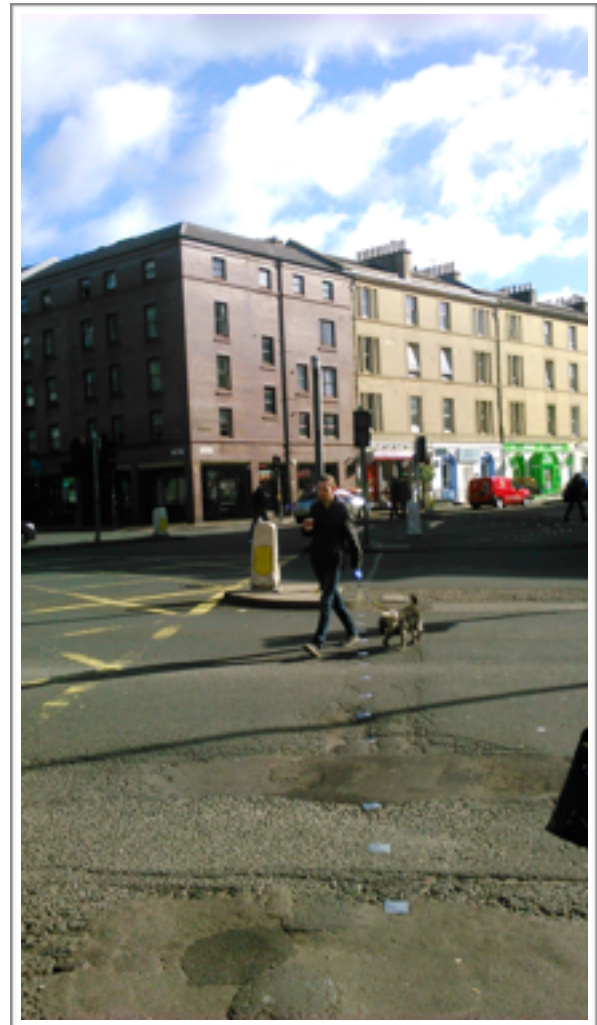
Figure 17

We would like to see a strategic review of this junction, which is very hostile for pedestrians (Figure 17). While our focus was on the crossing of the A702 (Home Street), there are important issues affecting the other pedestrian routes which crossing (West Tollcross, Earl Grey Street, Lauriston Place and Brougham Street). We appreciate that such a review must also take into account the flows and volumes of traffic as well as of pedestrians. We recorded detailed timings of pedestrian crossing routes across all roads at the junction; these are set out in the Appendix together with comments.

In essence, we would like to see a greater emphasis on 'place' over 'movement' (4) and a reduction in the time it takes for pedestrians to cross the junction: it takes almost 4 minutes to cross this junction on foot through the 'green man' phases at present, and many pedestrians currently take short cuts through 'red man' phases as a result. We suggest investigating the possibility of installing a central refuge where the clock is, combined with new timings on the green man in all directions at once to allow pedestrians to cross diagonally as desired.
