## Audit of 'Spaces for People' provision: A702 Tollcross to Morningside Station

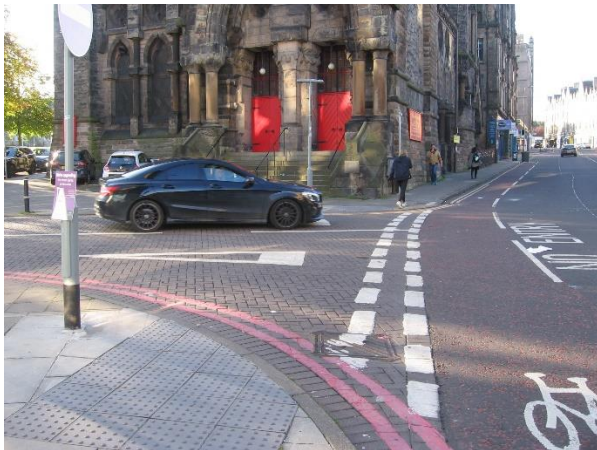
This is a classic example of catering for vehicles ahead of pedestrians. Glengyle Terrace (left) is only a minor road, but pedestrians walking along Bruntsfield Place (ahead) have to negotiate two wide vehicle lanes and look in three separate directions before crossing safely. This is a location where a continuous pavement would make walking considerably safer and more convenient.

*Recommendation: in the short-term, reduce the crossing width with concrete blocks as used elsewhere in the project, and in the longer-term create a continuous pavement.*

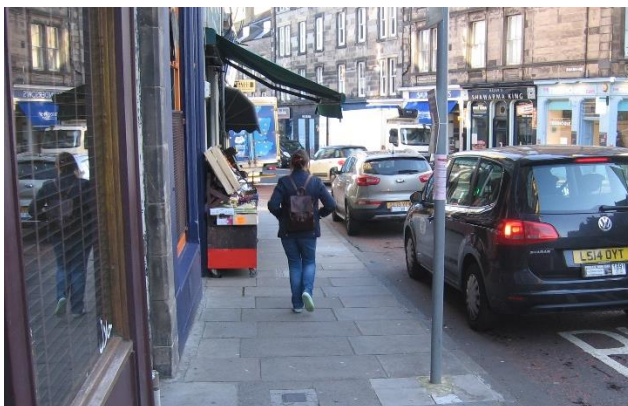
The pavement here is just 2.3m wide (ie less than the SDG 'absolute minimum' of 2.5m), and the Clear Walking Zone is even less, due to the goods on display outside the fruit shop. Section 129(9) of the Road Scotland Act 1984 forbids the placement of goods for sale on the public sections of the street. If alerted to such a problem, the Council can issue a statutory notice to the offending business and action then taken if they fail to comply.

*Recommendation: encourage the shop owner to convert his frontage to create street access to goods on display without encroaching on the pavement, as in the example on Home Street (east side) below.*

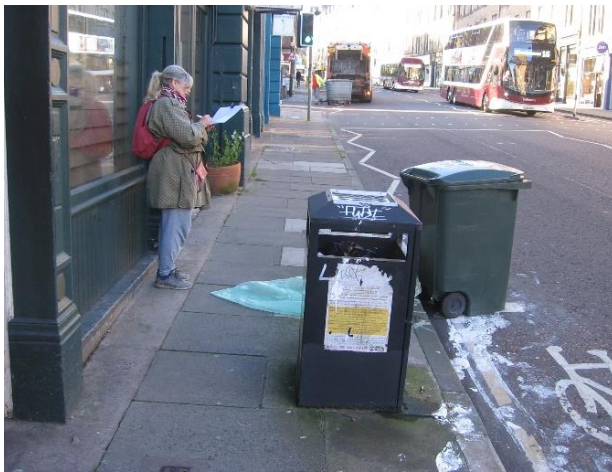
**Location 7E (Bruntsfield Place east):**

The pavement here is just 1.35m wide (ie substantially less than the SDG 'absolute minimum' of 2.5m), and the Clear Walking Zone is even less, due to the inappropriately located litter bin.

*Recommendation: Relocate litter bin to a more appropriate location.*

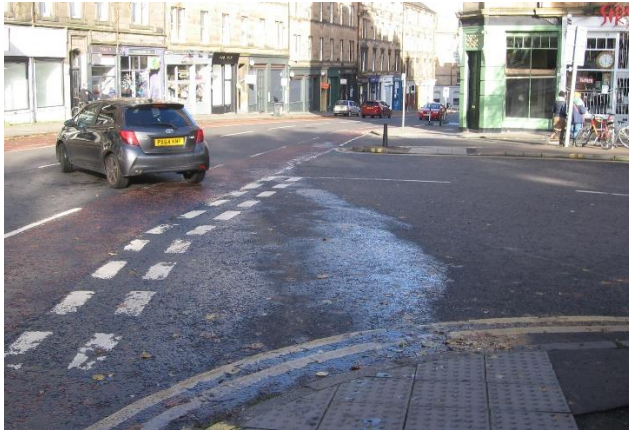
The junction of Bruntsfield Place and Whitehouse Loan is very difficult to cross for pedestrians walking up Bruntsfield Place. Whitehouse Loan is more than three lanes wide at the junction (left photo), and pedestrians have to look in three different directions in order to cross safely. Walking north along Bruntsfield Place, traffic coming from Whitehouse Loan is almost entirely obscured by an overgrown hedge (right photo), and there is no pavement at all along this side of Whitehouse Loan.

*Recommendation: create a SfP space on each side of Whitehouse Loan at the junction by installing concrete blocks as used elsewhere in the project, and cut back the overgrown hedge.*

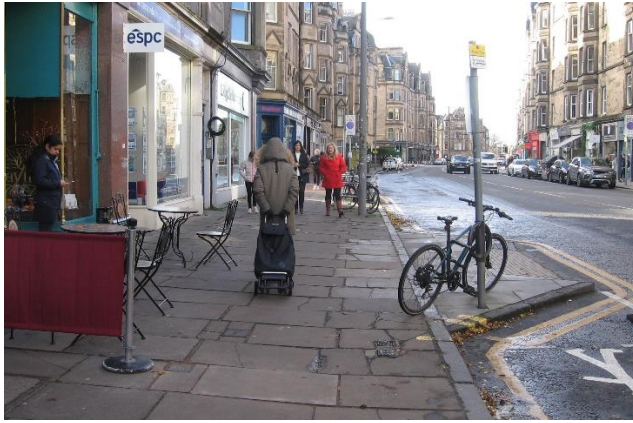
The pavement is already wide here (4.25m) but is to some extent obstructed by café tables and chairs, and informal cycle parking.

*Recommendation: use some of the SfP space to allow nearby cycle racks (see 14E below) to be relocated away from the pavement. Clarify space allowed for tables & chairs in the relevant licence.*

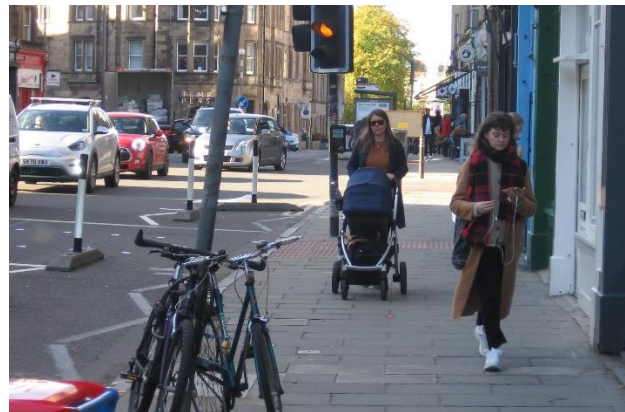
The pavement here is only 2.45m wide (ie less than the SDG 'absolute minimum' of 2.5m), and the Clear Walking Zone between the informally-parked bikes (and pole) is just 1.75m, and therefore the additional SfP space is welcome as a 'social' space and also a 'movement' space adjacent to a popular pedestrian crossing. The street here is extremely busy with children, parents / carers and buggies on their way to Bruntsfield Primary and Nursery at certain times of the day.

*Recommendation: retain the SfP space, remove the now-redundant pole (and hence the informal bike parking), install formal cycle parking facilities in the SfP space, and in the longer term permanently widen the pavement proper to create a continuous one-level space.*

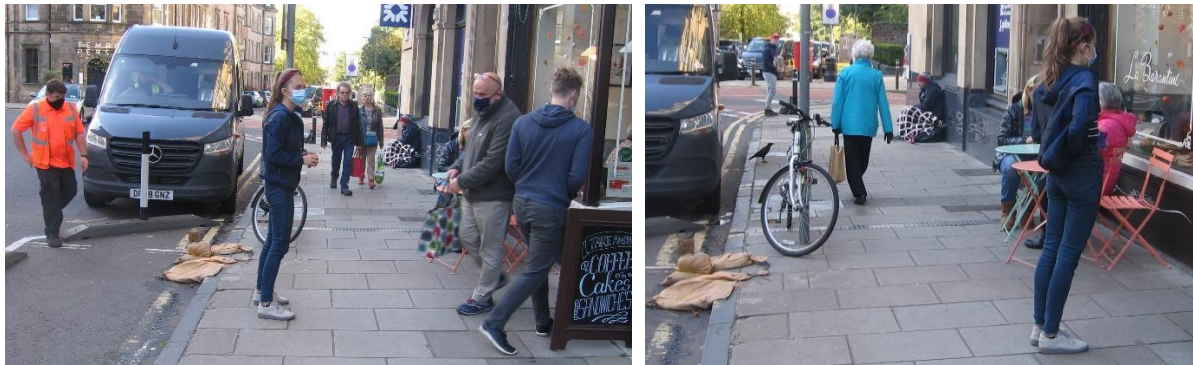
This is a short but useful SfP space at a location with heavy pedestrian footfall and regular queuing on the pavement, but the SfP space does not extend far enough (a) to stop illegal parking by vehicles (left photo), and (b) to avoid the barrier to pedestrians created by informal bike parking (and pole) and tables & chairs (right photo), the latter limiting the Clear Walking Zone to just 1.1m (in contrast to the SDG 'absolute minimum' of 1.5m).

*Recommendation: extend the SfP space towards the Montpelier Park junction, remove the pole, and clarify the space allowed for tables & chairs in the relevant licence. Install formal cycle parking facilities in the SfP space.*

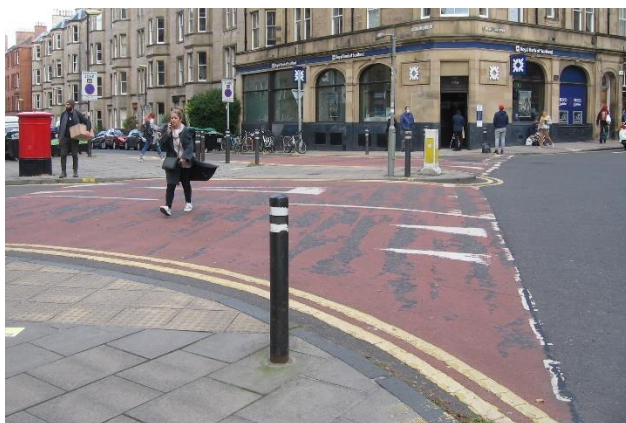
This is a difficult double junction for pedestrians where Merchiston Place (foreground) and Montpelier Park (background) join Bruntsfield Place. Pedestrians walking along Bruntsfield Place have to look in multiple directions and in the case of Merchiston Place have to cross an unnecessarily wide carriageway.

*Recommendation: investigate installation of a formal pedestrian crossing here (Pelican Puffin or Zebra) or creation of a 'continuous pavement' along Bruntsfield Place). Consider closing the Montpelier Park junction.*

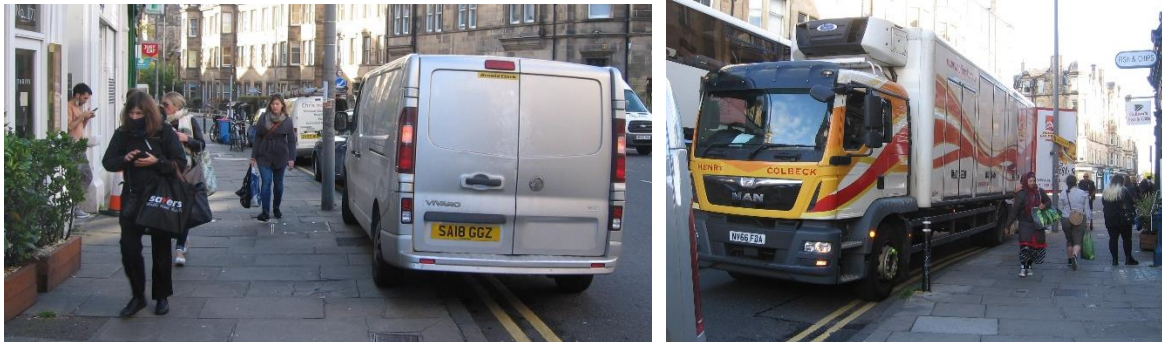
Although the pavement is reasonably wide here, illegal parking both infringes on pedestrian space (left photo) and seriously blocks the sightlines (right photo) for pedestrians seeking to safely cross Bruntsfield Place from west to east via the island in the centre of the carriageway.

*Recommendation: explore options to prevent any vehicles stopping here.*

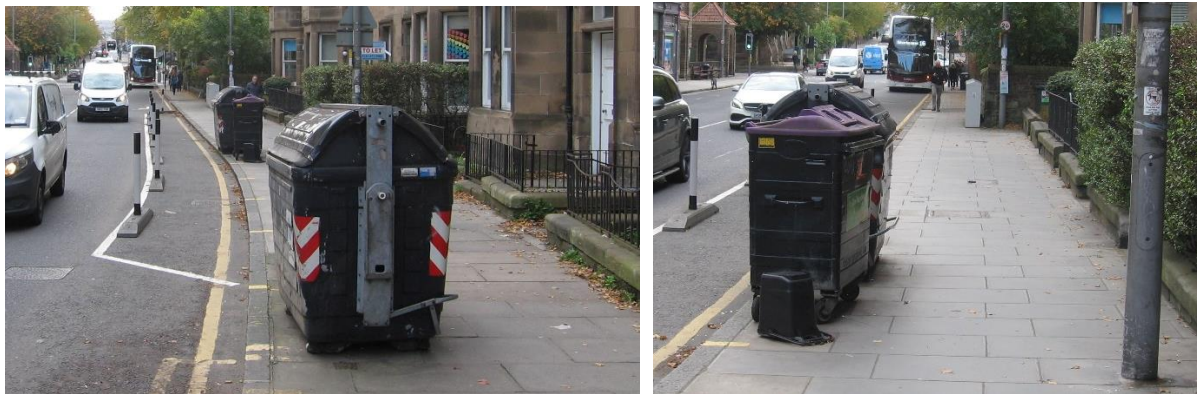
Although the pavement is reasonably wide here (3.2m), its utility is significantly constrained by the placement of communal bins, which reduce the Clear Walking Zone to just 1.2m (ie less than the SDG 'absolute minimum' of 1.5m).

*Recommendation: relocate the bins on to the SfP space in order to free up the pavement as a continuous one-level width for both movement and social space.*

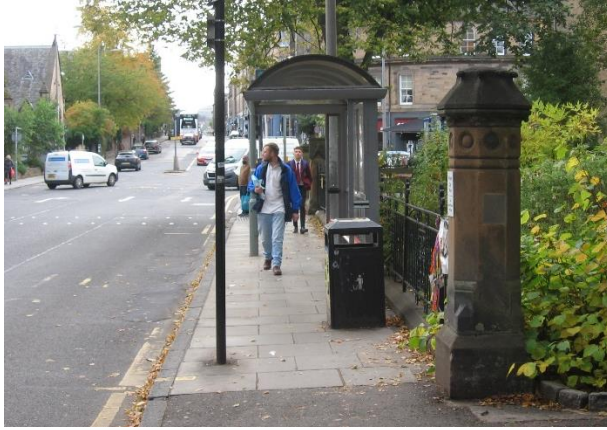
The pavement width here is only 2.15m (ie less than the SDG 'absolute minimum' of 2.5m) at a location where queuing (for buses) is frequent, and the Clear Walking Zone is just 1.35-1.45m (ie less than the SDG 'absolute minimum' of 1.5m).

*Recommendation: relocate the litter bin to a more appropriate location, and investigate relocating the signage pole.*

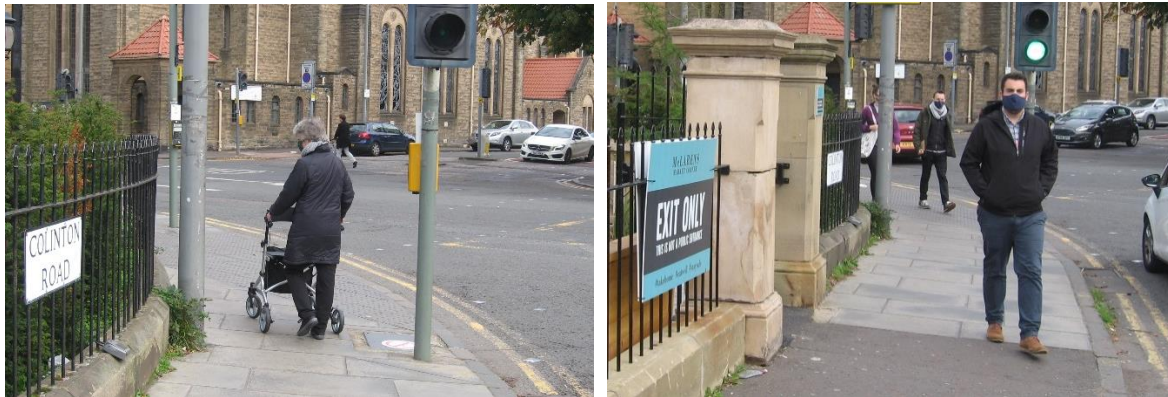
The pavement width at the queuing area for this important pedestrian crossing is only 2.3m (ie less than the SDG 'general minimum' of 2.5m), and the Clear Walking Zone between the two poles (left photo) is just 1.4m, compared to the SDG 'absolute minimum' of 1.5m.

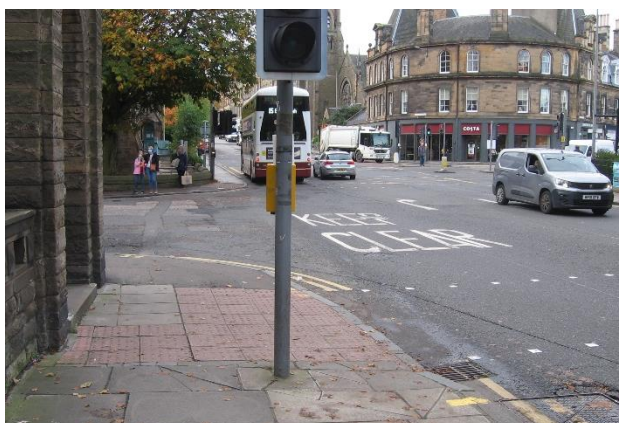
The pavement here is only 2.8m wide (ie less than the SDG 'general minimum' of 3m), and the Clear Walking Zone is just 1.8m.

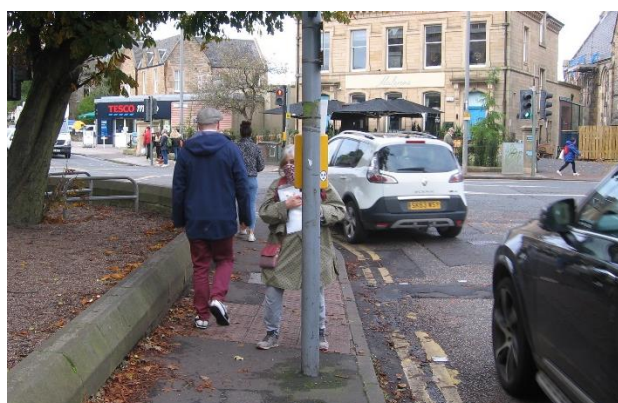
The pavement width here is only 1.7m (ie significantly less than the SDG 'absolute minimum' of 2m), and the Clear Walking Zone is just 1.1m (ie substantially less than the SDG 'absolute minimum' of 1.5m). There are long waits for the Green Man phase, during which large numbers of pedestrians can congregate in a way where it is impossible to maintain social distancing.

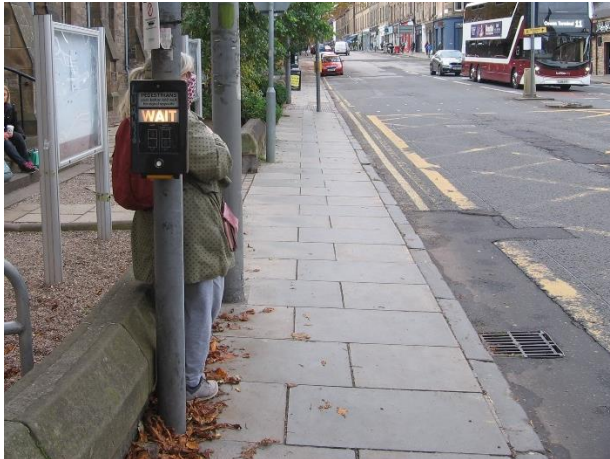
The pavement width here is only 1.8m (ie less than the SDG 'absolute minimum' of 2m). Pedestrians can feel very vulnerable at this location on such a narrow pavement strip, with southbound vehicles on Morningside Road passing at speed less than a metre away. There are long waits for the Green Man phase, during which large numbers of pedestrians can congregate in a way where it is impossible to maintain social distancing.

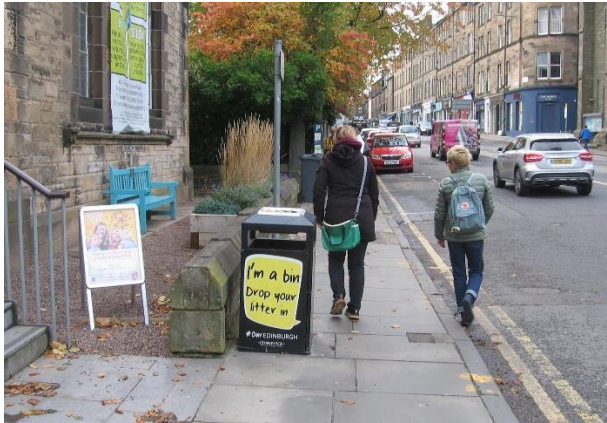
The pavement width here is only 1.85m (ie less than the SDG 'absolute minimum' of 2m), and the thoughtlessly-located litter bin reduces the Clear Walking Zone to just 1.25m (ie less than the SDG 'absolute minimum' of 1.5m) beside a very busy road.

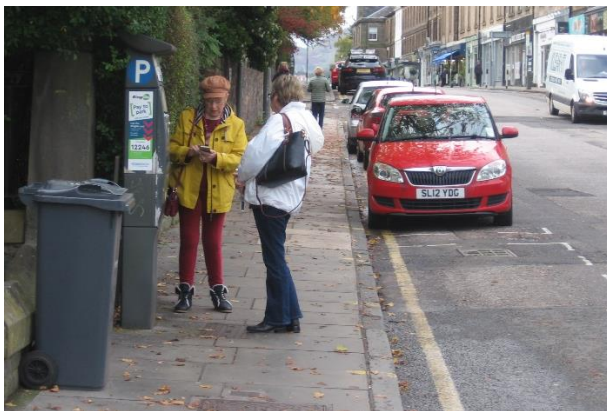
The pavement width here is only 1.9m (ie less than the SDG 'absolute minimum' of 2m), and the parking ticket machine reduces the Clear Walking Zone to just 1.5m.

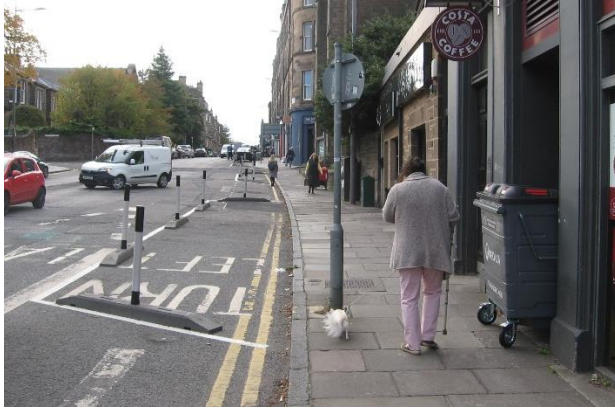
The pavement here is only 2.2m wide (ie less than the SDG 'general minimum' of 2.5m), and the Clear Walking Zone at the pole is just 1.65m. As queuing outside Luca's is common in the summer, the additional SfP space is welcome as a 'social' space and also a 'movement' space.

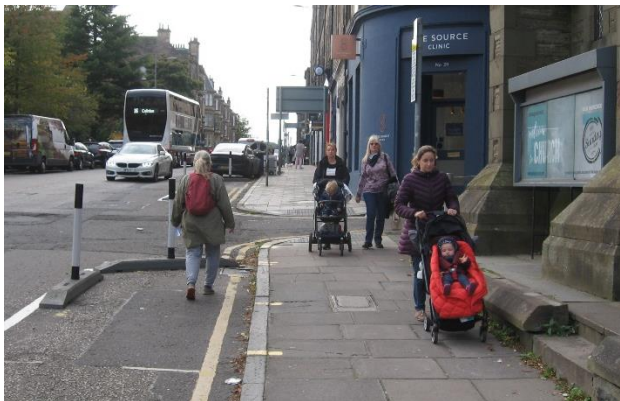
The pavement here is only 2.1m wide (ie less than the SDG 'general minimum' of 2.5m). This is often a busy section of pavement and queuing outside the Post Office is common, therefore the additional SfP space is welcome as a 'social' space and also a 'movement' space.

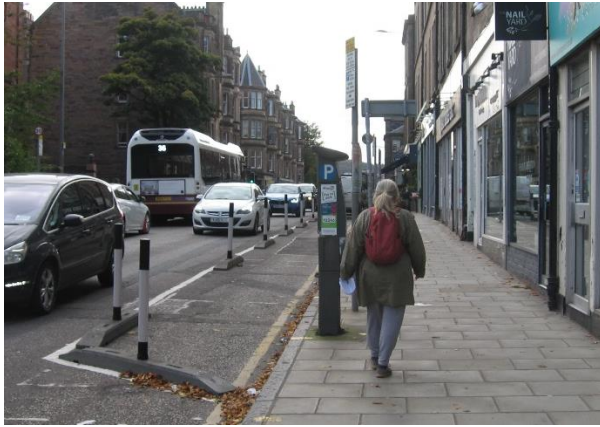
The pavement here is only 2.7m wide (ie less than the SDG 'general minimum' of 3m). This is often a busy section of pavement, therefore the additional SfP space is welcome as a 'social' space and also a 'movement' space.

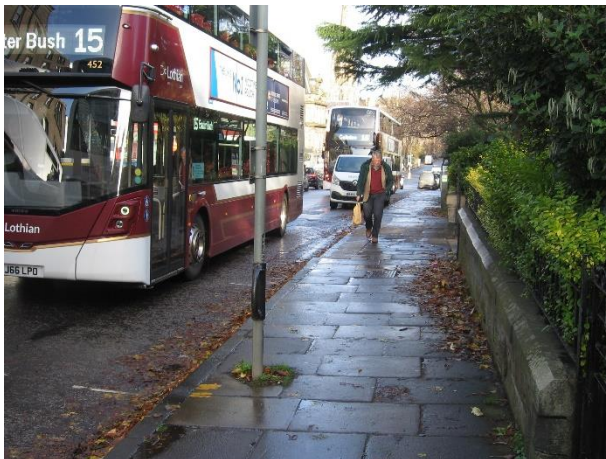
The pavement here is only 2.2m wide (ie less than the SDG 'absolute minimum' of 2.5m, which is 'only allowed in short sections').

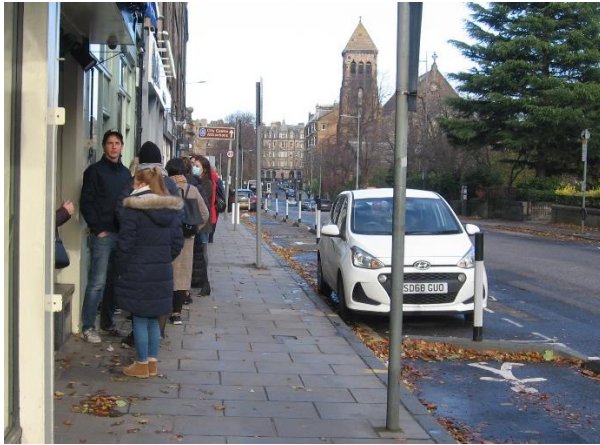
The pavement here is only 2.65m wide (ie less than the SDG 'general minimum' of 3m), and this is a location where queuing on the pavement is common.

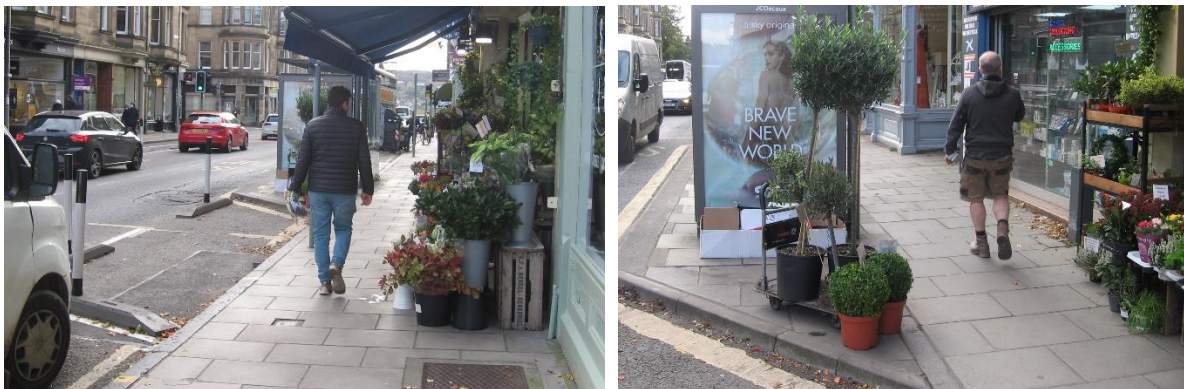
The pavement proper here is only 2.6m wide, and due to the depth of goods on display here, the Clear Walking Zone is only 1.2m in places (ie significantly less than the SDG 'absolute minimum' of 1.5m). Therefore the additional SfP space is welcome, albeit that the total width available for pedestrians is split into two levels rather than being continuous.

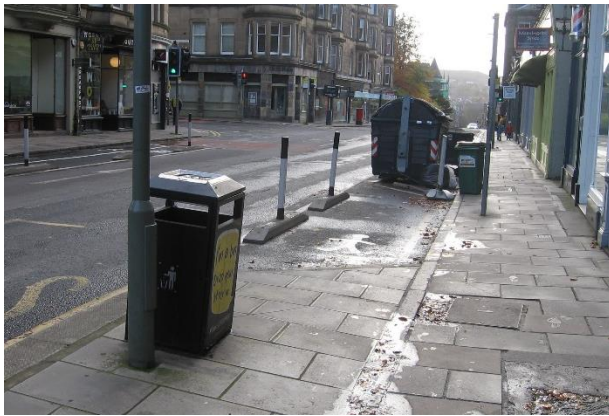
**Location 28W (Morningside Road west):**

The pavement here is only 1.9m wide (ie substantially less than the SDG ‘absolute minimum’ of 2.5m) and therefore the additional 1.8m SfP space is very welcome as a ‘social’ space and also a ‘movement’ space contiguous with the bus stop ‘build-out’.

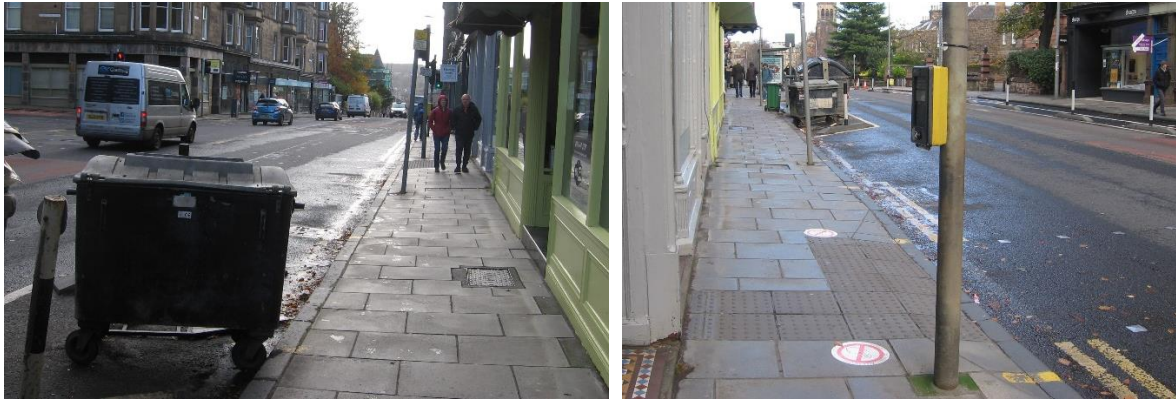
The pavement at the traffic light crossing of Morningside Road on the north side of the junction at Church Hill is only 1.9m wide, with a Clear Walking Zone of just 1.2m at the pole (right photo) – ie both substantially less than the SDG ‘absolute minimum’. Being at a crossing with a long interval between the Green Man phases, this is a location where people unavoidably congregate, in addition to those passing along Morningside Road.

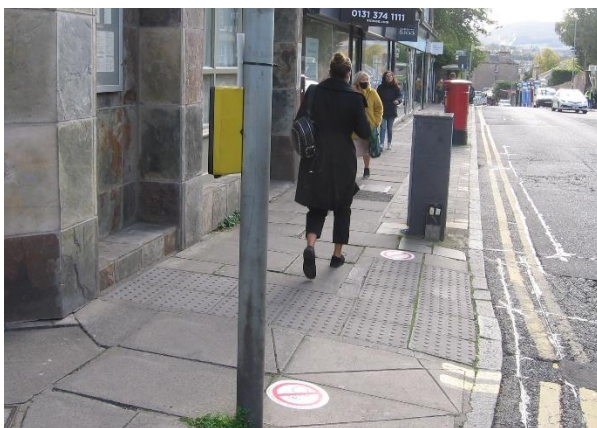
The pavement here is only 2.55m wide with a Clear Walking Zone of just 1.5m. There are long waits for the Green Man phase, during which large numbers of pedestrians can congregate in a way where it is impossible to maintain social distancing.

*Recommendation: as per Location 33NE.*

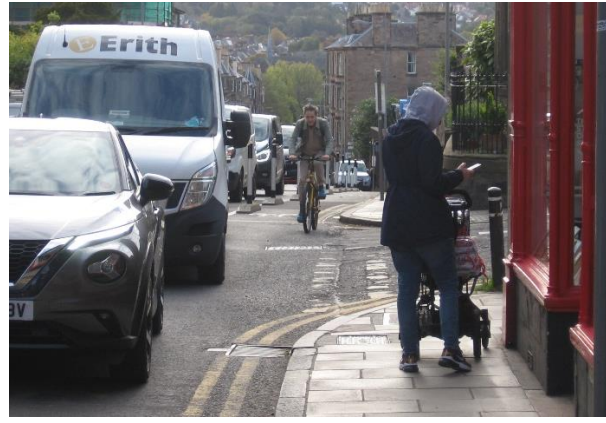
This one of the worst untreated pedestrian pinchpoints on the entire corridor. The pavement here is only 1.4m wide (ie substantially less than the SDG 'absolute minimum' of 2.5m), with vehicular traffic passing (sometimes at speed) less than a metre away from pedestrians. The problem is compounded when people are queuing outside the Shelter shop (right photo). Immediately beyond Shelter, the junction with Abbotsford Park can be difficult for pedestrians to cross, with the eastbound lane of Abbotsford Park 'sweetened' to enable vehicles to turn left on to Morningside Road without stopping.

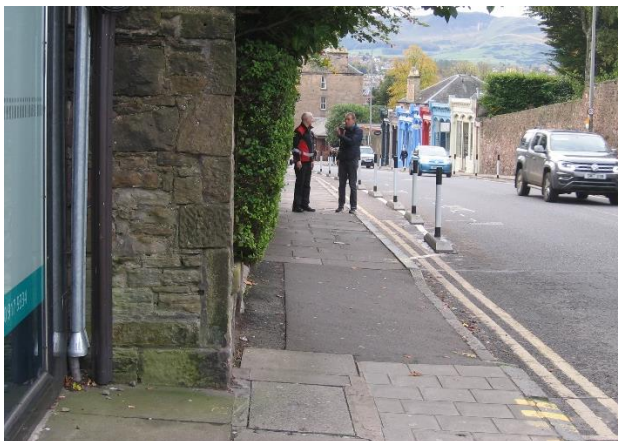
Immediately south of the southbound bus stop at Church Hill, the pavement narrows to just 2.05m, but vehicle access to a property on the left prevented the SfP space measure (see Location 35E2) being extended uphill to reach the wider pavement.

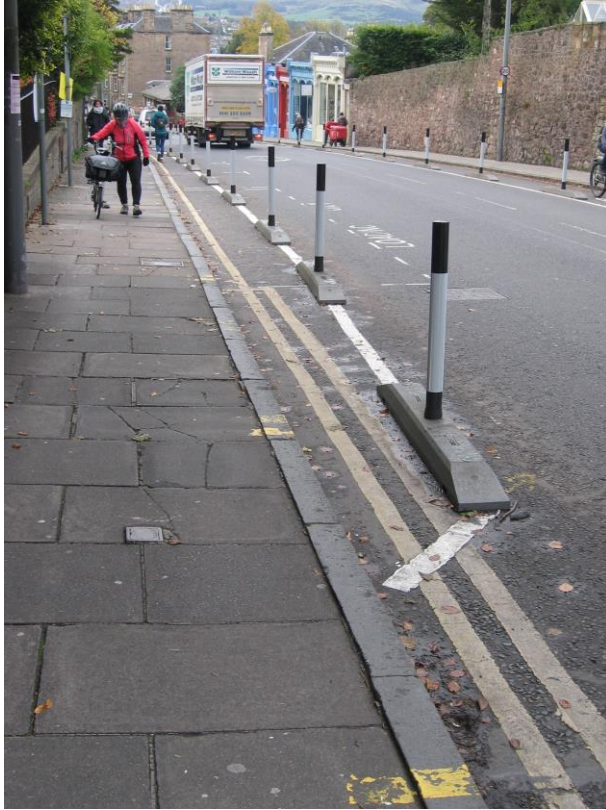
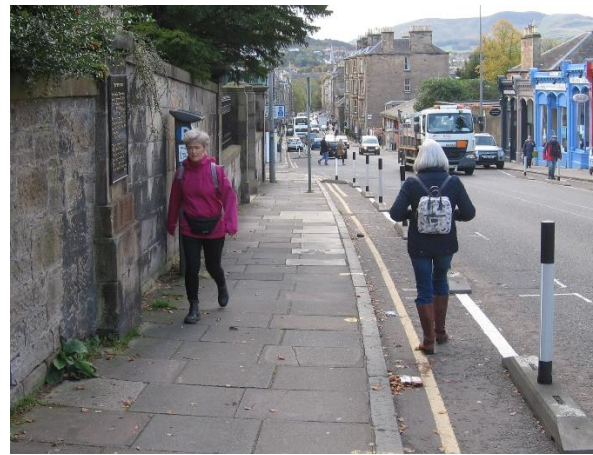
The pavement here is only 2.05m wide (ie significantly less than the SDG ‘absolute minimum’ of 2.5m) and the Clear Walking Zone is just 1.7m in places – therefore the additional 0.95m SfP space is most welcome.

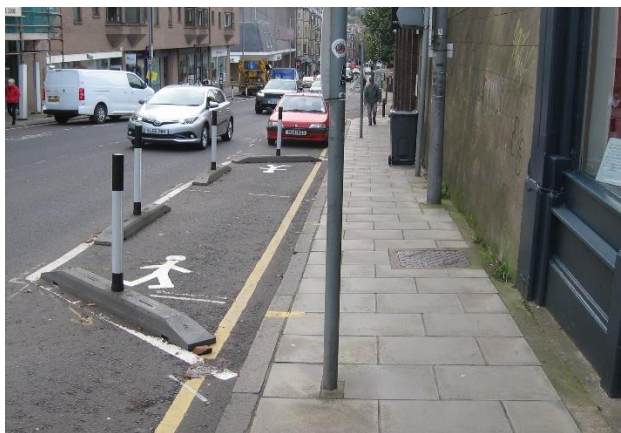
The pavement here is only 1.8m wide (ie substantially less than the SDG 'absolute minimum' of 2.5m) and the Clear Walking Zone is just 1.5m at the pole, therefore the additional Sfp space is most welcome.

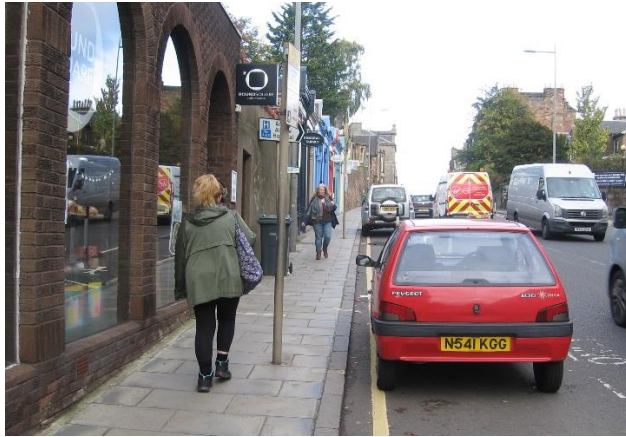
The pavement here is only 1.8m wide (ie substantially less than the SDG 'absolute minimum' of 2.5m) and the Clear Walking Zone is just 1.5m at the pole.

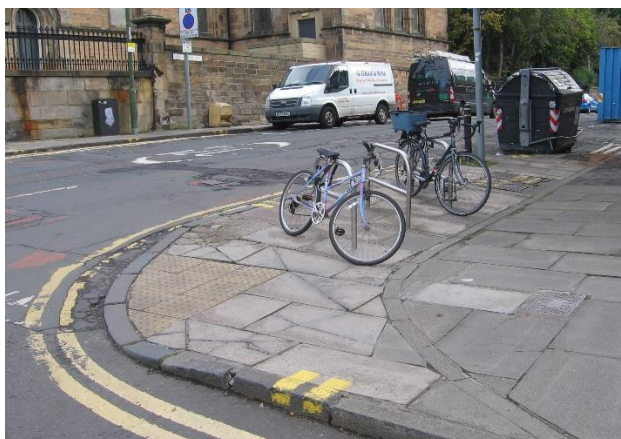
The cycle racks here impinge on the pedestrian area close to the tactile paving at the informal crossing point of Newbattle Terrace. However, the Council's current 'public realm' plan for the latter would relocate the cycle racks a short way further east along Newbattle Terrace (as well as creating a continuous pavement' across Newbattle Terrace at its junction with Morningside Road).

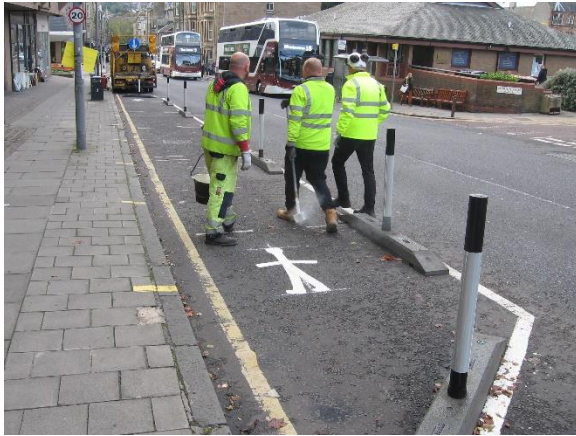
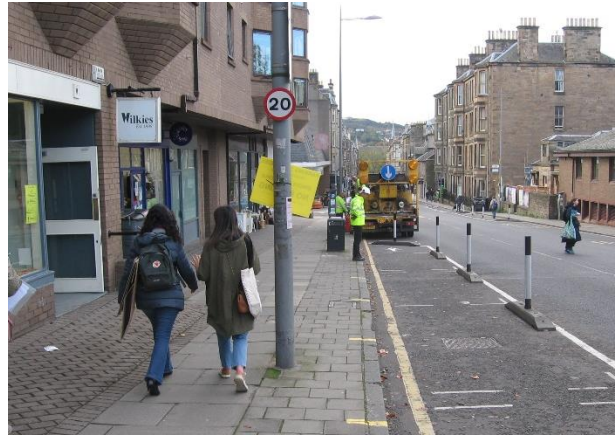
While the pavement here is reasonably wide, much of it is on a slope rising up to the shop entrances (right photo) which is unsuitable for more infirm pedestrians to walk along. On the horizontal pavement, the Clear Walking Zone is as narrow as 1.25m and 1.85m in places, and therefore the additional SfP space is welcome.

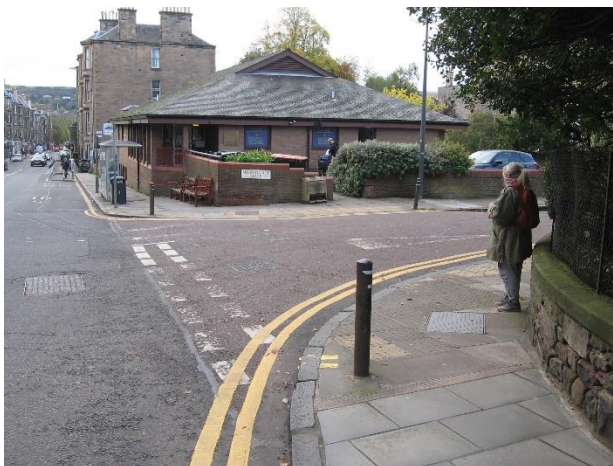
Morningside Place at its junction with Morningside Road is well in excess of two lanes wide, and can be difficult for pedestrians to cross, with the eastbound lane of Morningside Place (foreground of photo) 'sweetened' to enable vehicles to turn left on to Morningside Road without stopping.

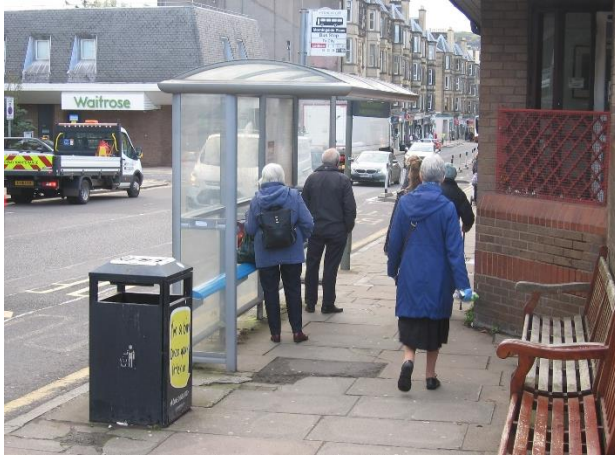
This is one of the most significant pedestrian pinchpoints on the A702 corridor. The pavement is only 2.5 wide (ie the SDG ‘absolute minimum’) and the Clear Walking Zone at the bus stop is just 1.65m – making it impossible to socially distance for much of the time.

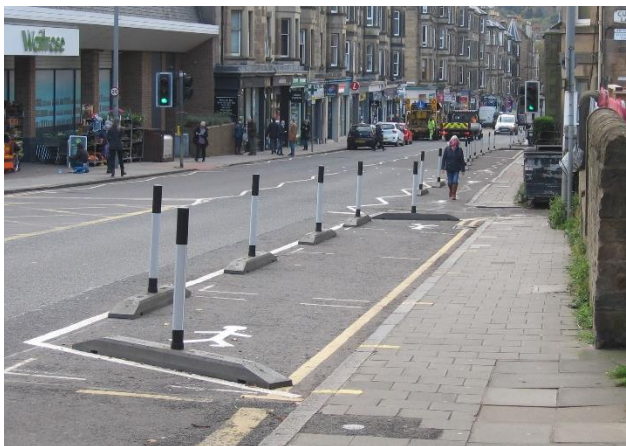
This is one of the most valuable improvements made by the SfP project along the A702 corridor. The pavement proper is only 2.15m wide (ie significantly less than the SDG 2.5m ‘absolute minimum’) and therefore the additional space is very welcome for pedestrians.

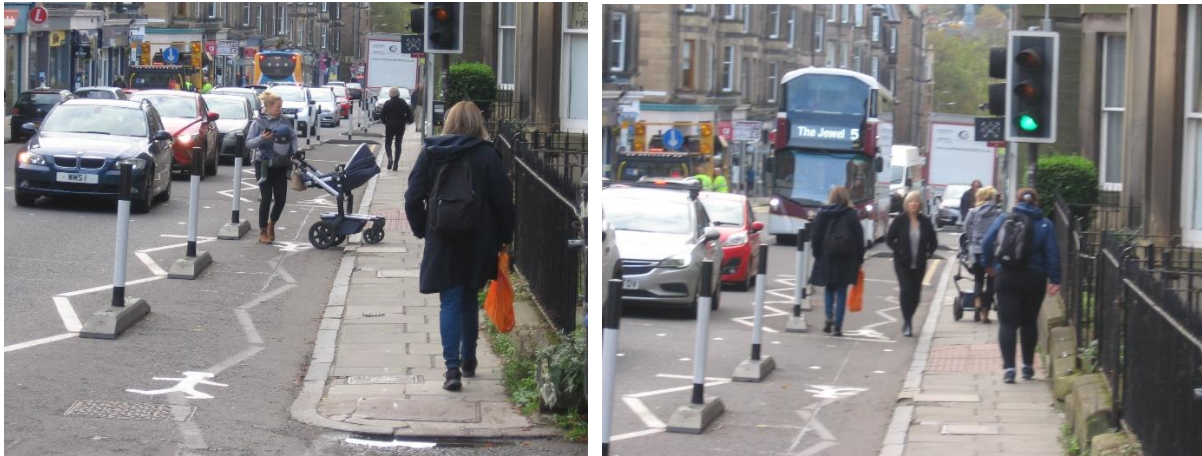
This is one of the most valuable improvements made by the SfP project along the A702 corridor. The pavement proper is only 1.39m wide (ie substantially less than the SDG 2.5m 'absolute minimum') and therefore the additional space beside a very popular pedestrian crossing is most welcome. The extra space reduces the width of the vehicle carriageway – and therefore also reduces the time taken to cross the crossing

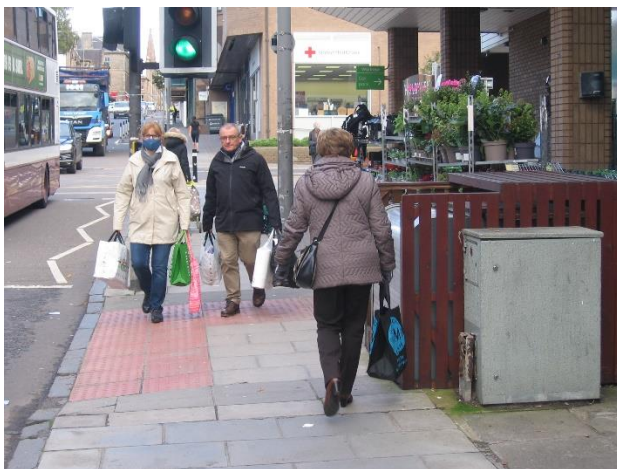
This is a very busy pedestrian location, beside the entrance to Waitrose and where pedestrians congregate waiting for the Green Man at the crossing. The wooden storage unit (right) impinges on to the pavement proper.

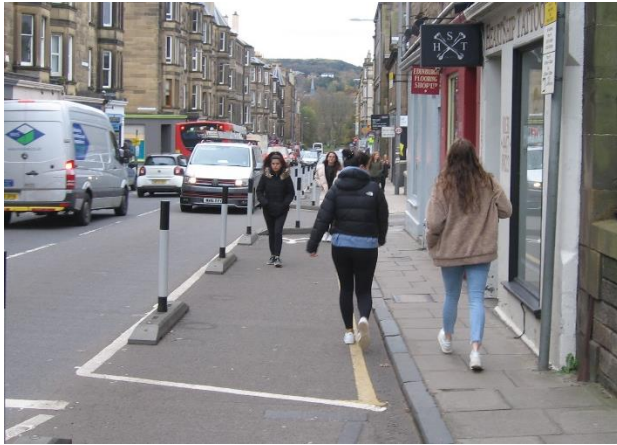
This is one of the most valuable improvements made by the SfP project along the A702 corridor. The pavement proper is only 1.25m wide (ie half the SDG 2.5m ‘absolute minimum’) and therefore the additional 1.75m SfP space is very welcome, taking the entire pedestrian space width up to the 3m SDG ‘general minimum’, albeit split in two levels.

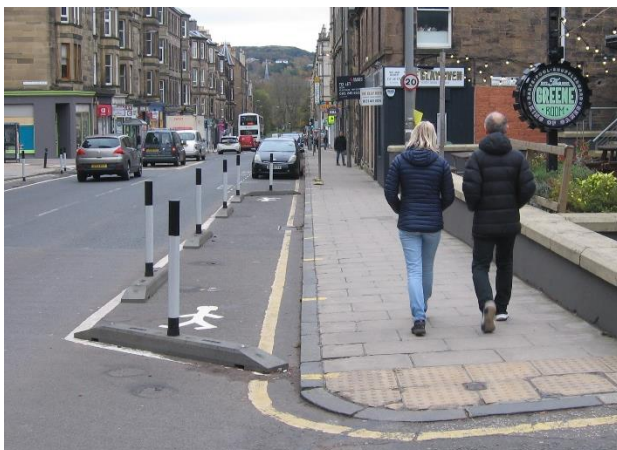
The pavement here is only 2.25m wide (ie significantly less than the SDG ‘absolute minimum’ of 2.5m) and therefore the additional 1.05m SfP space is welcome.

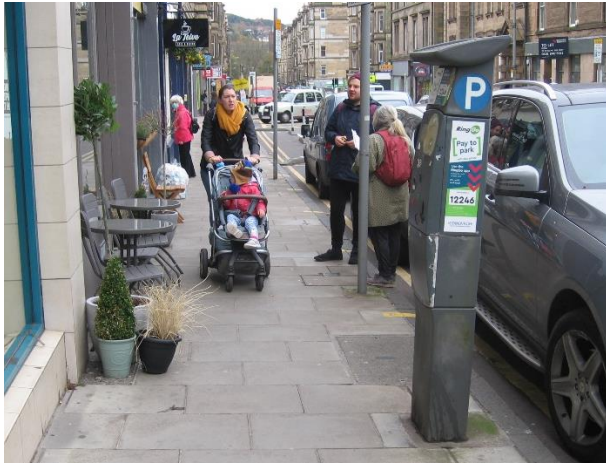
The pavement here is only 2.4m wide (ie less than the SDG 'absolute minimum' of 2.5m) and the parking ticket machine, tables & chairs and poles reduce the Clear Walking Zone in places to 1.45m.

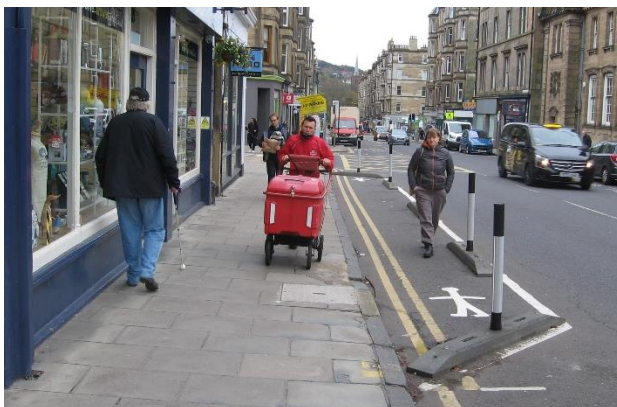
The pavement here is only 2.35m wide (ie less than the SDG 'absolute minimum' of 2.5m) and therefore the additional 1.3m SfP space is very welcome, not least as goods are sometimes on display on the pavement outside this shop. The extra width also narrows the width of (informal) crossing of the Morningside Road carriageway on a long section without formal crossing facilities.

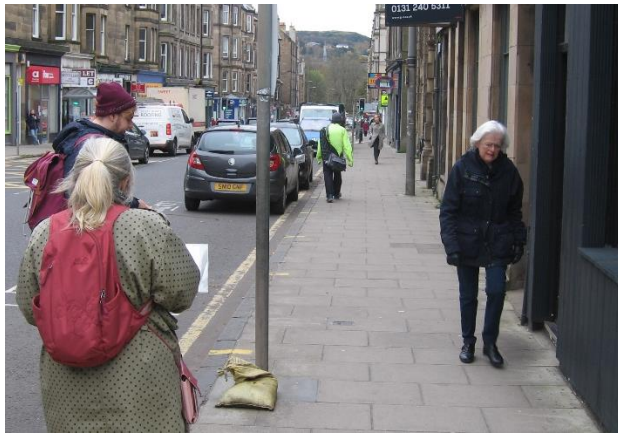
The pavement here is only 2.2m wide (ie significantly less than the SDG 'absolute minimum' of 2.5m) and the Clear Walking Zone is just 1.7m at the pole.

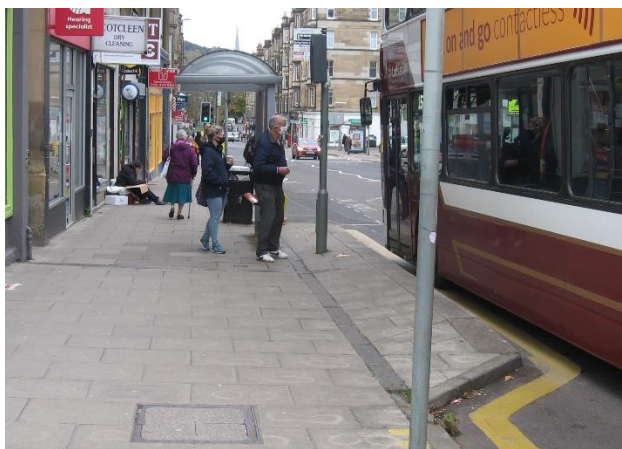
This is a good example of a bus stop build-out, allowing the pavement proper to extend to 4.4m width – one of the very few examples on the corridor where the width satisfies the SDG 'desirable minimum' of 4m or wider. The build-out also improves bus reliability, as buses do not have to wait for a gap in traffic to pull out into the main carriageway.

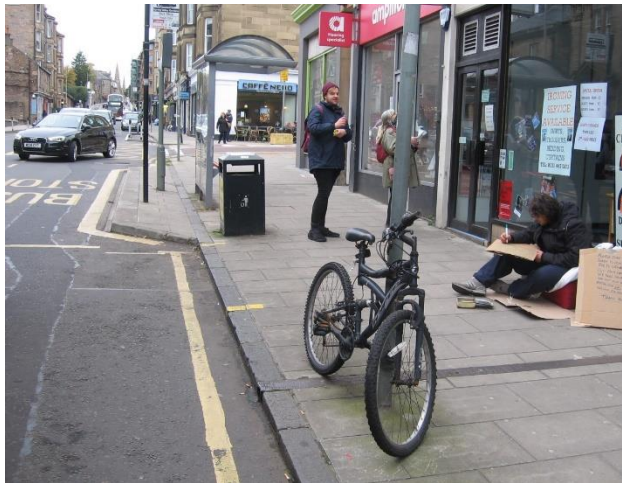
The pavement here is 3.1m wide (ie wider than the SDG 'general minimum' of 3m), but this is often a busy location and the Clear Walking Zone is just 2.3m at the signage pole / informally-parked bike and at the litter bin.

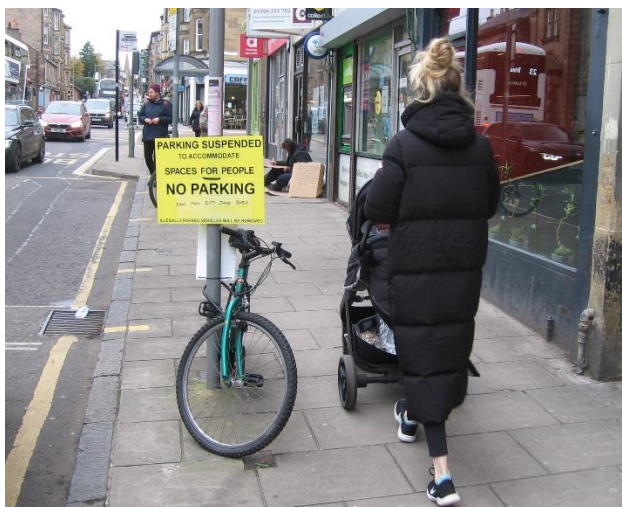
The pavement here is only 2.85m wide (ie less than the SDG 'general minimum' of 3m), and the Clear Walking Zone is reduced to just 2m by the signage pole / informally-parked bike (and the yellow SfP sign!).

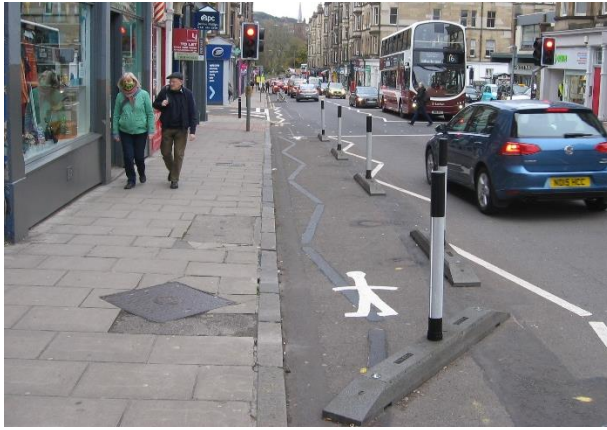
The pavement here is only 2.45m wide (ie less than the SDG 'absolute minimum' of 2.5m) and therefore the additional 1.5m SfP space is welcome. The latter also shortens the distance for pedestrians to cross the vehicle carriageway at the formal crossing in the middle distance. The angled concrete block in the foreground is not delineated by a white line, and this could represent a trip hazard.

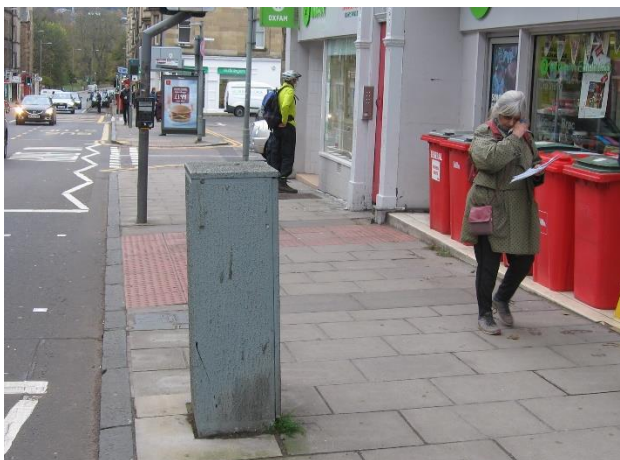
The pavement here is 3.15m wide, but the utility cabinet reduces the Clear Walking Zone to 2.25m.

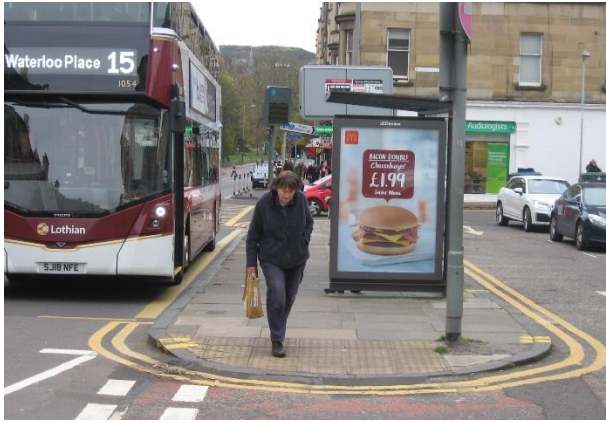
This location is poorly designed for pedestrians, both those walking up or down Morningside Road and those boarding or alighting from buses (this is normally a busy bus stop). The advertising screen at the north end of the JC Decaux shelter reduces the Clear Walking Zone to just 1.7m at this pinchpoint.

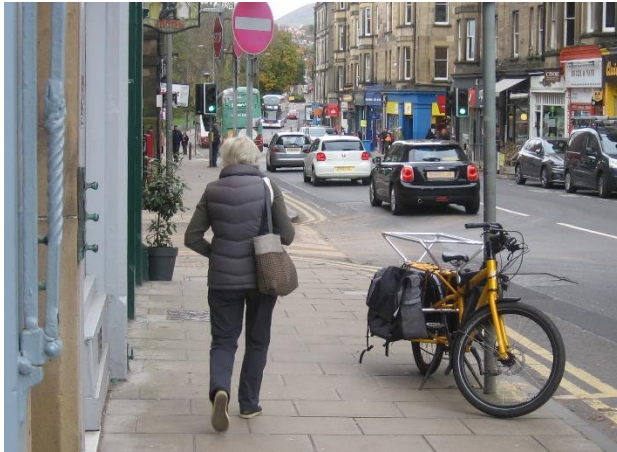
The pavement here is only 2.7m wide and the informally parked bike reduces the Clear Walking Zone to just 1.6m

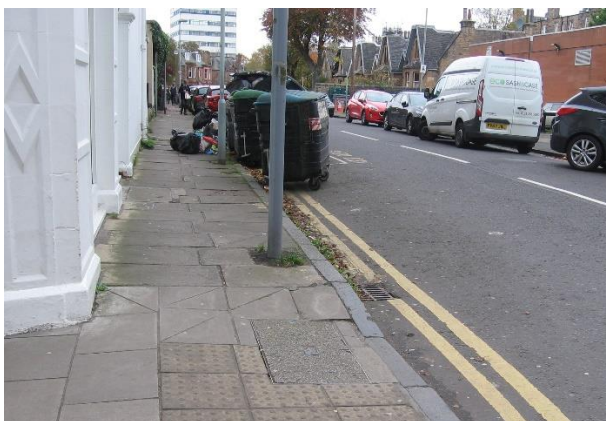
The junction of Morningside Park and Morningside Road has been an accident black-spot and the pavements here are narrow: only 1.8m beside the tactile paving for crossing Morningside Park (left photo) and 2.8m on the main pedestrian route (up Morningside Road, right photo), with a Clear Walking Zone of just 1.8m to the post box.

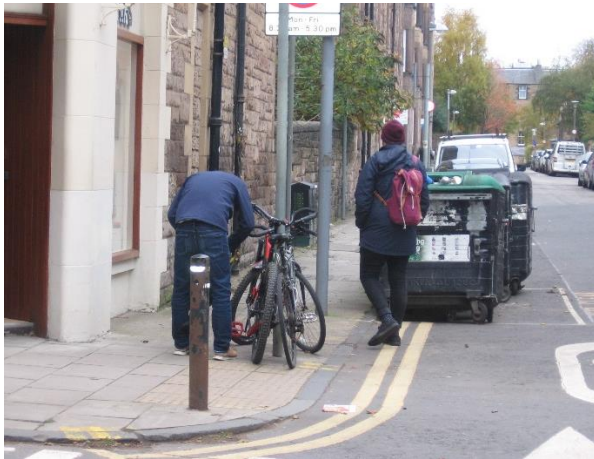
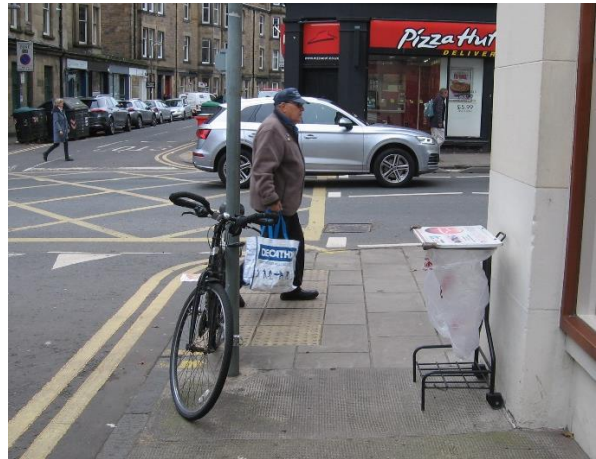
The pavement here is only 1.9m wide (ie substantially less than the SDG 'absolute minimum' of 2.5m) and, due to informal cycle parking and the shoe recycling bin, the Clear Walking Zone is just 0.65m (ie less than half the SDG 'absolute minimum').

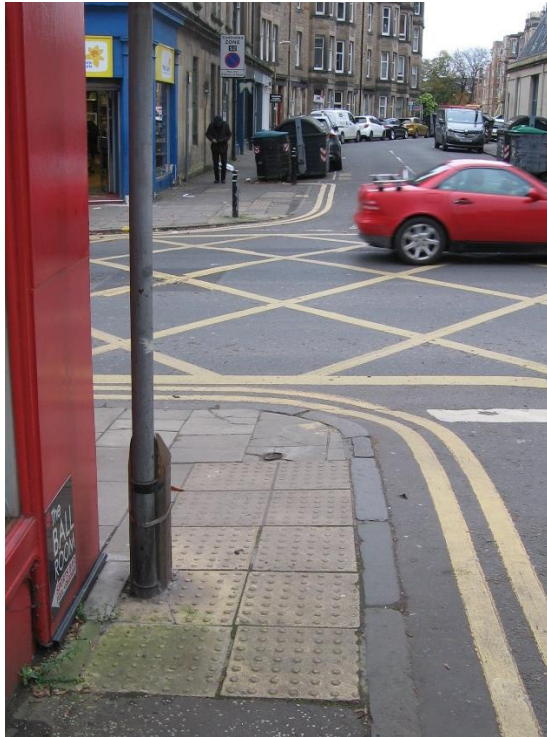
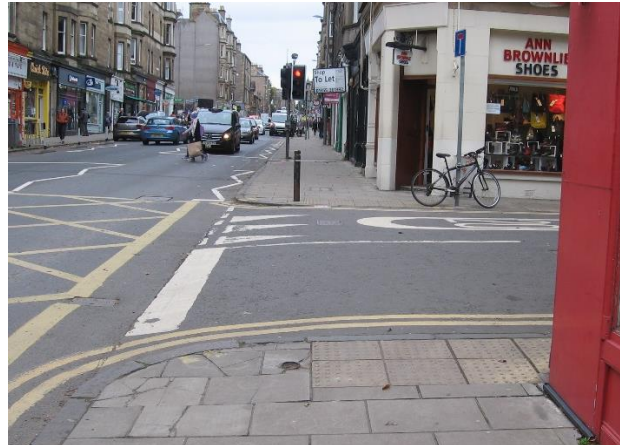
The pavement here is only 1.15m wide (with a Clear Walking Zone of just 0.85m) on Jordan Lane (left photo) and 2.7m wide on Morningside Road (right photo).
