**Living Streets Edinburgh Group**  
**POLWARTH STREET AUDIT (November 2020)**

Four Living Streets volunteers undertook the audit on a weekday mid-morning in late November 2020 – and details of what we found at each location are set out (with photos) in Section 4, followed by our conclusion in Section 5. We identified a wide range of problems faced by pedestrians at a large number of locations (38) along a relatively short length of street corridor. The types of problem which we found at more than one location were as follows:

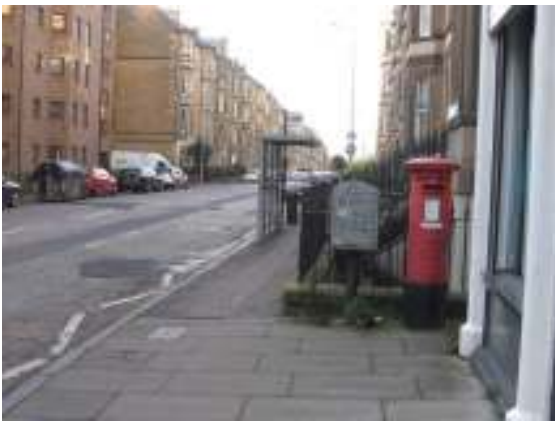
<i>Location</i>	<i>Observations</i>	<i>Suggestions / Proposals</i>
1. Polwarth Gardens.	Pavement (to SW) 1.75m wide Disused (?) Royal Mail holding box	Widen Remove

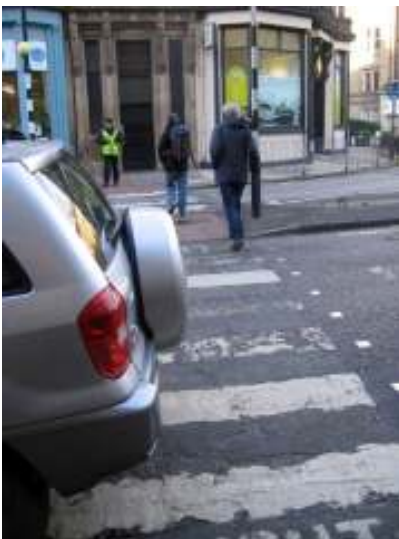
2. Zebra crossing at approach to busy junction

Traffic speeds excessive & a resident reported danger in using the crossing. Zebra is in poor condition

Widen pavements & raise crossing

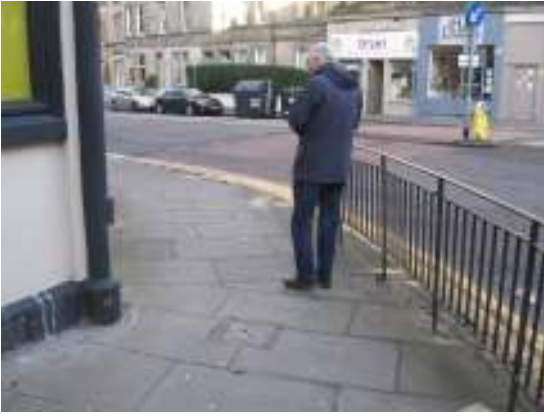
3. Margiotta's at roundabout

1.95m p.w. at busy location

Widen

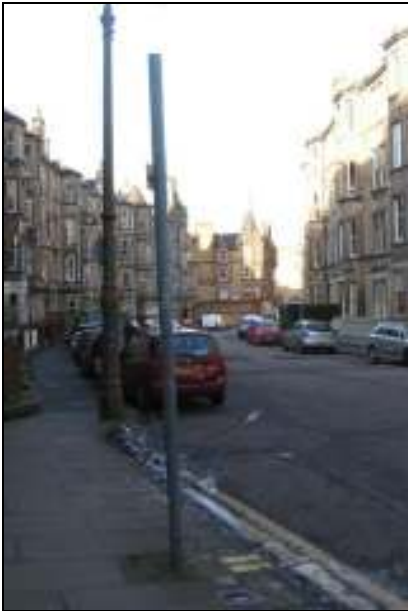
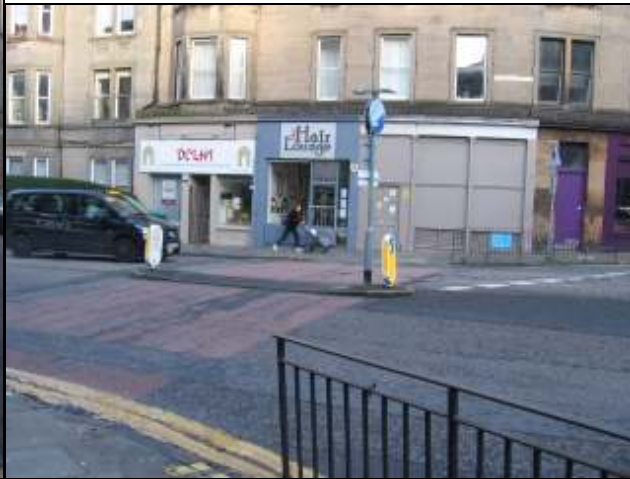
4. Polwarth Cres.

Unnecessary 'No Loading' sign on post

Informal pedestrian crossing at very busy junction

Remove.

Upgrade to zebra and raise

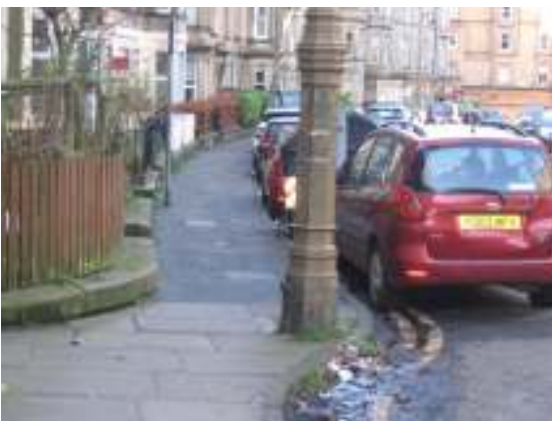
5. Polwarth Crescent

Large lamp post (first of a series)  
1.25m CWZ at post

Widen pavement

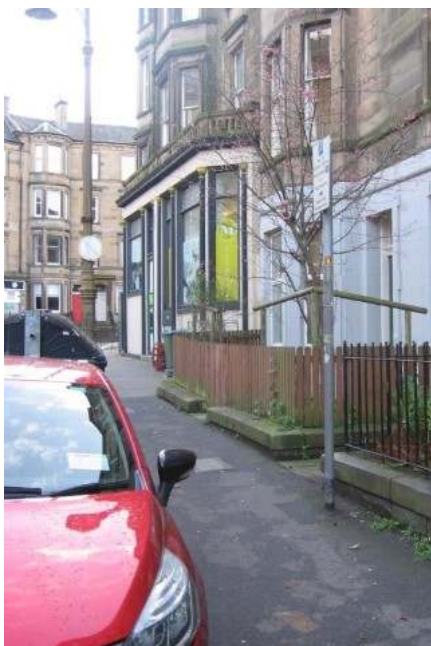
6. Polwarth Crescent

Parking signpost on 1.8m pw

Necessary post?

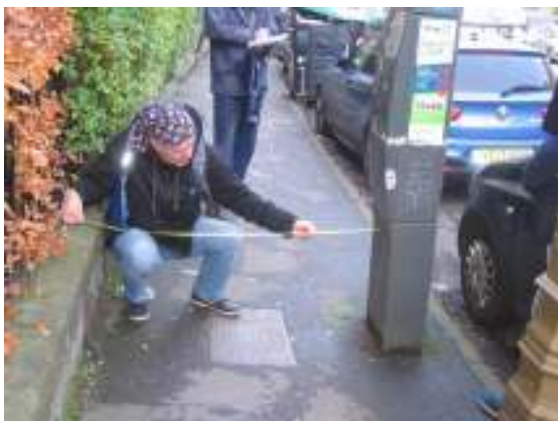
7. Polwarth Crescent

1.25m CWZ at parking machine, next to 2<sup>nd</sup> lamp post.

Relocate on build-out or next to bins on carriageway?

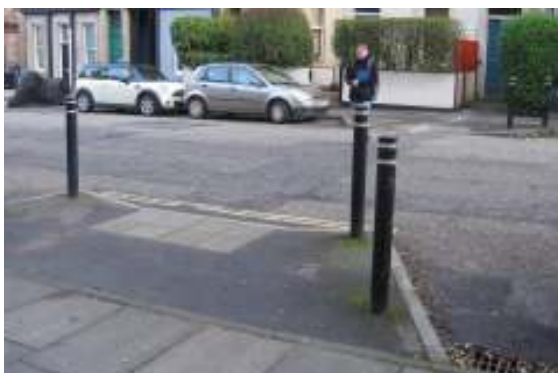
8. Polwarth Crescent  
(crossing at build-outs)

Good! But should be raised

Raise to establish pedestrian priority

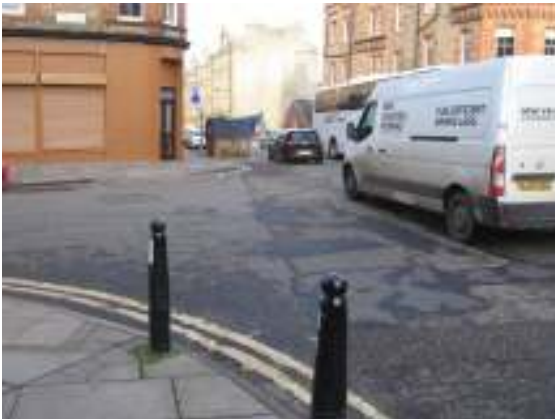
9. Polwarth Crescent  
(junction with Temple Park Crescent)

Excessively wide splay junction

Narrow and tighten corners

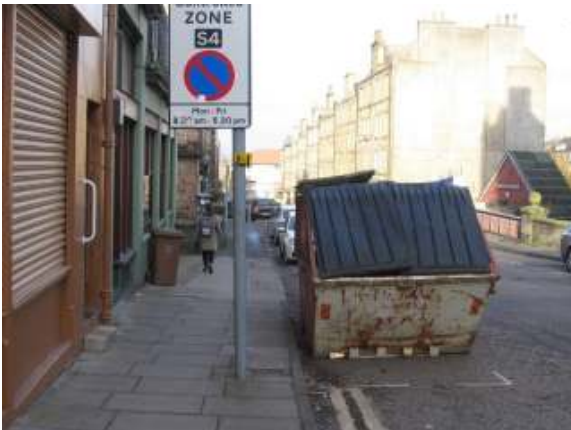
10. Polwarth Crescent  
(below Temple Park Crescent)

1.6m p.w. at Controlled Zone sign

Widen pavement and/or  
remove sign

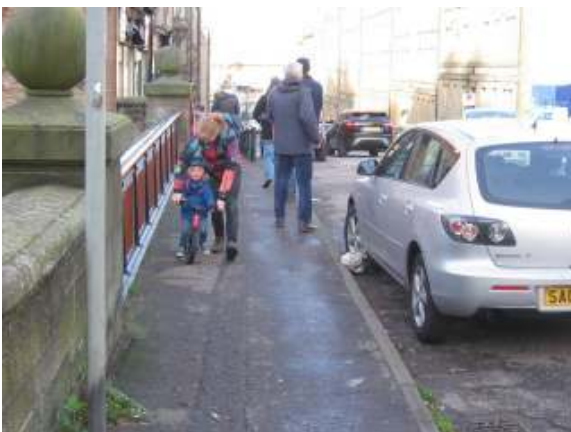
11. Bridge over canal

No pedestrian access to  
canal towpath

P.w. at poles only 1.7m.

Provide (at long last)!

Widen pavements and/or  
remove sign / put on bridge

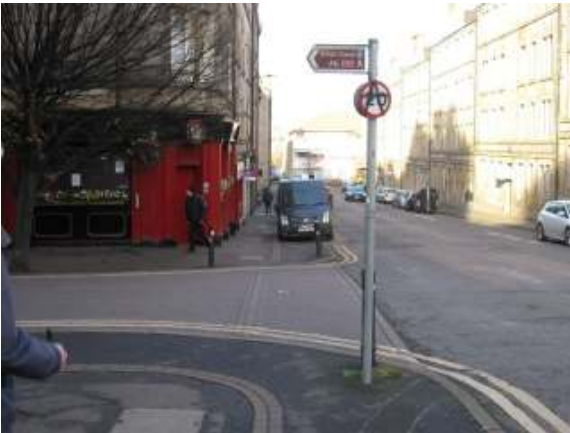
12. Watson Crescent junction

Good narrowed entrance  
with build-outs and tree

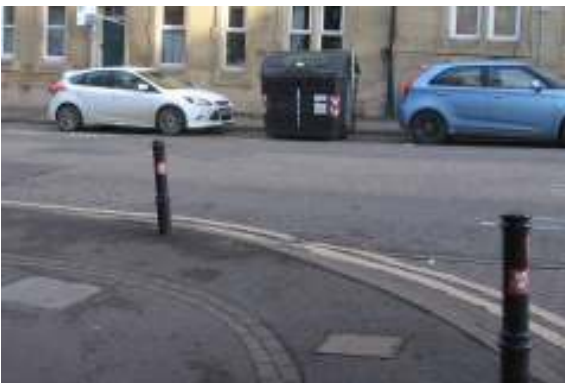
13. Yeaman Place, at  
Watson Crescent junction

Crossing needed at north  
side of junction

East side build-out missing

Provide raised crossing with  
build-outs and tactile  
paving on both sides

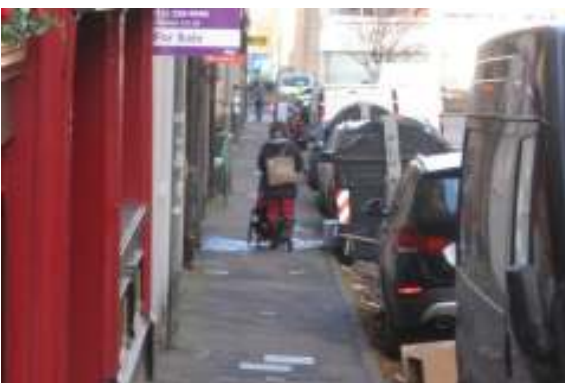
14. Yeaman Place, north of  
Watson Crescent junction

1.6m p.w.

Widen pavement

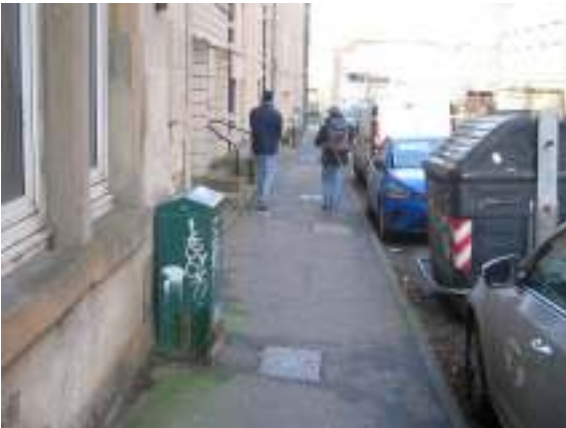
15a. Yeaman Place, north of Watson Crescent junction

Disused (?) utility box (green)

Remove

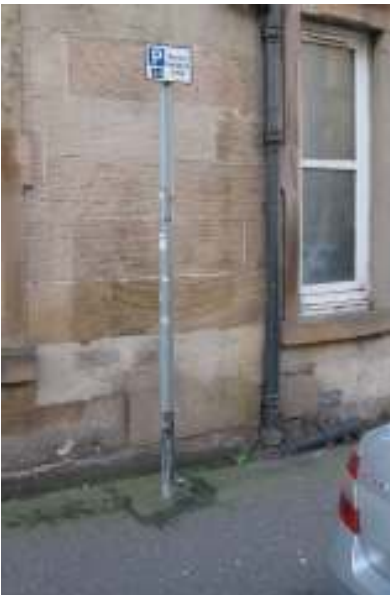
15b. Yeaman Place, north of Watson Crescent junction

One of a series of four parking posts which reduce the CWZ to 1.2m

Place on the building wall

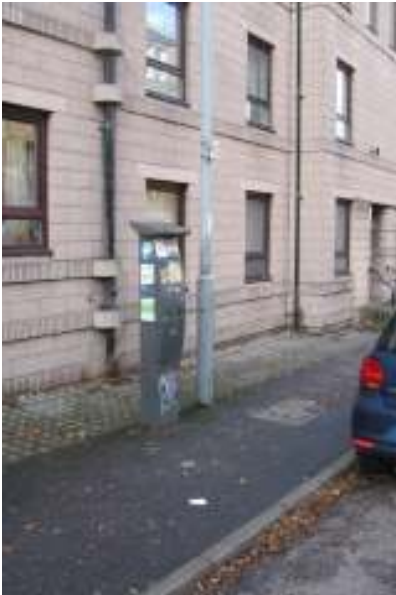
16. Yeaman Place, north of Watson Crescent

Inappropriate deterrence paving next to building

Parking ticket machine narrows p.w.

Replace with greenery?

Relocate to a build-out or the carriageway

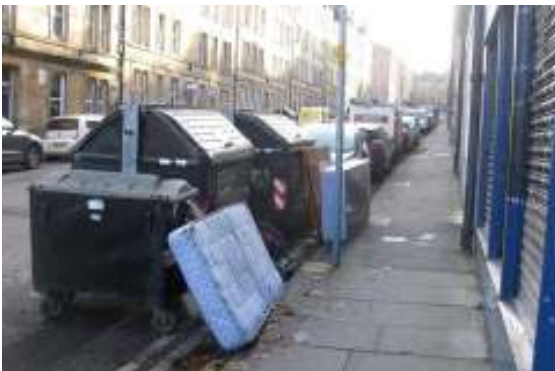
17. Yeaman Place, near Dundee Street junction

Rubbish on pavement around bins

City-wide problem

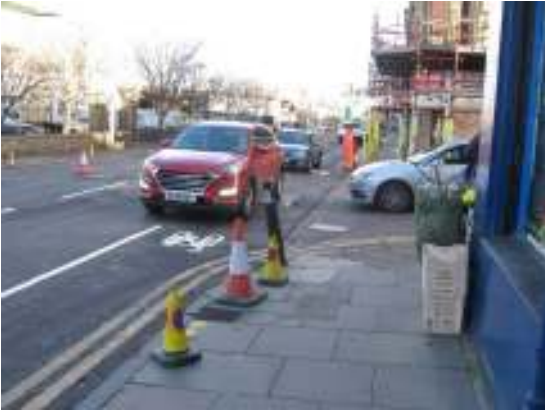
18a. Dundee Street corner with  
Yeaman Place (west side)

1.8m p.w. and 1.35m CWZ  
at bollard in Yeaman Place

Narrow the junction with  
build- outs

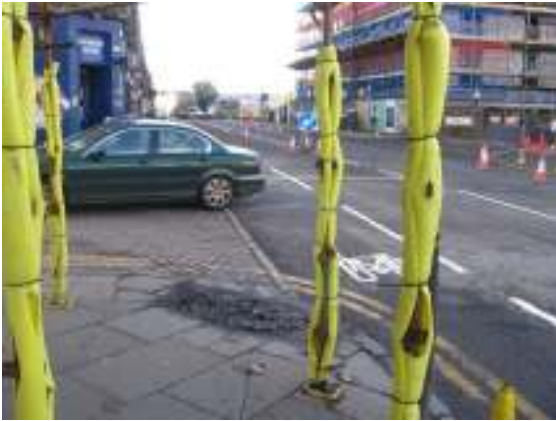
18b. Dundee Street corner with  
Yeaman Place (east side)

Pavement in dis-repaired mess  
2.37m & 2.35m p.w. at bollard

Raise the pavement level

Narrow junction with build-out

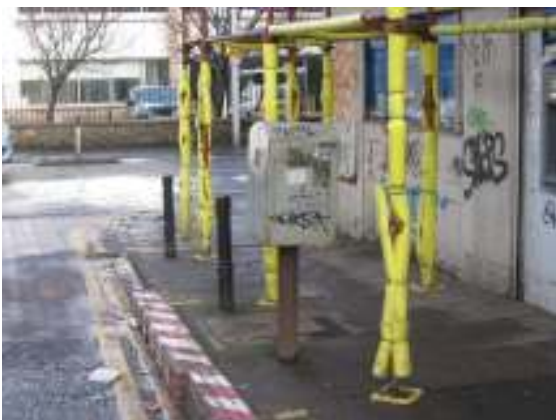
19. Yeaman Place (east side)

Disused(?) Royal Mail holding box,  
where p.w. is only 2.45m

Remove?

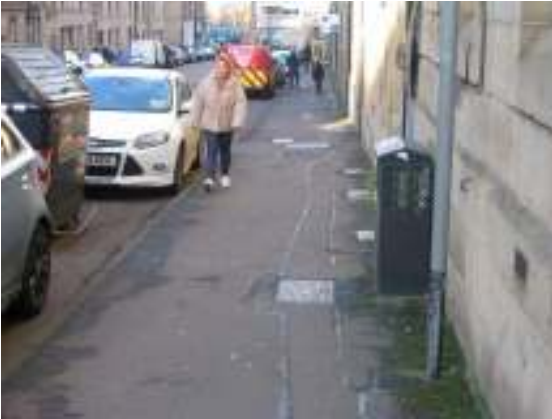
20. Yeaman Place,  
opposite Watson Crescent

Disused (?) utility box (black)

Remove?

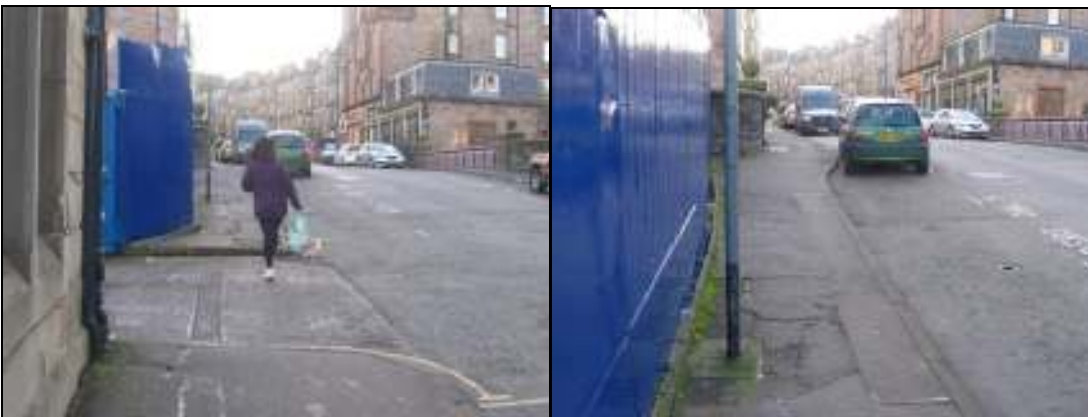
21. Entrance to scrap-yard  
Alongside scrap-yard

No dropped kerbs at entrance  
P.w. only 1.53m, CWZ 1.21m

Raise/continuous pavement  
Widen pavement

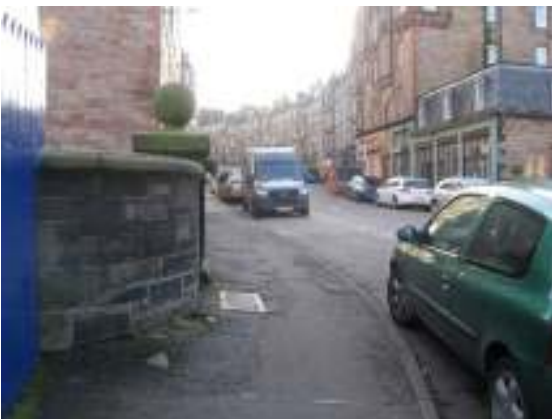
22. Bridge over canal.

1.65m p.w. at pillars.

Widen pavement

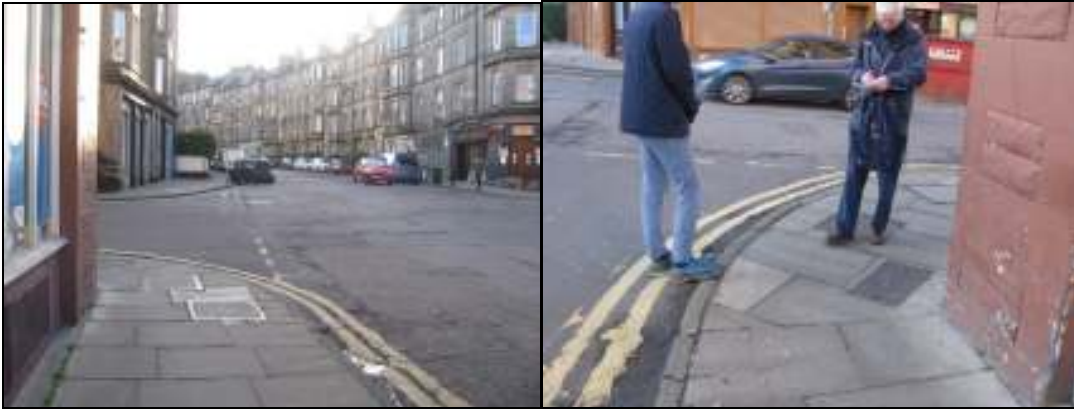
23. Merchiston Avenue junction

Wide splay junction,  
with no dropped kerbs

P.w. only 1.45m and 1.83m

Narrow with build-outs, and  
raise entrance

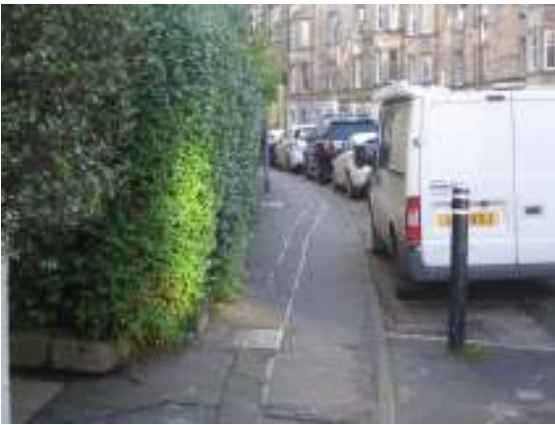
24. Polwarth Crescent  
(east side)

1.7m p.w. reduced to 1.4m CWZ  
by overgrown hedge

Cut back hedge along  
entire length

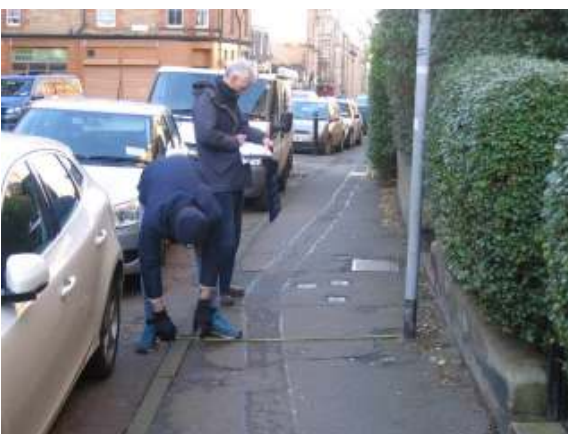
25. At 30 Polwarth Crescent

20mph / parking signpost  
reduces 1.7m p.w. to 1.4m CWZ

Widen pavement

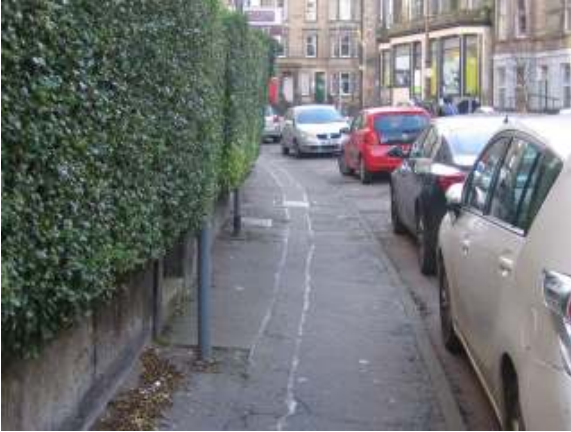
26. At 25 Polwarth Crescent

Parking signpost reduces  
1.8m p.w. to 1.4 CWZ  
Encroaching hedge

Widen pavement  
Cut back hedge

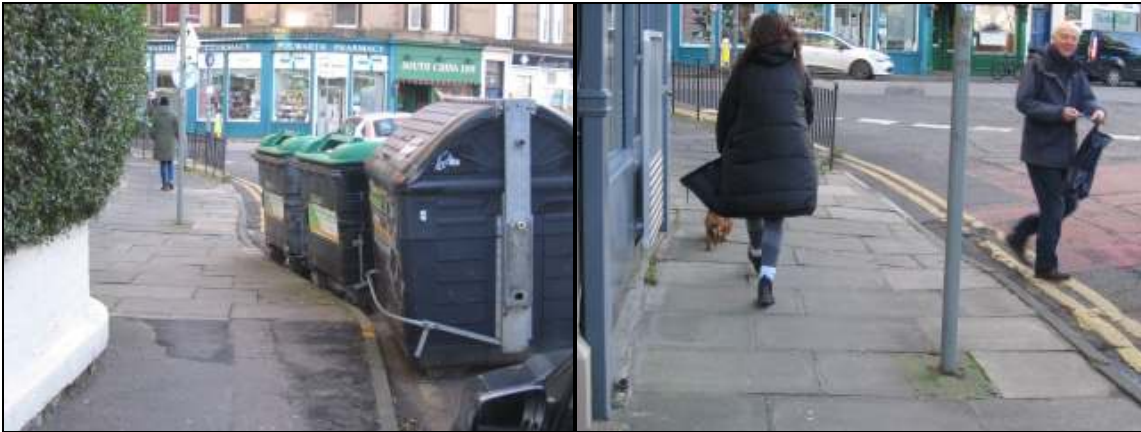
27. At 16 Polwarth Crescent

Parking signpost reduces CWZ  
to 1.4m

Widen pavement and  
relocate / remove sign

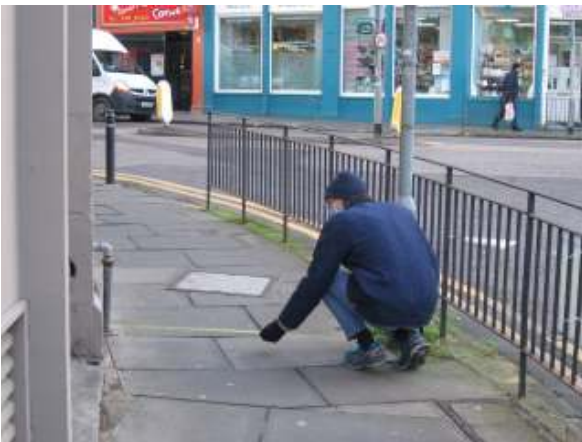
28. Roundabout (NE side)

Guardrail and signpost reduce CWZ  
to only 1.6m at signpost

Widen pavement

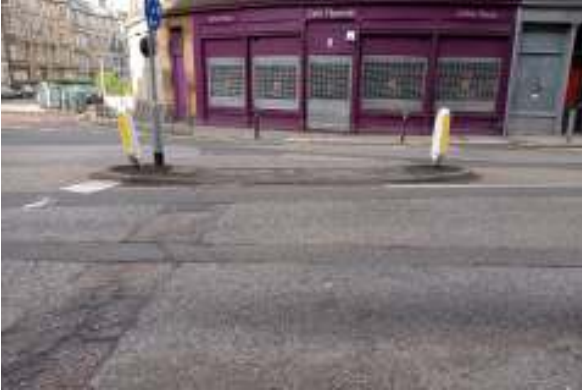
29. Dangerous semi-formal crossing at roundabout (E side)

No dropped kerbs, no zebra at wide junction mouth

Install zebra crossing

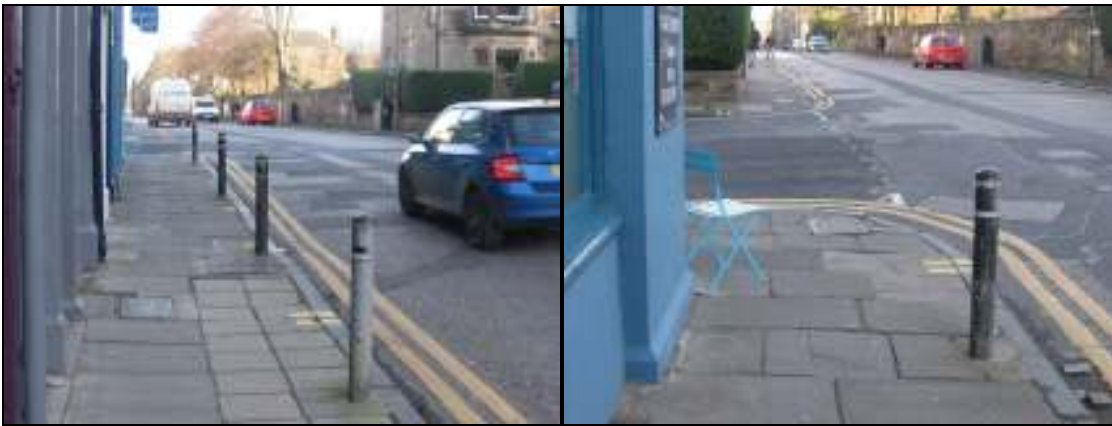
30. Polwarth Gardens (north side) towards Granville Terrace

P.w. only 1.8m, CWZ 1.4m

Seats on pavement at shop door

Widen pavement

Remove

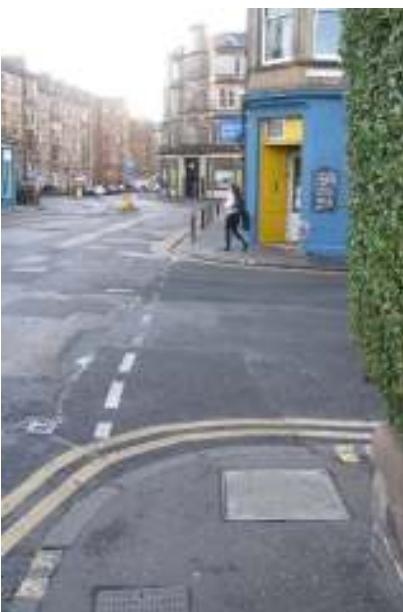
31. Merchiston Avenue junction (north side) with Granville Terrace

Carriageway too wide

No dropped kerbs

Narrow carriageway and raise entrance

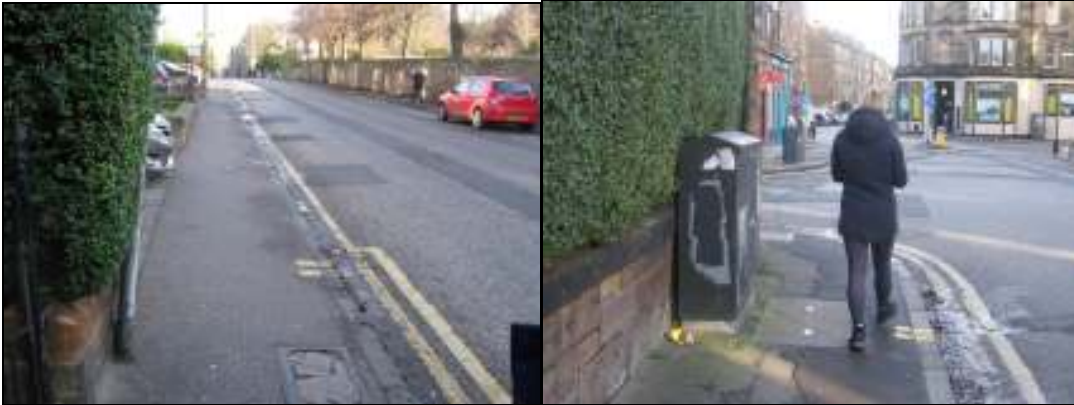
32. Granville Terrace at junction with Merchiston Avenue

P.w. only 1.5m on north side, 1.7m on south side (1.3m at utility box)

Widen pavements

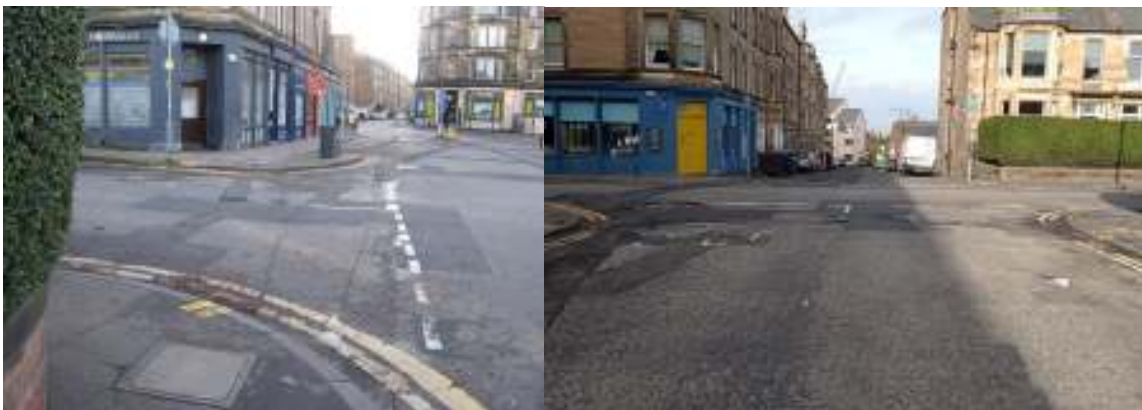
33. Merchiston Avenue junction (south side) with Granville Terrace

P.w. only 1.7m at bend.

No dropped kerbs

Provide build-out on east side (closest to camera), and install dropped kerbs

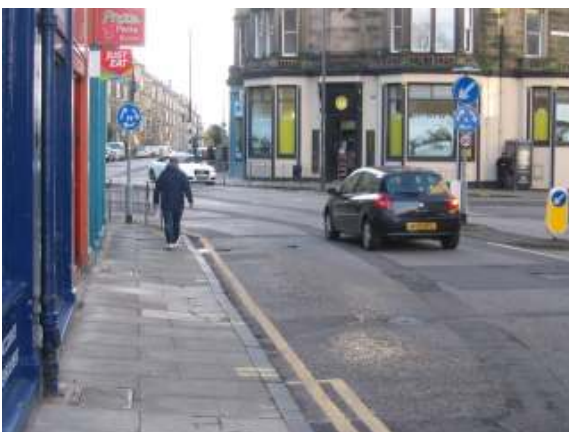
34. Polwarth Gardens shops (east of roundabout)

P.w. only 1.7m, CWZ 1.6m

Widen pavement

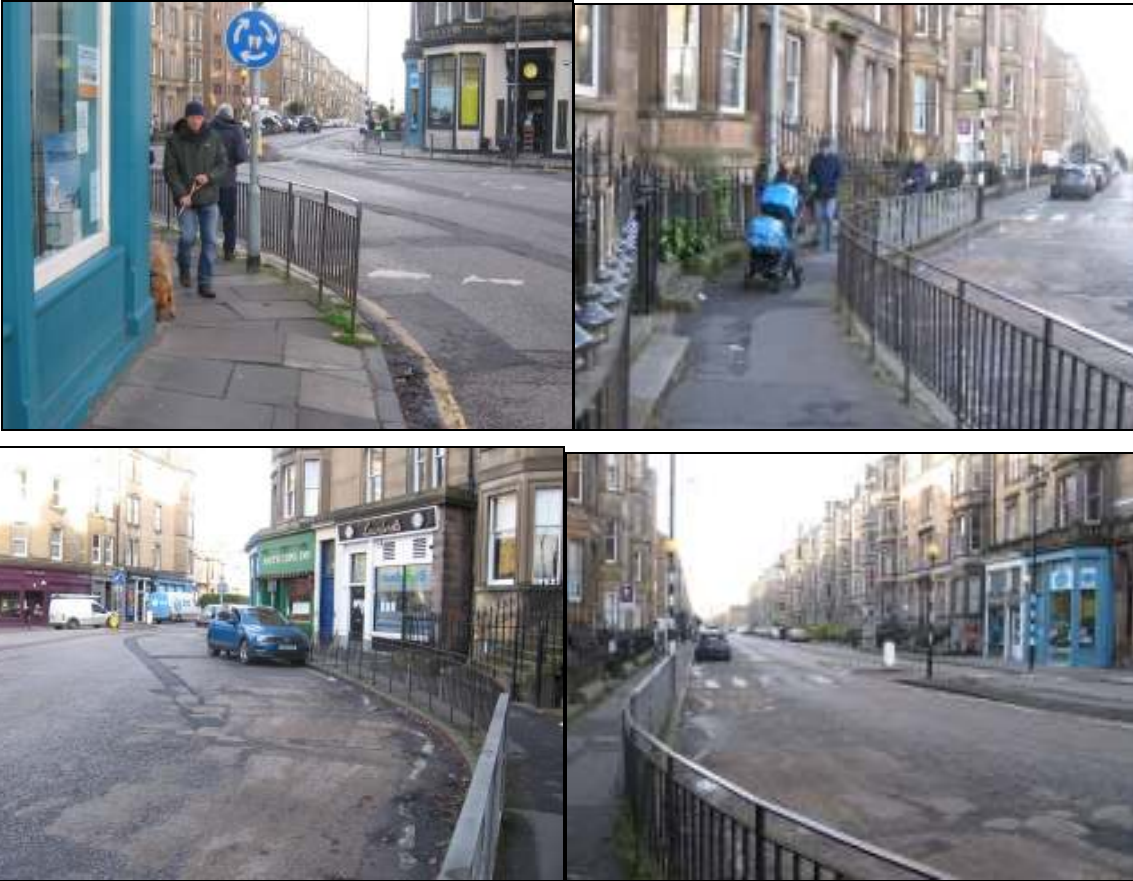
35. South side of roundabout.

1.4m CWZ to guardrail; p.w. 1.7m  
1.4m CWZ to post (traffic signs)  
1.4m CWZ at No.24 steps, 1.7m p.w.  
1.3m CWZ at lamppost, 1.6m to guardrail

Central island is little use to pedestrians  
(see RH side of bottom right photo below)

There is extensive wasted carriageway space on the south side of the roundabout, such that it is frequently used by parked or waiting vehicles. By contrast the pavement space for pedestrians is cramped and further confined by a long length of unnecessary guardrail. The guardrail is now commonly used for cycle parking.

Widen pavement and  
remove guardrail.

Converting the excess carriageway into pavement would also allow space for the provision of cycle parking and/or seating, eg adjacent to the launderette. Seating generally was notable for its absence from the corridor: another reason for folk – especially the elderly and/or infirm – not to linger in the area.

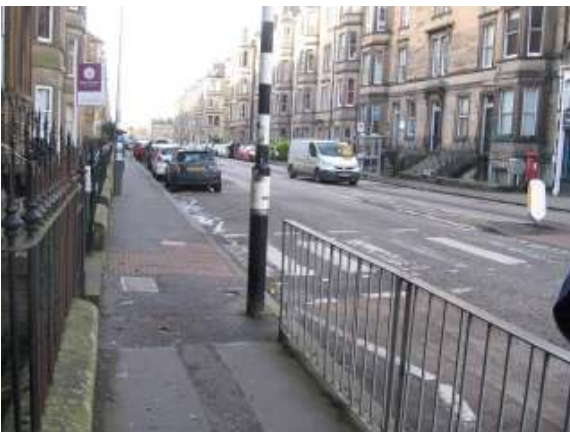
36. At zebra crossing

CWZ only 1.4m at post / end of  
Guardrail, p.w. only 1.8m

Widen pavement
