Leamington Terrace, Gilmore Place Wednesday 13th July 2022

Euan Klein and Annie Pollock (Leamington Terrace), David Hunter (Gilmore Place), Marek Atter (Tollcross) and Councillor Margaret Graham walked down Leamington Terrace, across Gilmore Place and along Lower Gilmore Place to look at general street issues as part of a 'Meet the new Councillor' initiative organised by the Living Streets Edinburgh Group.

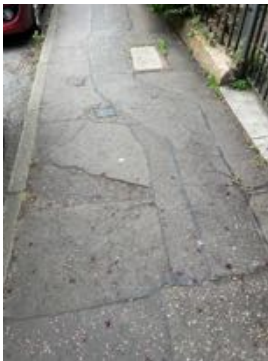
Photo 1

The pavements are hot-rolled asphalt. Where excavations and repairs have been undertaken, the surfaces are in many cases rough as shown in this photo.

10 years or more ago, pavements at the bottom of the street were resurfaced, and they are in much better condition.

We understand that there are a lot of services underneath the pavements – and wonder if small unit paving slabs (e.g. 600 x 450mm or smaller) might be a better surface, thereby avoiding asphalt patching after lifting, which is so often the cause of unevenness as it breaks down.

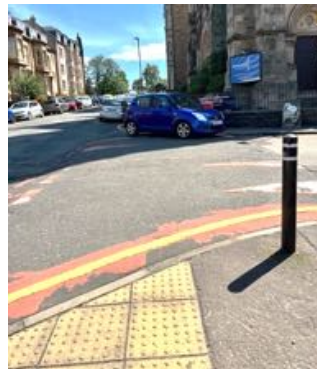
Photo 2

Residents have noted the lack of double yellow lines at the dropped kerb crossing at Westhall Gardens. Because there is only a single yellow line, cars frequently park over the crossing.

This photo shows a parked car blocking the crossing, making it almost impossible for wheelchairs to cross.

It also blocks sightlines, when walking down from Bruntsfield Place.

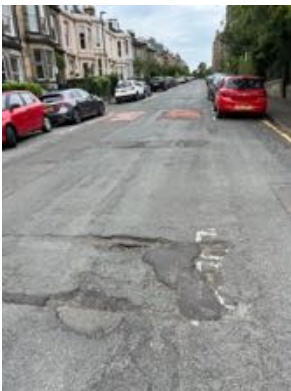
Photo 3

Photos 3 and 4 look up towards Bruntsfield Place; photo 5 looks down towards Gilmore Place; photo 6 shows a typical example of the loose gravel surface from the road.

A 'temporary' overcoat repair was applied many years ago to Leamington Terrace (possibly 20-25 year ago). The surface is now breaking up and it is badly potholed, which is particularly hazardous to cyclists and those crossing the road.

The loose gravel from the road surface washes down the street, blocking gullies on its way. Residents have cleaned the street 4 times this year, and the greater part of 'litter' collected at the lower end of the street are bags of loose grit from the road.

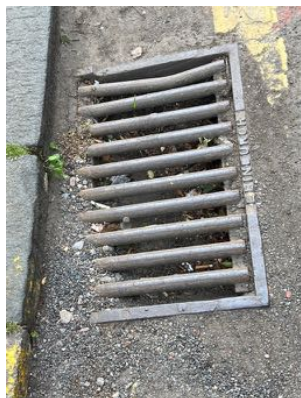
Photos 7 & 8: The gully at the bottom of Leamington Terrace, reported as completely blocked in 2019, 2020, 2021 and lastly, July 2022. Photo 7 shows it as it currently is with road gravel tipping into it. Photo 8 shows it recently after a heavy fall of rain.

When these gullies are blocked (and if there is heavy rainfall) the ground floor flats at no 10 can be flooded. This has already happened twice in the last couple of years.

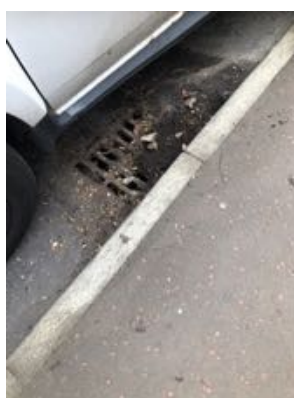
Photo 9

Photo 9: This is one further up the terrace, also blocked with gravel and litter.

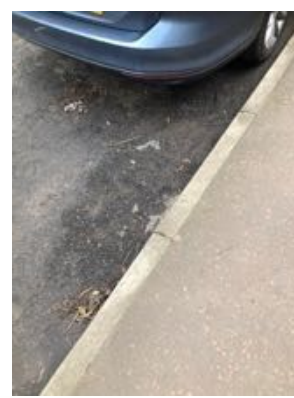
Photo 10

Photo 10: Shows the build-up of gravel in the gutter, after cleaning only a few weeks ago.

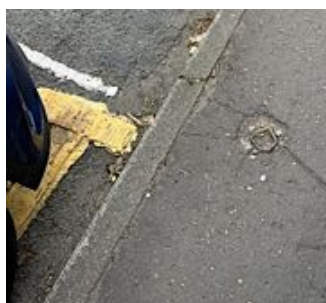
Photo 11

Photo 11: Remains of a cut pole, left with a sharp cut end exposed.

All these could injure someone – for example children, someone with sight and/or with mobility issues, someone using a walking stick – indeed anyone not seeing the hazard...

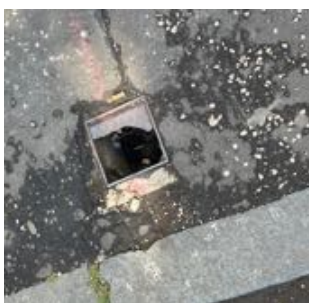
Photo 13

Photo 13: A broken cover, Lower Gilmore Place

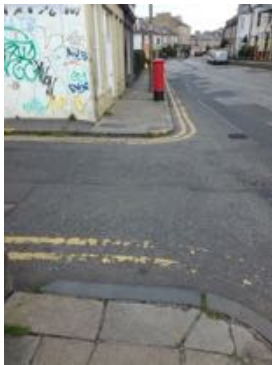
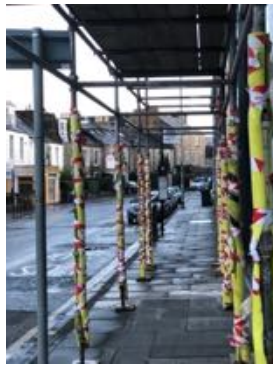
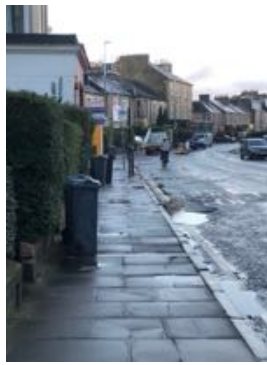
There is a lack of drop kerbs along Gilmore place.

These photos show a particular issue at road crossings and where there are bus stops at both sides of the road.

A wheelchair user would have to travel some distance to cross the road. Also the pavements are very narrow and frequently obstructed.

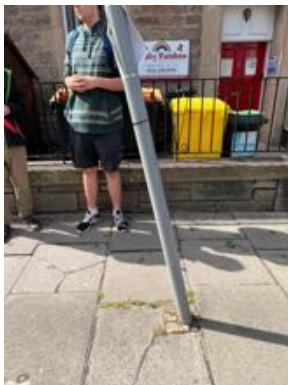
Photo 18

Gilmore Place:
This shows a damaged sign pole outside children's nursery in Gilmore Place, now reported.

Large pavement slabs are broken and potentially dangerous.

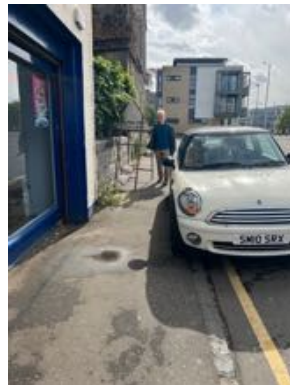
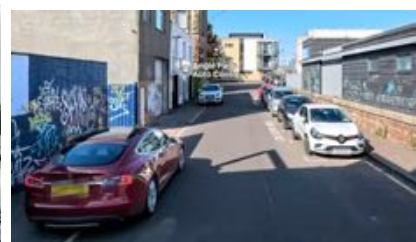
Photos 19 & 20

Lower Gilmore Place:
Pavement parking and traffic signage blocking pavement. (Photo 20 is a screen shot).

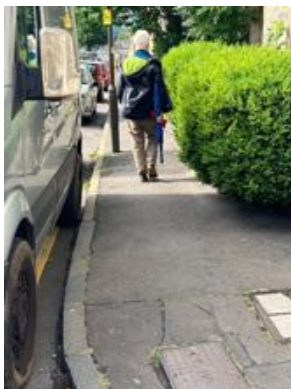
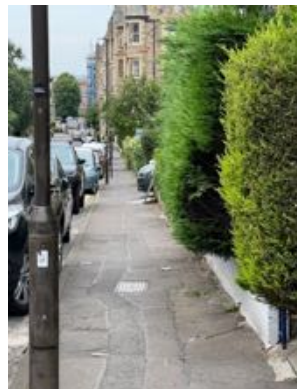
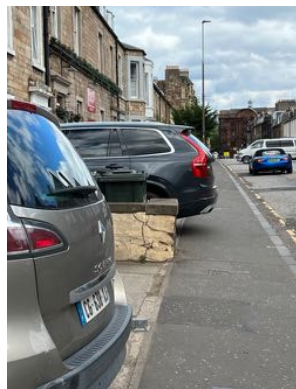
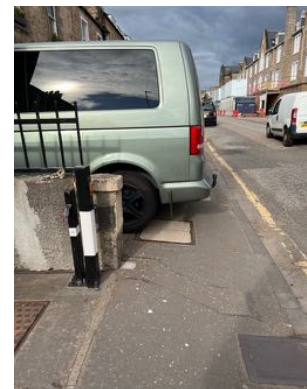
There are many hedges to front gardens, which is great for privacy and reducing poor air quality. However, if not maintained and cut back to the property boundary, hedges reduce the pavement width and can be hazardous for all, especially people with sight impairment.

In both Leamington Terrace and Gilmore Place, several front gardens have have been surfaced to allow for car parking. This is a problem where the car projects over the pavement, particularly if the pavements are narrow and in poor condition. It forces people to walk in the road and is impossible for wheelchair users or people with walking frames.

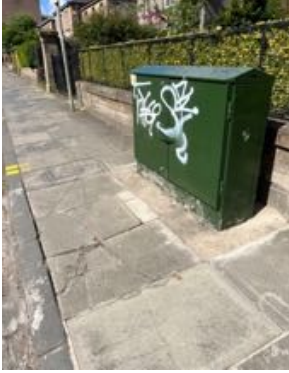
Photo 25

Gilmore Place: a recently installed BT box, set c. 300mm away from boundary wall. This reduces the pavement and is now of insufficient width for wheelchairs to safely pass.
Also now covered in graffiti.

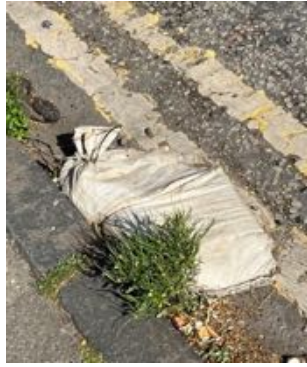
Photo 26

Sand bags from from road works signs left in the gutter.
It's the same with the actual signs too –there are several left at the bottom of Leamington Terrace from past works.

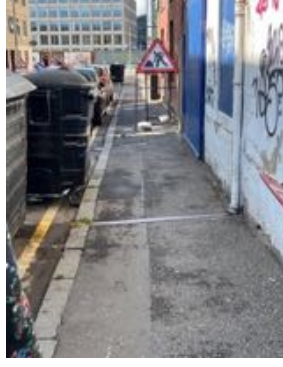
Photo 27

Lower Gilmore Place, an example of traffic signs blocking the pavement – and you can't even step off the kerb here!

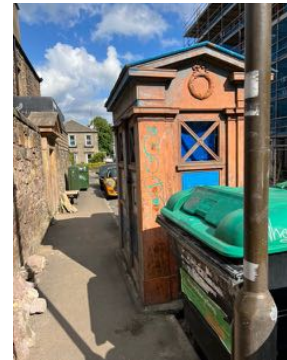
Photo 28

Former police box in Leamington Terrace, overhanging the quite narrow footpath. It limits water flowing to the gully, currently blocked, at the end of the street. Unused, it has been in the street for decades.
It is getting painted, slowly, by a volunteer. Potentially useful? Or simply street clutter?
