## Audit of 'Spaces for People' provision: A702 Tollcross to Morningside Station

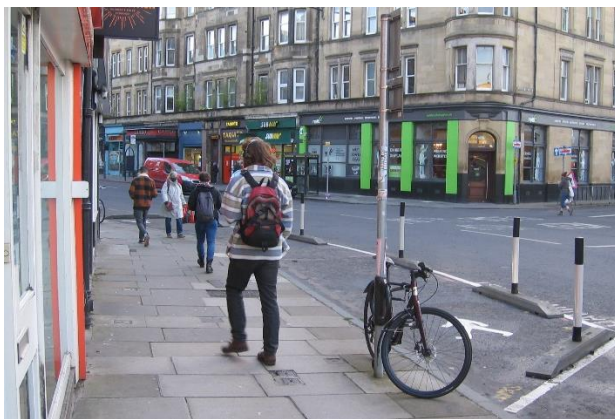
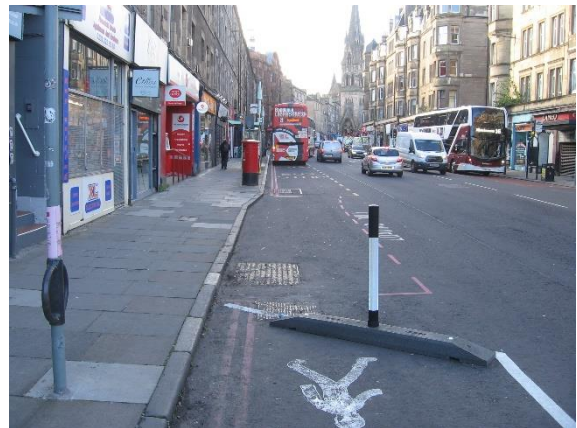
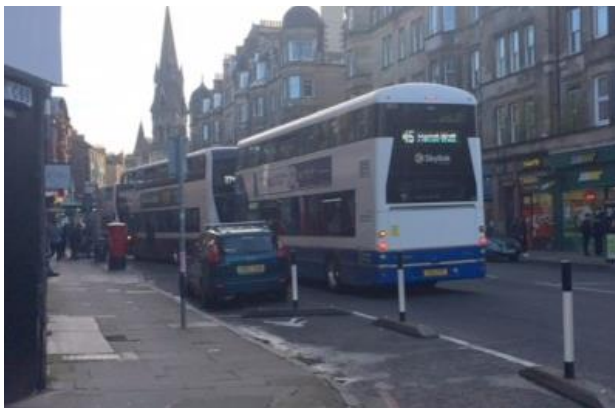
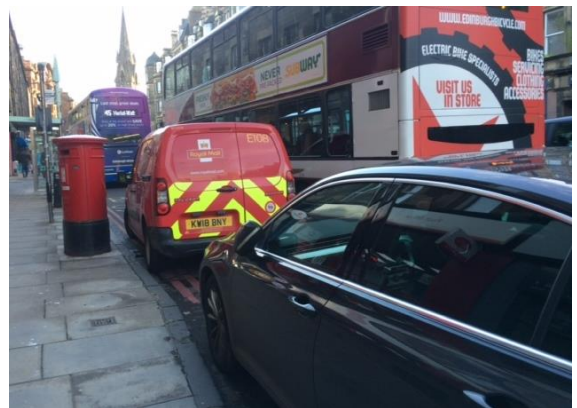
#### Location 1E (Home Street east):

The SfP space here provides a useful 2m addition where the pavement proper is just 3m wide, ie significantly less than the Street Design Guidance (SDG) 'desirable minimum' of 4m or wider. The extra space is useful not just for 'movement' but also for pedestrians to stop and chat in 'social' space without obstructing others. This location is very busy with school students in the morning peak, at lunchtimes and mid-afternoon.

As in quite a number of locations along the corridor, the Clear Walking Zone is reduced by informal cycle parking (top left photo).

*Recommendation: retain SfP space but explore the scope for some adjustment of the space and the loading bay to better accommodate bus queuing and prevent illegal stopping / parking.*

*In the longer term, permanently widen the pavement proper to create a continuous one-level space.*

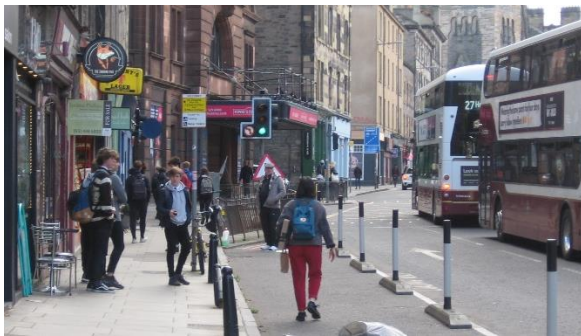
#### **Location 2E (Home Street east):**

A useful 2.1m addition where the pavement proper is just 2.65m wide, ie significantly less than the SDG 'desirable minimum' of 4m or wider.

*Recommendation: retain SfP space. In the longer term, permanently widen the pavement proper to create a continuous one-level space*

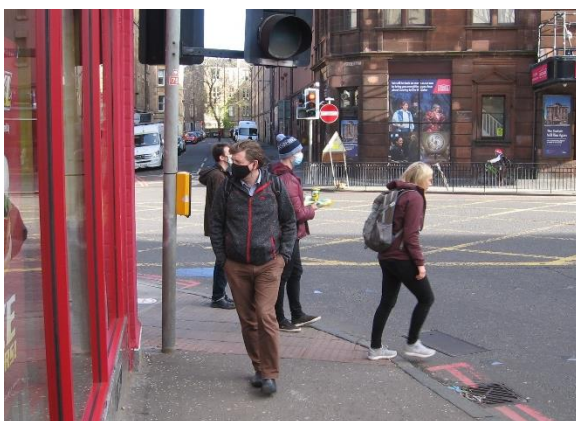
#### **Location 3WN (Home St / Leven St / Gilmore Place junction):**

This is a very busy junction where the pavement is just 2.2m wide (ie less than the SDG 'absolute minimum' of 2.5m). There are long waits for the Green Man phase, during which large numbers of pedestrians can congregate in a way where it is impossible to maintain social distancing. This is a serious pinchpoint.

*Recommendation: in the short term, increase the frequency of the Green Man phase.*

*In the longer-term, explore the scope to reduce the Gilmore Place carriageway here to just one vehicle lane in each direction, allowing the pavement (on both sides) to be substantially widened.*

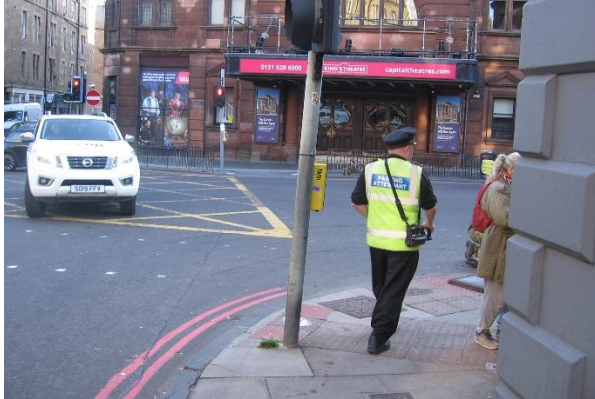
**Location 3WS (Home St / Leven St / Gilmore Place junction):**

This is a very busy junction where the Leven Street pavement is only 2.4m wide (ie less than the SDG 'absolute minimum' of 2.5m) and the Gilmore Place pavement (pictured) is just 1.6m wide. There are long waits for the Green Man phase, during which large numbers of pedestrians can congregate in a way where it is impossible to maintain social distancing. This is a serious pinchpoint.

*Recommendation: in the short term, increase the frequency of the Green Man phase.*

*In the longer-term, explore the scope to reduce the Gilmore Place carriageway here to just one vehicle lane in each direction, allowing the pavement (on both sides) to be substantially widened.*

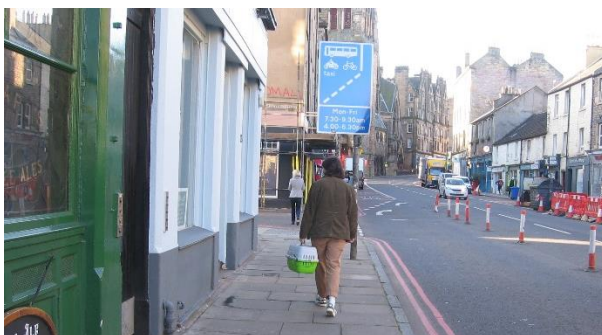
**Location 4E (Leven Street east):**

The pavement here is just 2.35m wide (ie less than the SDG 'absolute minimum' of 2.5m). While the current traffic management works associated with the ScotMid reconstruction site opposite preclude early action, this is a pavement which needs widening.

*Recommendation: explore the scope to widen the pavement once ScotMid reconstruction is completed.*

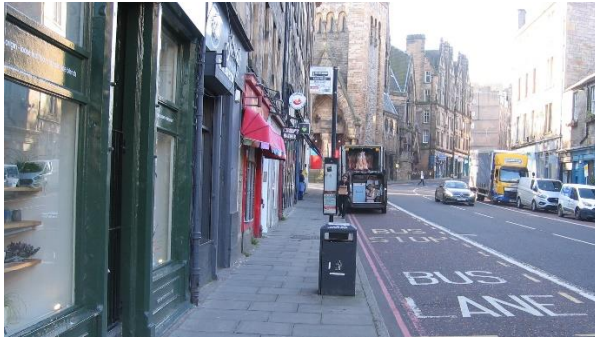
**Location 5E (Leven Street east):**

The pavement here is just 2.3m wide (ie less than the SDG 'absolute minimum' of 2.5m), and the Clear Walking Zone is even less, due to the litter bin.

*Recommendation: explore the scope to widen the pavement once ScotMid reconstruction is completed. In the meantime, relocate the litter bin closer to the bus stop in order to concentrate the obstructions at a single location.*

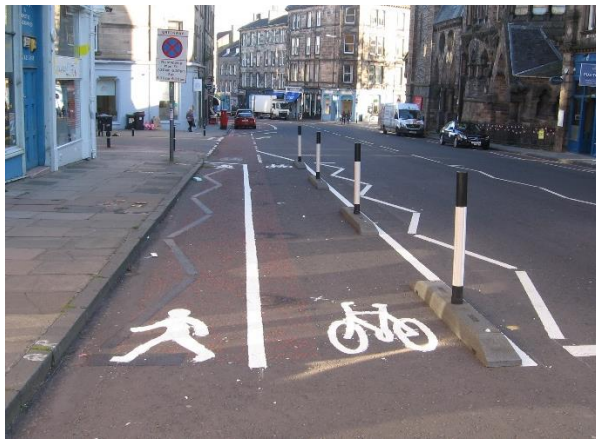
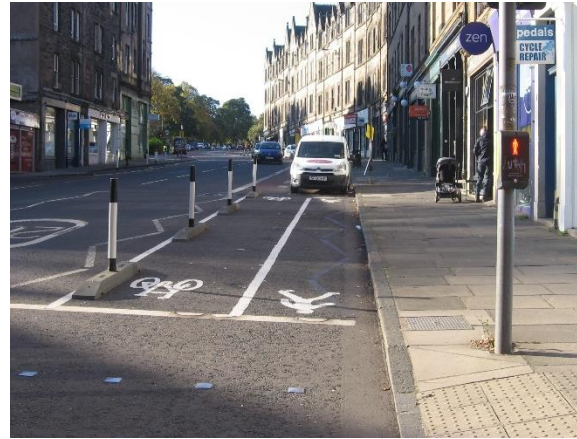
#### Location 7W (Bruntsfield Place west):

The pavement here is 3m wide (ie satisfying the SDG 'general minimum' of 3m), albeit that the Clear Walking Zone at the pedestrian crossing (pole) is just 1.35m. While the SfP walking lane (1.45m wide) does provide some potentially useful 'social space' this is undermined by its abutting directly on to the cycle lane, with no segregation other than a white line. As the carriageway slopes significantly downhill here, cyclists can readily achieve speeds well in excess of 20mph – a deterrent to pedestrians using the walking lane. It is not clear what purpose is served by such short stretches of cycle lane, nor how they contribute to social distancing.

Pre-coronavirus this was a very useful bus lane, which is lost to bus operators at a time when competition from resurgent car travel is very challenging.

*Recommendation: given the modest benefits to walking and cycling, convert this space back to a bus lane.*

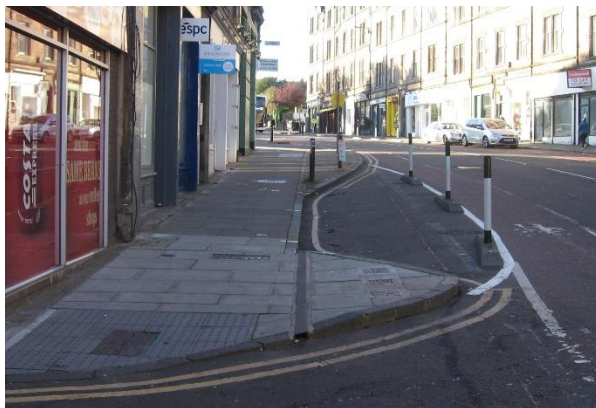
#### Location 8E (Bruntsfield Place east):

The pavement here is just 2.05m wide (ie less than the SDG 2.5m 'absolute minimum') so the additional SfP 2.25m width is welcome for both 'movement' and 'social space' reasons.

*Recommendation: retain the SfP space, and in the longer term permanently widen the pavement proper to create a continuous one-level space.*

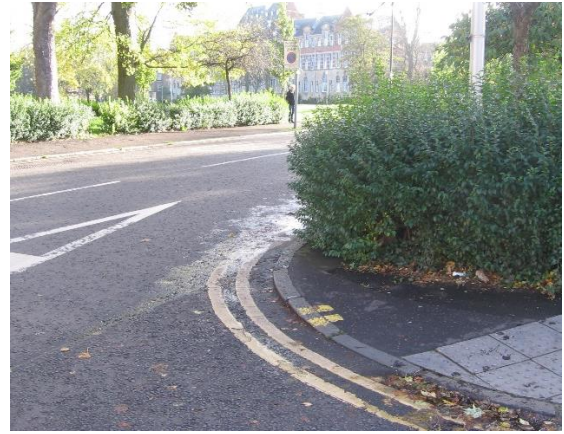
#### Location 9E (Bruntsfield Place east):

The junction of Bruntsfield Place and Whitehouse Loan is very difficult to cross for pedestrians walking up Bruntsfield Place. Whitehouse Loan is more than three lanes wide at the junction (left photo), and pedestrians have to look in three different directions in order to cross safely. Walking north along Bruntsfield Place, traffic coming from Whitehouse Loan is almost entirely obscured by an overgrown hedge (right photo), and there is no pavement at all along this side of Whitehouse Loan.

*Recommendation: create a SfP space on each side of Whitehouse Loan at the junction by installing concrete blocks as used elsewhere in the project, and cut back the overgrown hedge.*

*In the longer term, permanently narrow the carriageway and widen the Whitehouse Loan pavements here (or create a 'continuous pavement' along Bruntsfield Place across the junction), and create a new pavement along the southern section of Whitehouse Loan.*

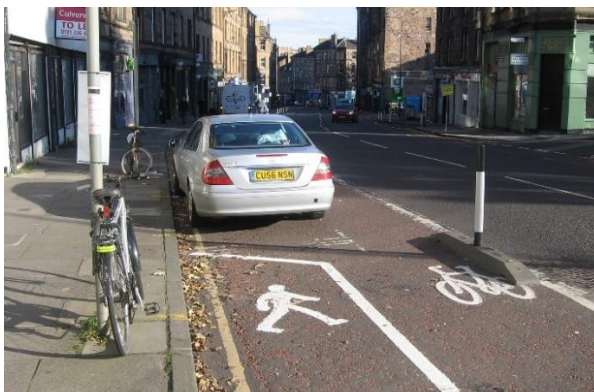
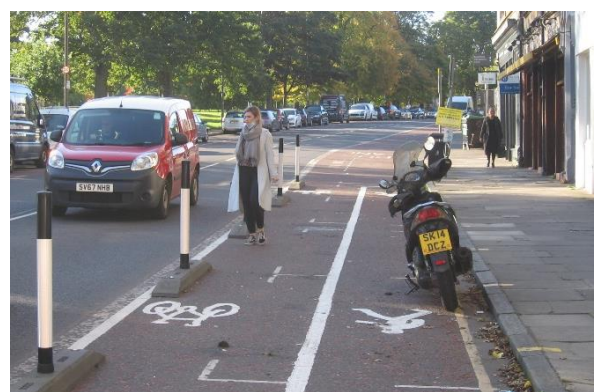
#### Location 9W (Bruntsfield Place west):

The pavement here is 3m wide (ie satisfying the SDG 'general minimum' of 2.5m), albeit that the Clear Walking Zone in places is just 1.4m. While the SfP walking lane (1.4m wide) does provide some potentially useful 'social space' this is undermined by its abutting directly on to the cycle lane (1.25m), with no segregation other than a white line. As the carriageway slopes significantly downhill here, cyclists can readily achieve speeds well in excess of 20mph – a deterrent to pedestrians using the walking lane. It is not clear what purpose is served by such short stretches of cycle lane, nor how they contribute to social distancing.

Pre-coronavirus this was a very useful bus lane, which is lost to bus operators at a time when competition from resurgent car travel is very challenging.

*Recommendation: given the modest benefits to walking and cycling, convert this space back to a bus lane.*

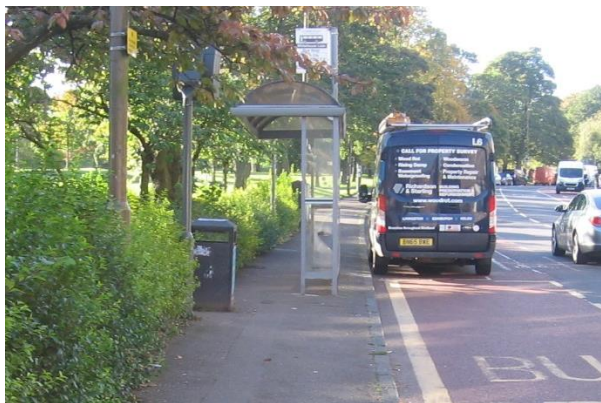
**Location 10E (Bruntsfield Place east):**

The pavement at the hedge here (foreground) is only 2m wide (ie the SDG 'absolute minimum'). At the litter bin the Clear Walking Zone is just 1.6m, while at the north end of the bus stop it is just 1.2m (ie significantly less than the SDG 'absolute minimum of 1.5m).

*Recommendation: ensure that the hedge is regularly cut back, and identify an alternative bin location further back from the kerb.*

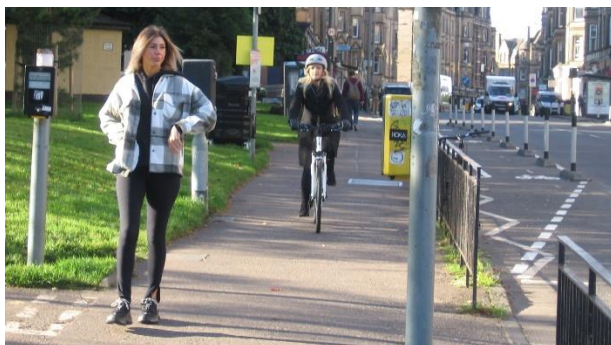
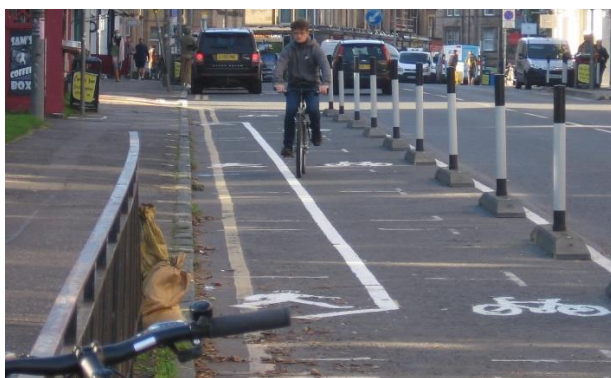
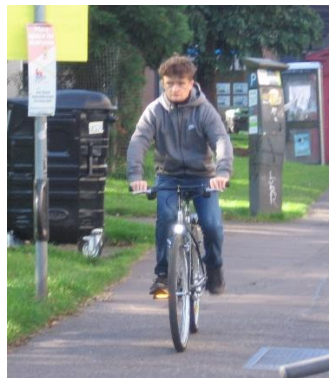
**Location 11E (Bruntsfield Place east):**

Cyclists routinely cycle the wrong way (northbound) on this southbound cycle lane and then cross over on to the pavement.

*Recommendation: It is not obvious how this problem can be solved other than by means of a continuous physical barrier between the cycle lane and the walking lane (see 12E below).*

*In the longer term, permanently widen the pavement proper to create a continuous one-level space.*

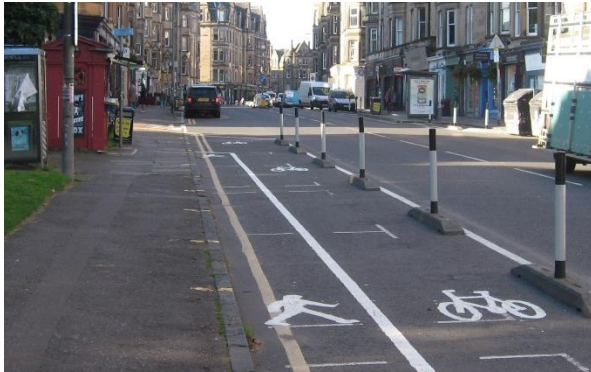
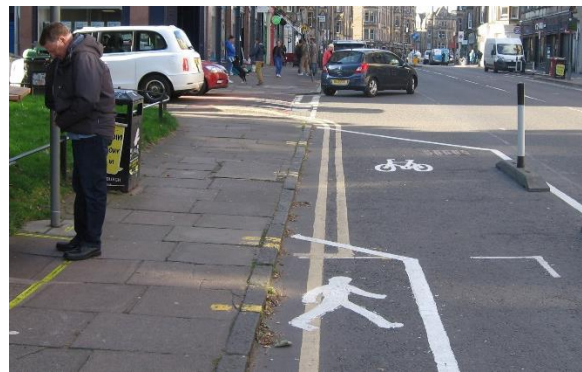
**Location 12E (Bruntsfield Place east):**

The pavement here is just 2.1m wide (ie significantly less than the SDG ‘absolute minimum’ of 2.5m), with a Clear Walking Zone of just 1.6m at the litter bin. The additional 1m walking lane is therefore very welcome, but this still leaves the total width for pedestrians at substantially less than the SDG ‘desirable minimum’ of 4m or wider, and the width is at two levels rather than being continuous.

Also the 1m walking lane is cut short before the junction with Bruntsfield Terrace (second photo), while in contrast the cycle lane is 1.55m wide, and all at one level – and is continuous through to the Bruntsfield Terrace junction. There is no physical segregation between pedestrians and cyclists, just a white line.

*Recommendation: narrow the cycle lane, widen the walking lane, create a continuous physical barrier between the two, and extend the walking lane right through to the Bruntsfield Terrace junction.*

*In the longer term, permanently widen the pavement proper to create a continuous one-level space.*

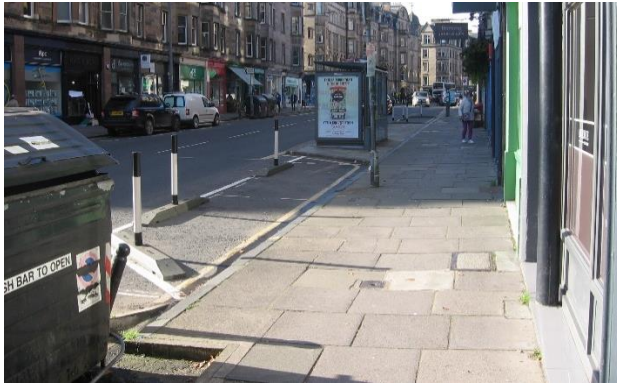
**Location 12W (Bruntsfield Place west):**

The pavement here is just 2.8m wide (ie less than the SDG 'general minimum' of 3m) and therefore the additional SfP space is welcome, close to the bus stop.

*Recommendation: retain the SfP space, and in the longer term permanently widen the pavement proper to create a continuous one-level space.*

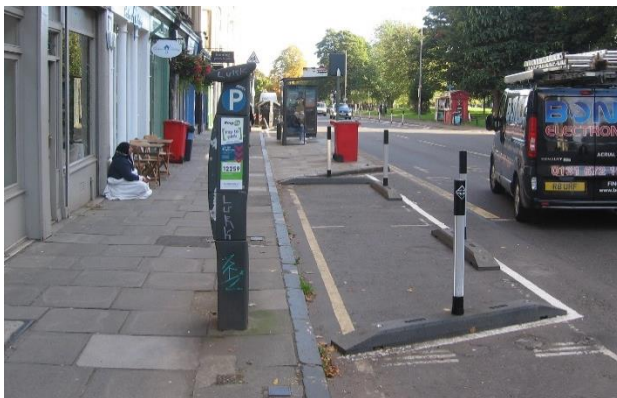
**Location 13W (Bruntsfield Place west):**

The pavement here is only 2.8m wide (ie less than the SDG 'general minimum' of 3m), and the Clear Walking Zone is just 1.85, due to the parking ticket machine, and therefore the additional SfP space is welcome.

*Recommendation: retain the SfP space, and in the longer term permanently widen the pavement proper to create a continuous one-level space.*

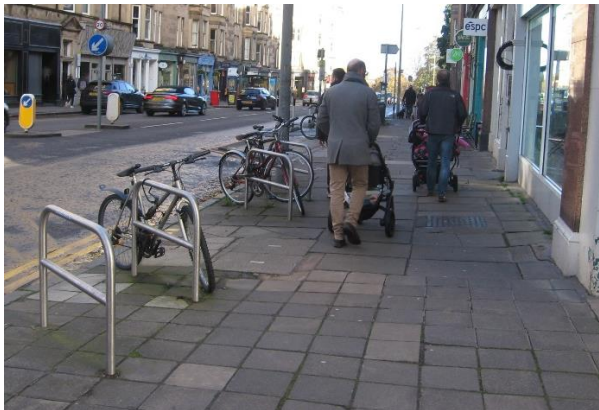
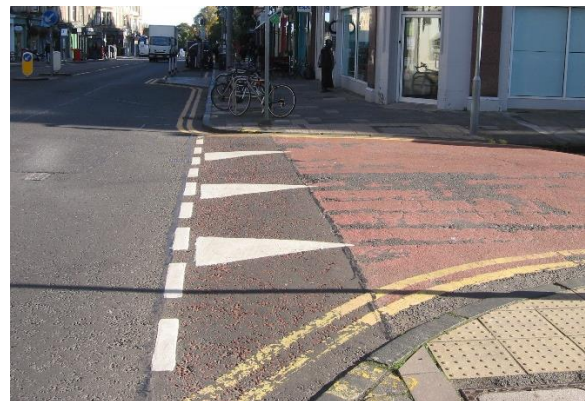
**Location 14E (Bruntsfield Place east):**

The cycle racks here at the junction with Forbes Road unnecessarily take up pavement space when there is now SfP space a short distance to the north. The junction carriageway is far too wide for a one-way street with heavy pedestrian footfall along Bruntsfield Road.

*Recommendation: relocate cycle racks further north in the SfP space, and create a new SfP space on each side of Forbes Road at the junction by installing concrete blocks as used elsewhere in the project.*

*In the longer term, permanently narrow the carriageway and widen the Forbes Road pavements here (or create a 'continuous pavement' along Bruntsfield Road across the junction).*

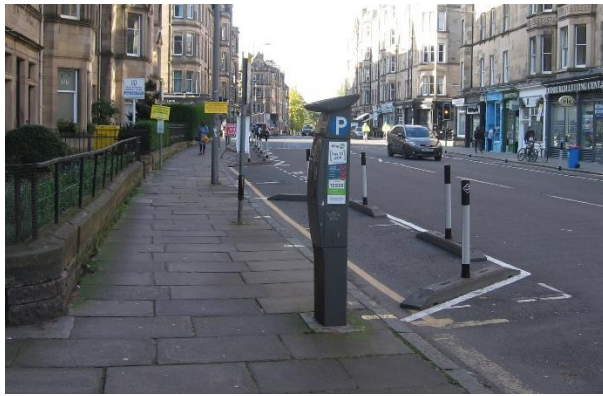
#### Location 15E (Bruntsfield Place east):

The pavement here is only 2.7m wide (ie only just wider than the SDG 'absolute minimum' of 2.5m) and the Clear Walking Zone is just 1.85m in places – therefore the additional SfP space is welcome as a 'social' space. Its utility as a 'movement' space is less clear, as it is a short length, discontinuous with the next short SfP space a short distance to the south (see 16E below).

*Recommendation: extend the SfP space to link up with 16E in order to create a much more useful, continuous 'movement' space.*

*In the longer term, permanently widen the pavement proper throughout this length to create a continuous one-level space.*

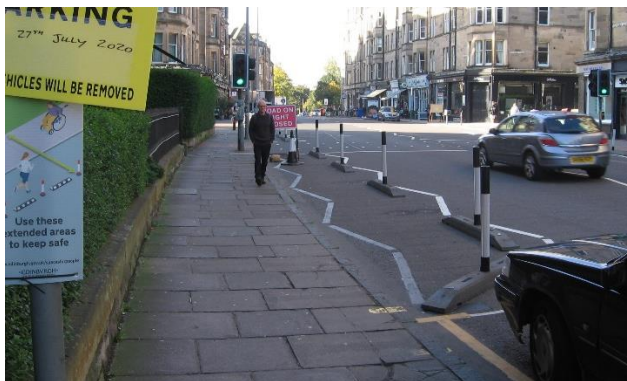
#### Location 16E (Bruntsfield Place east):

The pavement here is only 2.2m wide (ie less than the SDG 'absolute minimum' of 2.5m) and therefore the additional 1.8m SfP space is welcome as a 'social' space and also a 'movement' space adjacent to a popular pedestrian crossing. However its utility as a movement space is less than it could be, as it is a short length, discontinuous with the previous SfP space to the north (see 15E above). The angled concrete block in the foreground is not delineated by a white line, and this could represent a trip hazard.

*Recommendation: extend the SfP space to link up with 15E in order to create a much more useful, continuous 'movement' space. Apply a white line to the edge of the angled concrete block.*

*In the longer term, permanently widen the pavement proper throughout this length to create a continuous one-level space.*

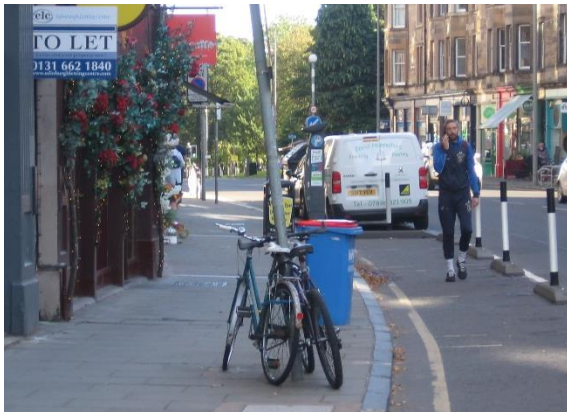
**Location 16W (Bruntsfield Place west):**

The pavement here is only 2.45m wide (ie less than the SDG 'absolute minimum' of 2.5m), and the Clear Walking Zone between the informally-parked bikes (and pole) is just 1.75m, and therefore the additional SfP space is welcome as a 'social' space and also a 'movement' space adjacent to a popular pedestrian crossing. The street here is extremely busy with children, parents / carers and buggies on their way to Bruntsfield Primary and Nursery at certain times of the day.

*Recommendation: retain the SfP space, remove the now-redundant pole (and hence the informal bike parking), install formal cycle parking facilities in the SfP space, and in the longer term permanently widen the pavement proper to create a continuous one-level space.*

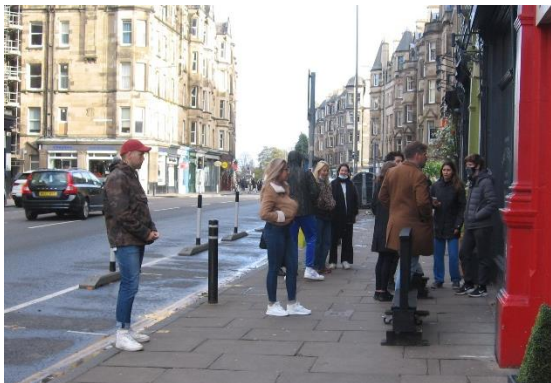
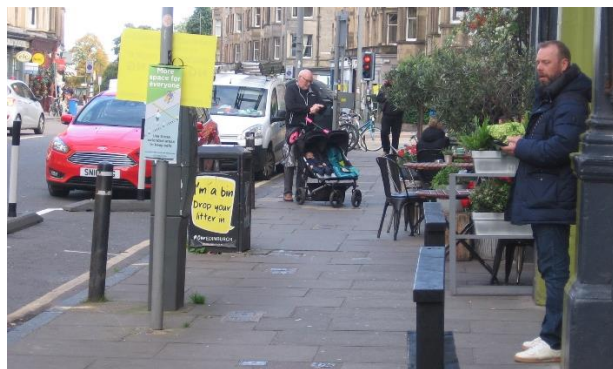
**Location 17E (Bruntsfield Place east):**

The southern end of this pavement section (left photo) is often occupied by queuing, while the northern end (right photo) is particularly cluttered. The welcome SfP space (for both 'movement' and 'social' purposes) unfortunately does not extend far enough north to provide a continuous addition to the pavement unobstructed by tables and chairs.

*Recommendation: extend the SfP space a short distance north to avoid the tables & chairs clutter, and clarify the space allowed for tables & chairs in the relevant licence.*

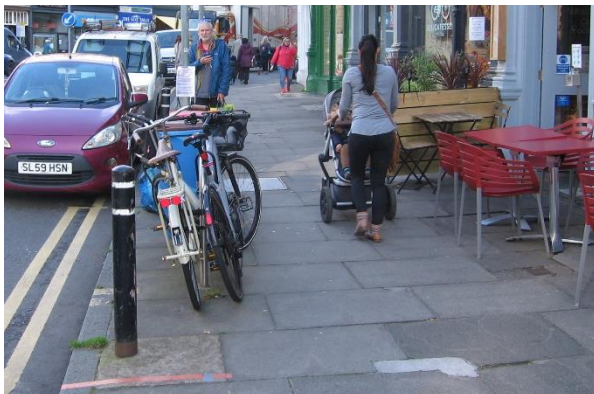
**Location 19E2 (Bruntsfield Place west):**

Although the pavement is reasonably wide here, its utility is significantly constrained by a combination of formal cycle parking and tables & chairs, leaving a Clear Walking Zone of just 1.4m on a pavement section regularly busy with pedestrians.

*Recommendation: relocate formal cycle parking to a designated space on the vehicle carriageway, and clarify the space allowed for tables & chairs in the relevant licence.*

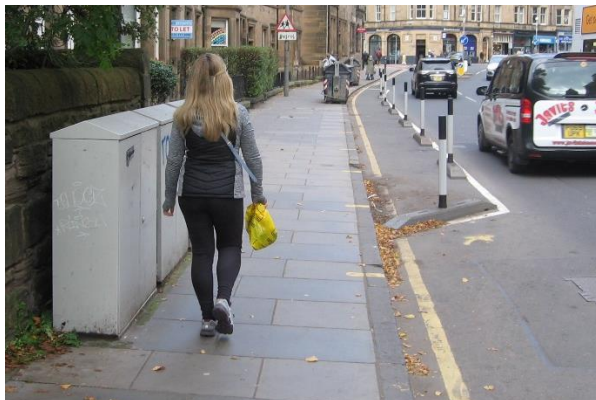
### Location 21W (Morningside Road west):

The pavement narrows to only 2.15m here (ie less than the SDG 'absolute minimum' of 2.5m), and the grey utility boxes reduce the Clear Walking Zone to just 1.6m.

*Recommendation: extend the SfP space a short distance towards Holy Corner in order to remove the pedestrian pinchpoint.*

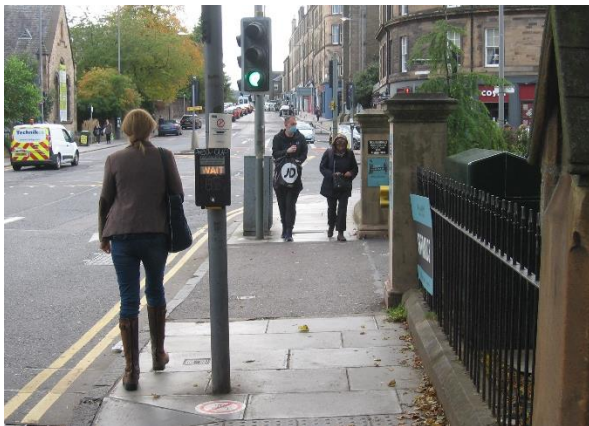
**Location 22NW3 (Holy Corner north west):**

Despite this being a major pedestrian pinch-point, no SfP measures have been applied to any part of the busy intersection at Holy Corner.

The pavement width here is only 2.2m (ie less than the SDG 'general minimum' of 2.5m) at a busy pedestrian location, and the Clear Walking Zone is just 1.3m (ie less than the SDG 'absolute minimum' of 1.5m). There are long waits for the Green Man phase, during which large numbers of pedestrians can congregate in a way where it is impossible to maintain social distancing.

A further hazard to pedestrians is the vehicular access to McLaren's restaurant, across which lorries and vans regularly reverse.

*Recommendation: in the short term, increase the frequency of the Green Man phase.*

*In the longer-term, review the design of the Holy Corner intersection to (i) allow social distancing, (ii) ensure that pedestrians' place at the top of the movement hierarchy is delivered in practice, and (iii) comply with the guidelines in the Council's Street Design Guidance.*

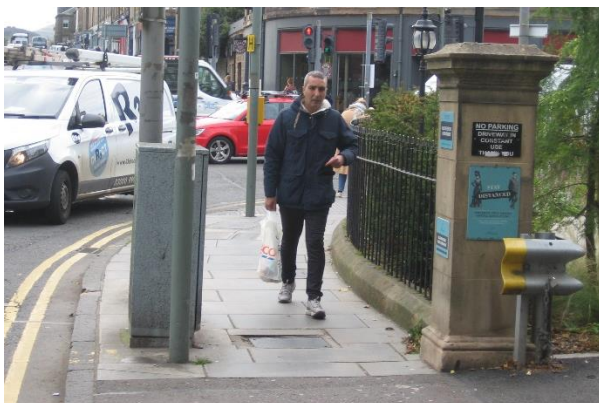
#### **Location 22NW4 (Holy Corner north west):**

The pavement here is only 2.3m wide (ie less than the SDG 'general minimum' of 2.5m), despite this being one of the busiest pedestrian junctions on the entire corridor) and the poles / grey utility box reduce the Clear Walking Zone to just 1.4m (compared to the SDG 'absolute minimum' of 1.5m).

*Recommendation: as per Location 22NW3 above, plus investigate the scope for relocation of the utility box / poles.*

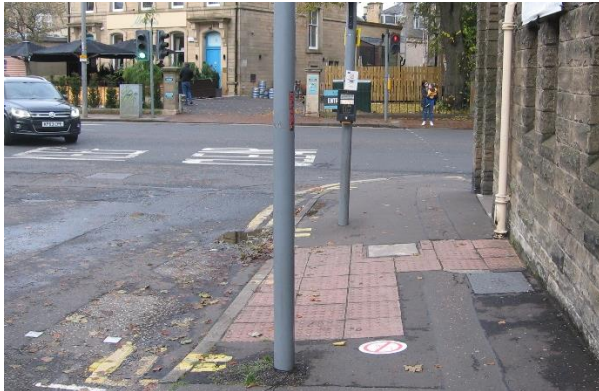
**Location 22NE2 (Holy Corner north east):**

The pavement here is only 2.4m wide, and the Clear Walking Zone is just 1.6m. There are long waits for the Green Man phase, during which large numbers of pedestrians can congregate in a way where it is impossible to maintain social distancing.

*Recommendation: as per Location 22NE1 above.*

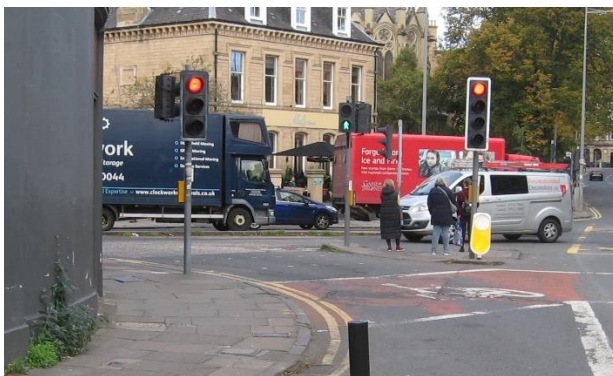
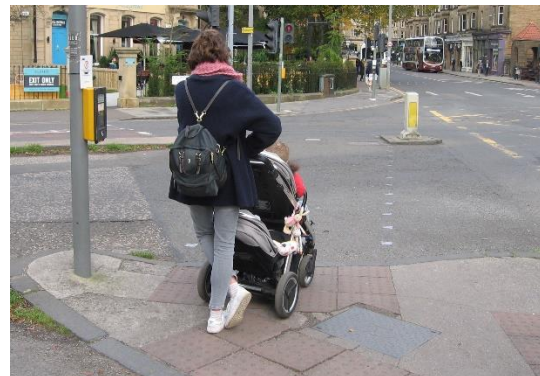
**Location 22SW1/2 (Holy Corner south west):**

The pavement width beside Costa (left photo) at the waiting area for the crossing is only 2.2m, and the Clear Walking Zone is just 1.5m. The width of the pedestrian island part-way across Colinton Road (right photo) ranges from 1.7m to 3.2m.

There are long waits for the Green Man phase, during which large numbers of pedestrians can congregate in a way where it is impossible to maintain social distancing.

*Recommendation: in the short term, increase the frequency of the Green Man phase.*

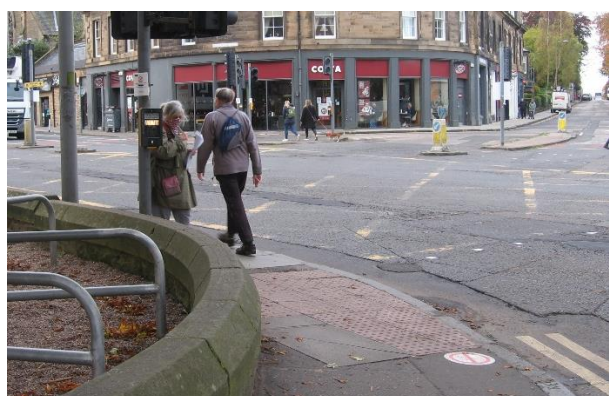
**Location 22SE2 (Holy Corner south east):**

The pavement width here is only 1.65m (ie significantly less than the SDG 'absolute minimum' of 2m), and the Clear Walking Zone is just 1.45m (ie less than the SDG 'absolute minimum' of 1.5m). Pedestrians can feel very vulnerable at this location on such a narrow pavement strip, with southbound vehicles on Morningside Road passing at speed less than a metre away. There are long waits for the Green Man phase, during which large numbers of pedestrians can congregate in a way where it is impossible to maintain social distancing.

*Recommendation: as per Location 22SW1/2 above.*

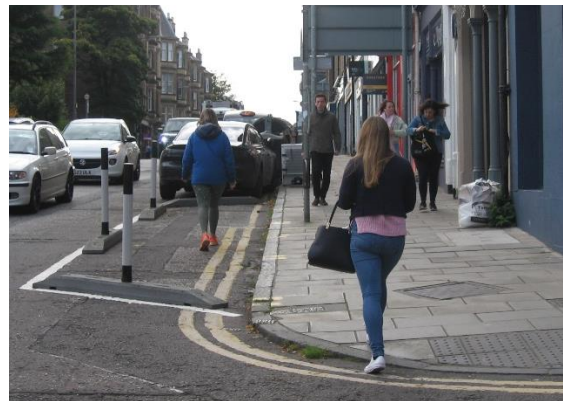
**Location 24W (Morningside Road west):**

The pavement here is only 2.1m wide (ie less than the SDG 'general minimum' of 2.5m). This is often a busy section of pavement and queuing outside the Post Office is common, therefore the additional SfP space is welcome as a 'social' space and also a 'movement' space.

*Recommendation: retain the SfP spaces, and in the longer term permanently widen the pavement proper to create continuous one-level spaces.*

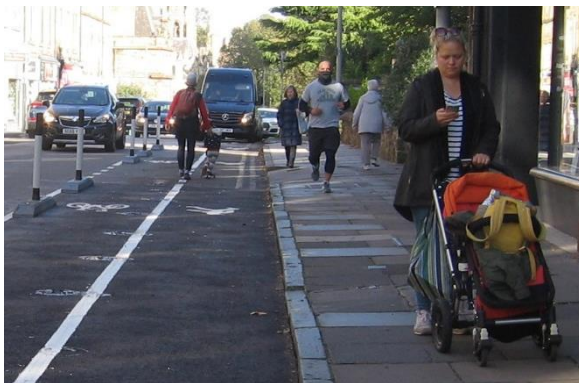
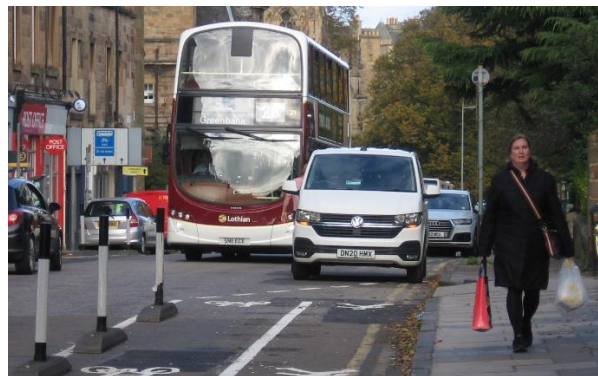
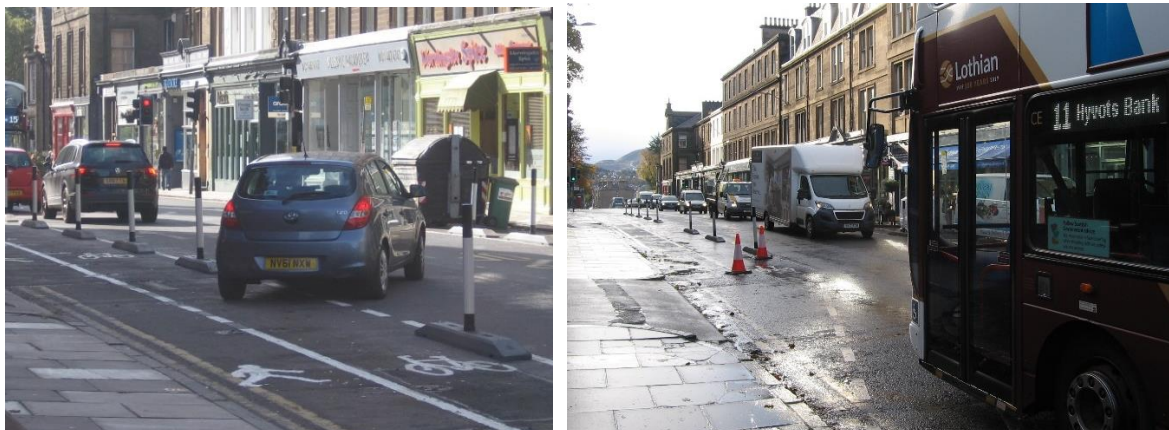
**Location 28E (Morningside Road east):**

The pavement here is only 2.2m wide (ie significantly less than the SDG ‘absolute minimum’ of 2.5m), with a Clear Walking Zone of just 1.7m in places, and therefore the additional SfP walking lane (1.35m) is welcome.

However, in the first (temporary) phase of the SfP space there was a physical separation between the walking and cycling lanes, but this has now been removed, leaving only a white line, which does not give sufficient protection for pedestrians.

There is no permanent physical deterrent to vehicles entering the two lanes from the north (top right photo) and on a number of occasions vehicles have been observed using the ‘Active Travel’ lanes (bottom left photo).

*Recommendation: provide a permanent physical deterrent to vehicles entering the ‘Active Travel’ lanes (plastic cones are currently in place).*

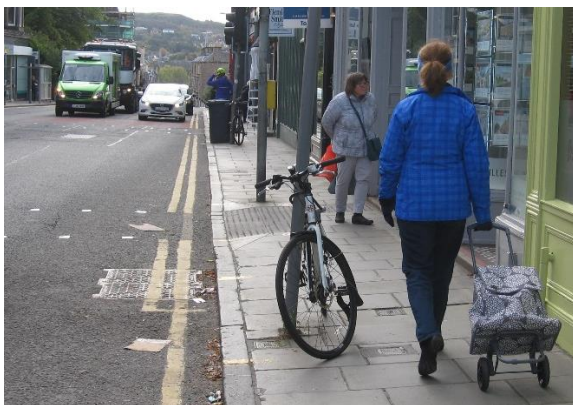
**Location 30W (Morningside Road west):**

The pavement here is only 1.85m wide (ie substantially less than the SDG ‘absolute minimum’ of 2.5m), with a Clear Walking Zone of just 1.5m. There are long waits for the Green Man phase, during which large numbers of pedestrians can congregate in a way where it is impossible to maintain social distancing.

*Recommendation: as per Location 29W.*

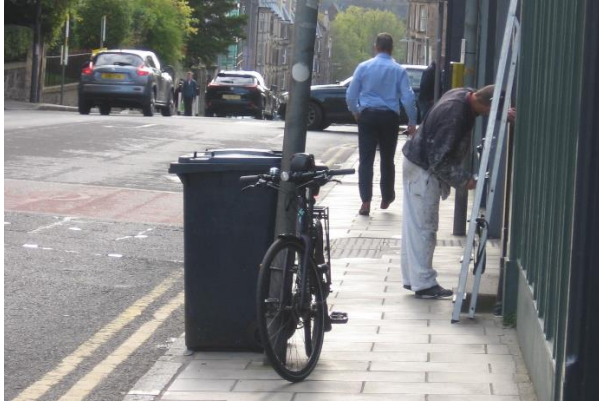
**Location 31W (Morningside Road west):**

The pavement here is only 1.9m wide (ie substantially less than the SDG 'absolute minimum' of 2.5m), with a Clear Walking Zone of just 1.2m. (ie substantially less than the SDG 'absolute minimum' of 1.5m). There are long waits for the Green Man phase, during which large numbers of pedestrians can congregate in a way where it is impossible to maintain social distancing.

*Recommendation: in the short term, increase the frequency of the Green Man phase.*

*In the longer term, review the design of the Church Hill junction (see Location 34W) to eliminate the danger and inconvenience for pedestrians posed by the unacceptably narrow pavement on the west side of Morningside Road.*

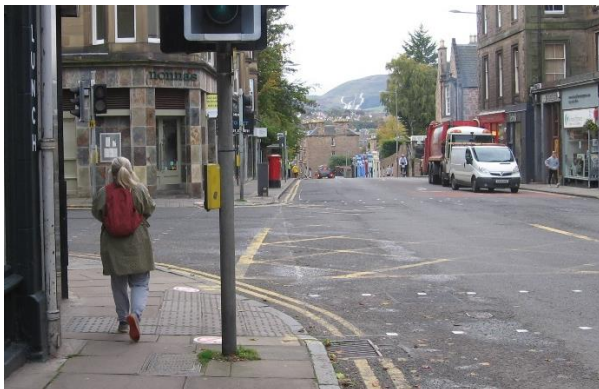
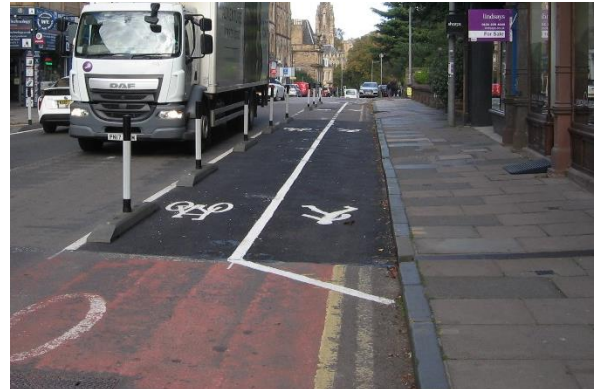
**Location 32E (Morningside Road east):**

The pavement here is only 2.35m wide (ie less than the SDG 'absolute minimum' of 2.5m), with a Clear Walking Zone of just 1.3m. (ie less than the SDG 'absolute minimum' of 1.5m). There are long waits for the Green Man phase, during which large numbers of pedestrians can congregate in a way where it is impossible to maintain social distancing.

*Recommendation: in the short term, increase the frequency of the Green Man phase.*

*Undertake a longer-term review of the whole Church Hill junction to identify more pedestrian-friendly designs.*

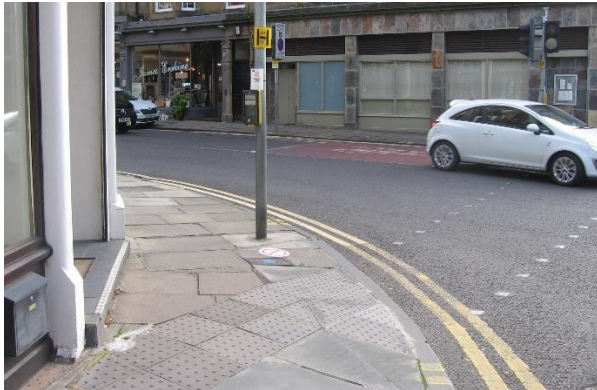
**Location 33NE (Morningside Road east):**

The pavement here is only 2.4m wide. There are long waits for the Green Man phase, during which large numbers of pedestrians can congregate in a way where it is impossible to maintain social distancing.

*Recommendation: in the short term, increase the frequency of the Green Man phase.*

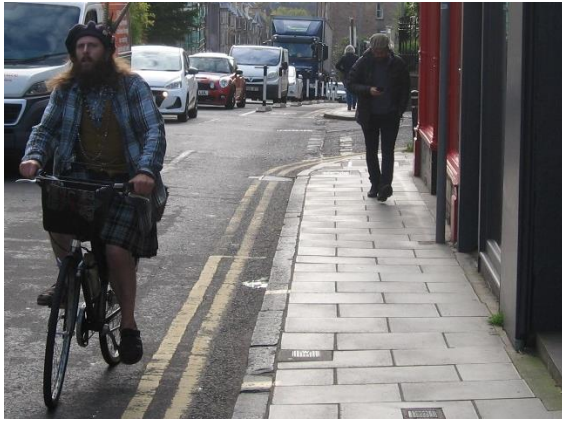
**Location 34W (Morningside Road west):**

This one of the worst untreated pedestrian pinchpoints on the entire corridor. The pavement here is only 1.4m wide (ie substantially less than the SDG 'absolute minimum' of 2.5m), with vehicular traffic passing (sometimes at speed) less than a metre away from pedestrians. The problem is compounded when people are queuing outside the Shelter shop (right photo). Immediately beyond Shelter, the junction with Abbotsford Park can be difficult for pedestrians to cross, with the eastbound lane of Abbotsford Park 'sweetened' to enable vehicles to turn left on to Morningside Road without stopping.

*Recommendation: encourage Shelter to introduce a queuing system which has its head just round the corner on Abbotsford Park (ie not on Morningside Road).*

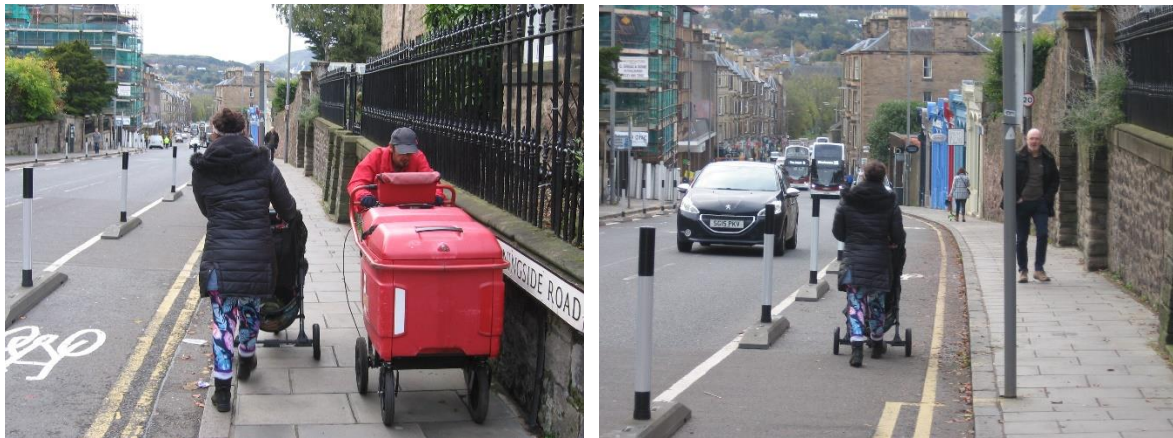
**Location 35W (Morningside Road west):**

The pavement here is only 1.65m wide (ie substantially less than the SDG ‘absolute minimum’ of 2.5m) and the Clear Walking Zone is just 1.15m in places. (ie substantially less than the SDG ‘absolute minimum’ of 1.5m)

During the earlier ‘temporary’ phase of the SfP project, vertical ‘wands’ were installed to create a narrow additional width for pedestrians, acting as a buffer zone to clearly distance vehicles from the pavement.

*Recommendation: review the relative benefits to cyclists and pedestrians of this design – taking into account the relative number of cyclists and pedestrians on this section) and seek to identify ways of enhancing a severely sub-standard width of pavement.*

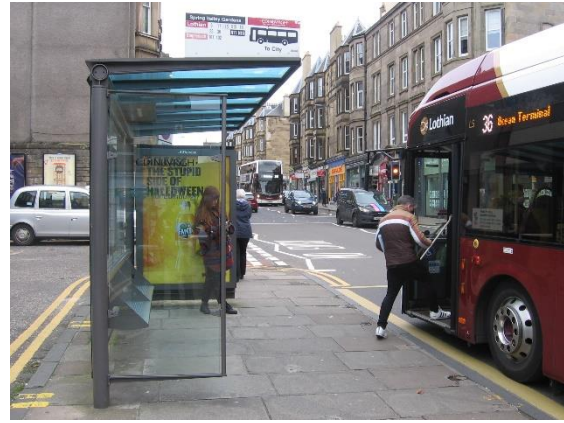
#### **Location 49W (Morningside Road west):**

This location is poorly designed for pedestrians, both those walking up or down Morningside Road and those boarding or alighting from buses (this is normally a busy bus stop). The advertising screen at the north end of the JC Decaux shelter reduces the Clear Walking Zone to just 1.7m at this pinchpoint.

*Recommendation: in the short-term replace the advertising screen with a narrower glass panel (like that in the right photo).*

*In the longer-term explore the scope for a bus build-out and/or a complete redesign of the public realm here (including the carriageway behind the bus stop) in order to prioritise pedestrians and bus users.*

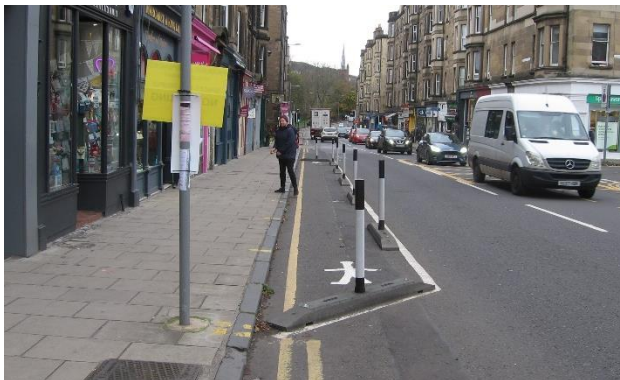
#### **Location 49E (Morningside Road east):**

The pavement here is only 2.7m wide, and the signage pole (and SfP sign), and therefore the additional 1.4m SfP space is welcome.

*Recommendation: retain the SfP space, and in the longer term permanently widen the pavement proper to create a continuous one-level space.*

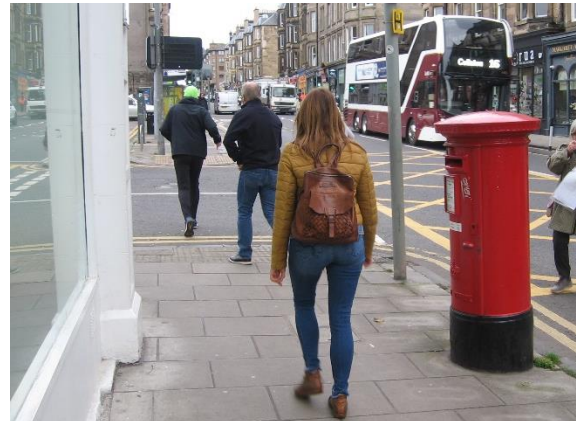
**Location 50W (Morningside Road west):**

The junction of Morningside Park and Morningside Road has been an accident black-spot and the pavements here are narrow: only 1.8m beside the tactile paving for crossing Morningside Park (left photo) and 2.8m on the main pedestrian route (up Morningside Road, right photo), with a Clear Walking Zone of just 1.8m to the post box.

*Recommendation: in the short-term, reduce the crossing width with concrete blocks (on the south side of Morningside Park) as used elsewhere in the project, and in the longer-term create a continuous pavement across Morningside Park.*

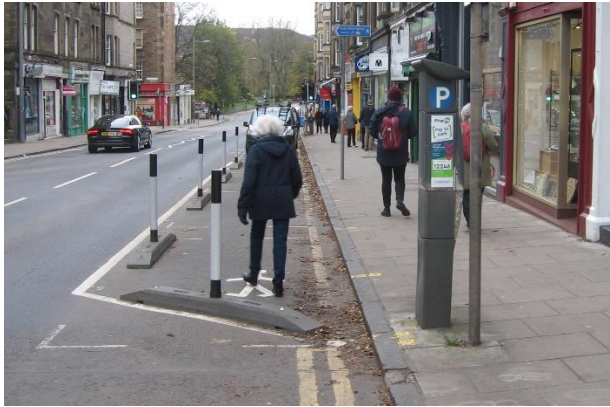
**Location 51W (Morningside Road west):**

The pavement here is only 2.7m wide (ie only just wider than the SDG 'absolute minimum' of 2.5m) and therefore the additional 2m SfP space is welcome.

*Recommendation: retain the SfP space, and in the longer term permanently widen the pavement proper to create a continuous one-level space.*

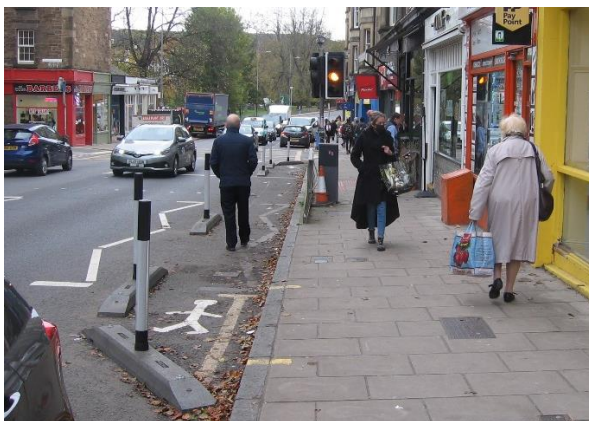
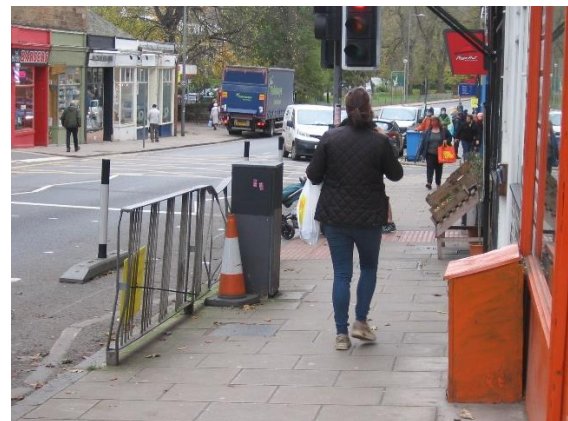
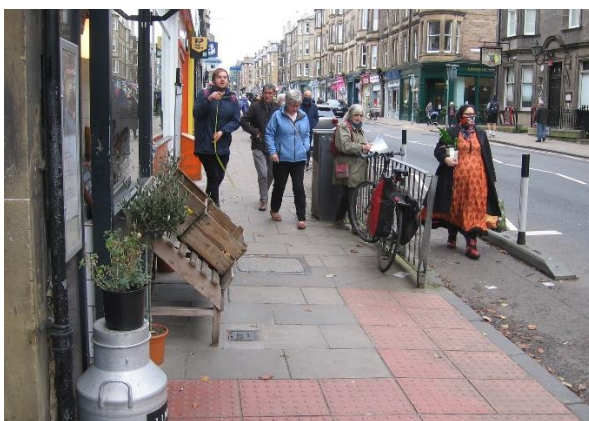
**Location 52W (Morningside Road west):**

The pavement proper here is only 2.6m wide, and due to various items of pavement clutter (and goods on display) the Clear Walking Zone is reduced to 1.5m in places – and therefore the additional 1.1m SfP space is welcome. The latter also reduces the width of carriageway to cross at the pedestrian crossing. However the total width available for pedestrians is split both horizontally (by

the kerb drop) and vertically (by the redundant guard rail). The angled concrete block in the foreground is not delineated by a white line, and this could represent a trip hazard.

Section 129(9) of the Road Scotland Act 1984 forbids the placement of goods for sale on the public sections of the street. If alerted to such a problem, the Council can issue a statutory notice to the offending business and action then taken if they fail to comply.

*Recommendation: retain the SfP space, and remove the redundant guard rail. Encourage the shop owner to convert his frontage to create street access to goods on display without encroaching on the pavement, as in the earlier examples on Home Street and Bruntsfield Place. Apply a white line to the edge of the angled concrete block.*

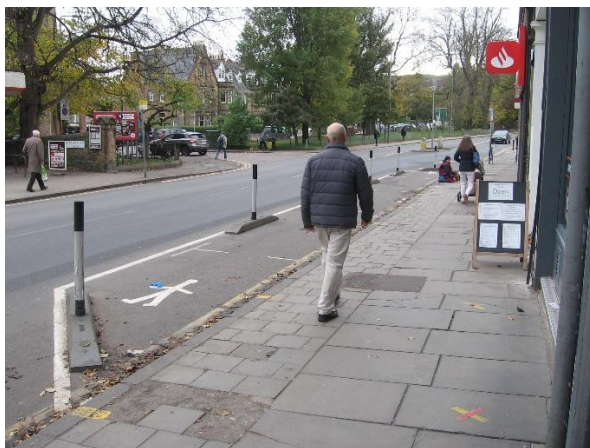
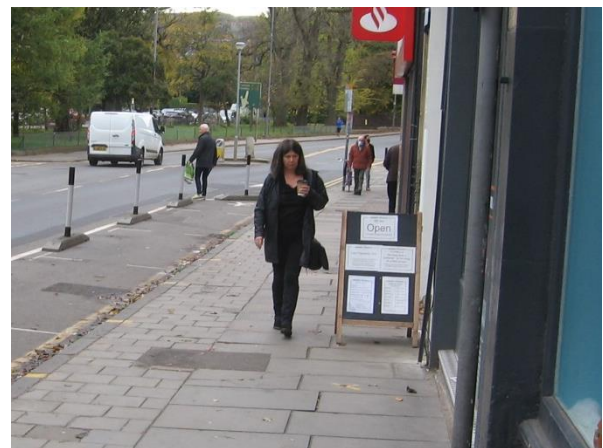
**Location 54W / 55W (Morningside Road west):**

The pavement here is only 2.8m wide (ie less than the SDG 'general minimum' of 3m) and therefore the additional SfP space is welcome. However, an illegally-sited advertising board partly obstructs the pavement proper.

*Recommendation: retain the SfP space, and in the longer term permanently widen the pavement proper to create a continuous one-level space. Remind the shop owner about the city-wide ban on advertising boards.*

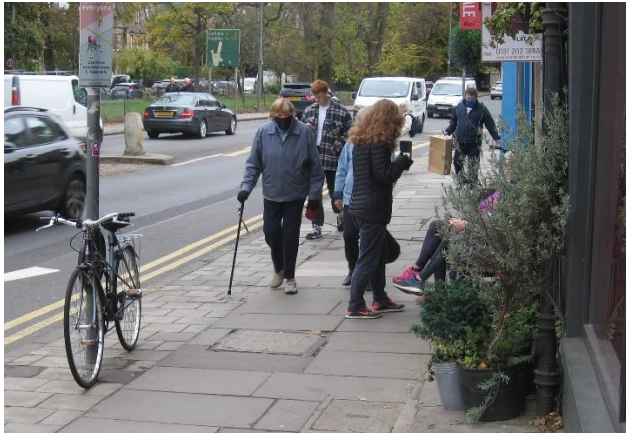
**Location 56W (Morningside Road west):**

The pavement here is reasonably wide (3.6m) but informal cycle parking and pot plants reduce the Clear Walking Zone to just 1.7m.

*Recommendation: explore the scope for the sign on the pole to be relocated on the building wall, and investigate alternative locations in the vicinity for formal cycle parking. Ask the shop owner to reduce or remove the obstruction caused by pot plants.*

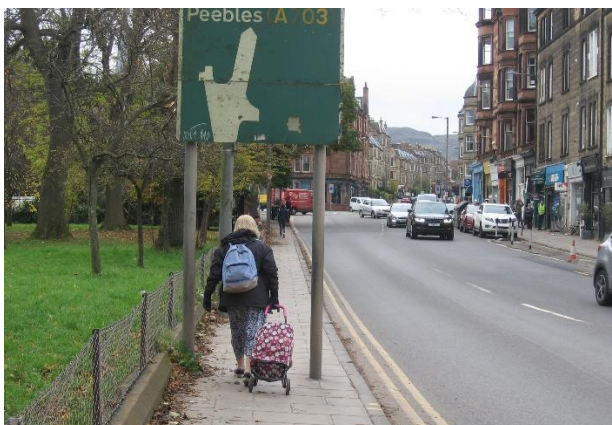
**Location 56E (Morningside Road east):**

The pavement here is only 1.8m wide (ie substantially less than the SDG 'absolute minimum' of 2.5m) and the Clear Walking Zone at the poles is just 1.05m (ie substantially less than the SDG 'absolute minimum' of 1.5m).

*Recommendation: in the short-term erect a new sign on a single pole. In the longer-term review the whole street design to create a much more pedestrian-friendly environment.*

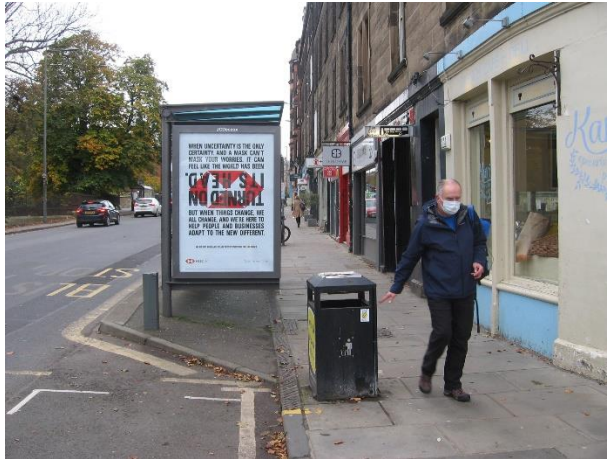
**Location 57W1 (Morningside Road west):**

The bus build-out helps to relieve a pavement which is otherwise only 2.7m wide, but the inappropriately located litter bin reduces the Clear Walking Zone to just 1.8m

*Recommendation: relocate the litter bin to the bus build-out.*
