## Audit of 'Spaces for People' provision: A702 Tollcross to Morningside Station

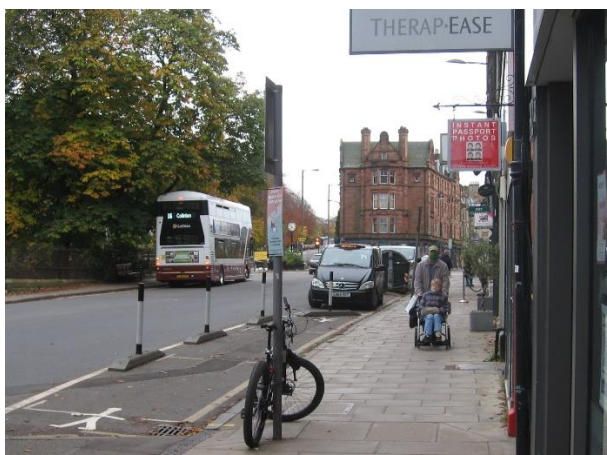
**Location 57W2 (Morningside Road west):**

The pavement here is only 2.9m wide and the Clear Walking Zone is reduced by the informal bike parking and pole – and therefore the additional 2m SfP space is welcome.

*Recommendation: retain the SfP space, create formal cycle parking facilities within the SfP space, and explore the scope for the sign on the pole to be relocated on the building wall.*

*In the longer term permanently widen the pavement proper to create a continuous one-level space.*

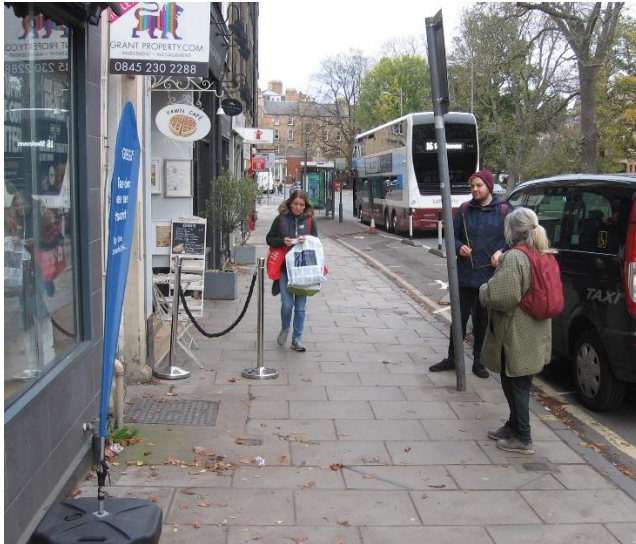
**Location 58W (Morningside Road west):**

The pavement here is 3.15m wide, but the Clear Walking Zone at the signage pole is just 1.4m wide (ie less than the SDG 'absolute minimum' of 1.5m).

*Recommendation: review the tables & chairs licence for the café, and explore the scope for the sign on the pole to be relocated on the building wall. Remind the owner of the blue 'feather' advert about the city-wide ban on advertising boards.*

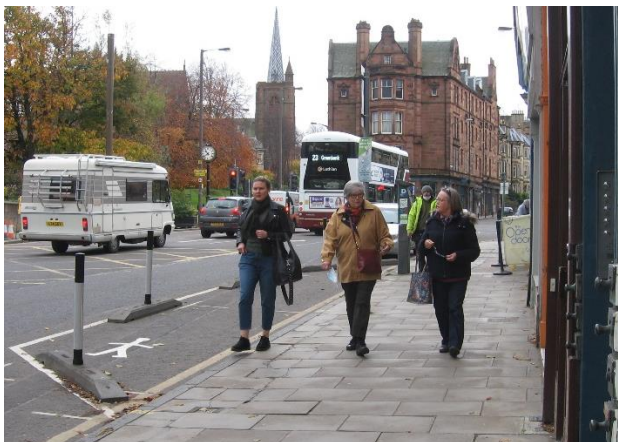
**Location 59W (Morningside Road west):**

The pavement here is only 2.95m wide (ie less than the SDG 'general minimum' of 3m) and therefore the additional SfP space is welcome.

*Recommendation: retain the SfP space, and in the longer term permanently widen the pavement proper to create a continuous one-level space.*

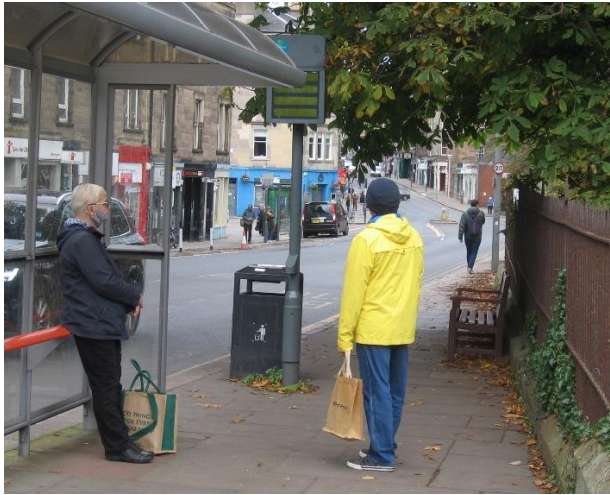
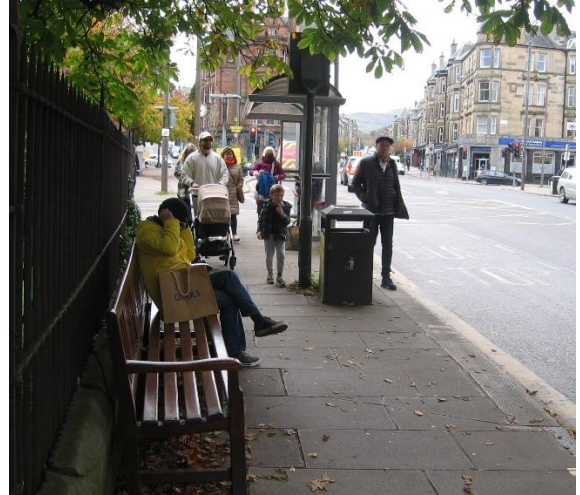
**Location 59E (Morningside Road east):**

The pavement at the bus stop is only 2.9m wide, with a Clear Walking Zone of just 1.7m. At the bench the pavement is only 2.4m wide, with a Clear Walking Zone of just 2m.

*Recommendation: review the design, potentially relocating the litter bin and the bus tracker pole, and moving the bench slightly closer to the bus stop.*

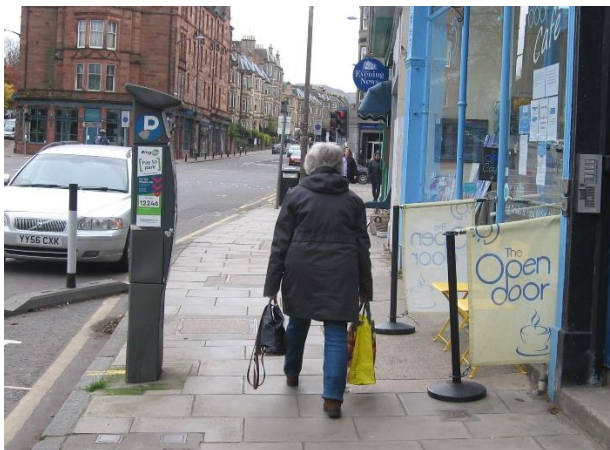
**Location 60W (Morningside Road west):**

The pavement here is only 2.85m wide, and the tables & chairs and parking ticket machine reduce the Clear Walking Zone to just 1.6m.

*Recommendation: review the tables & chairs licence for the café, and explore the scope for the parking ticket machine to be relocated into the SfP space.*
